SERVICE BULLETIN No.1098

COACH MODEL	: All coaches equipped with Detroit Diesel engine
BULLETIN TYPE	: Service Information
MANUAL & SECTION	: Not applicable
PARTS BOOK REVISION	: No
DATE	: February 6th, 2002
SUBJECT	: Detroit Diesel accessory drive specification change
TERMS & CONDITIONS	: No claims will be accepted with reference to this Bulletin.

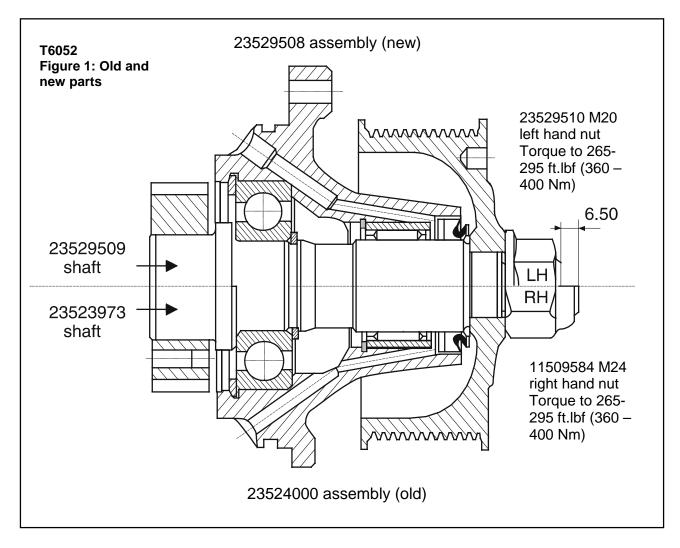
Detroit Diesel have made a change to the accessory drive assembly to increase the bearing length and force feed oil to the bearing. An improved seal was also included in the change. As a result, the shaft length of the pulley assembly increased by 1/4 inch (6.5 mm). This increase in length caused clearance problems with the cooling fan belt installation (see Figure 2). As a *temporary* countermeasure, Van Hool have, on a number of engines, shortened the shaft by removing the self locking nut, cutting ¼ inch off the shaft and installing an M24 flat nut using Loctite 243 as thread locking adhesive. The procedure in this Bulletin shows how production have modified the shaft to obtain sufficient drive belt clearance.

Attached to this Bulletin is a drawing showing both the old and the new design. The new accessory drive assembly has been cut into production as from C2045 unit #45820.

As a *permanent* countermeasure, Detroit Diesel have now introduced a new accessory drive assembly with a shortened shaft to provide the required clearance, and a left hand threaded M20 nut to secure the pulley. This feature avoids the necessity of a locking feature on the nut, as opposed to the right hand threaded nut on the original shaft, since the pulley will turn in the direction to cause the nut to tighten.
