Service Bulletin No. 1058

| COACH MODEL | : T2100 Series ; S2100 ; C2000 Series |
| DATE | : November 30th, 2000 |
| SUBJECT | : Coolant and oil pressure warning light trigger signals |

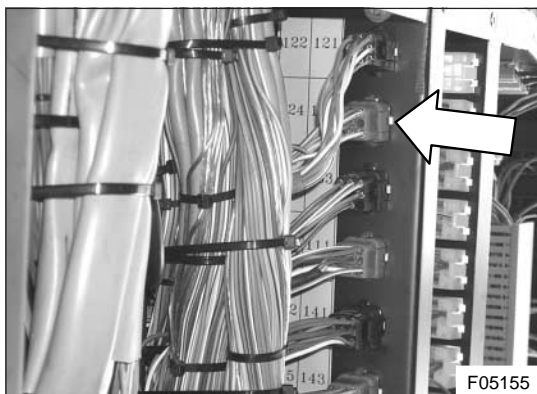
Figure 1: Location of connector #123, on the right hand side rack, second row from the top.

4. Separate both these connectors and remove terminals #3 and #9 (receiver end) from connector #123 as described in the Maintenance Manual - Chapter 9 : Electrical System. Remove terminals #6 and #9 (receiver end) from connector #701.
5. Refit the connectors. Cut off the terminals from their respective wires (white-green & orange-white). Tie back the wires with tie-wraps.

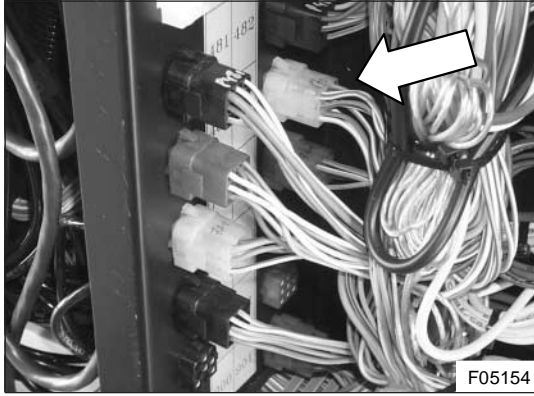
Figure 2: Location of connector #701, on the left hand side rack, fifth row from the bottom.
