SERVICE BULLETIN No.1121

COACH MODEL	: C2045
BULLETIN TYPE	: Service Information
MANUAL & SECTION	: N/A
PARTS BOOK REVISION	: No
DATE	: October 27th, 2003
SUBJECT	: Alternator harness and lavatory slide valve heat shield interference possibility on coaches with Detroit Diesel engine
TERMS & CONDITIONS	: Van Hool/ABC will reimburse 30 minutes of labor per vehicle inspected upon receipt of a completed claim form on which has been specified "B+ alternator harness inspected as per Van Hool Service Bulletin No.1121."

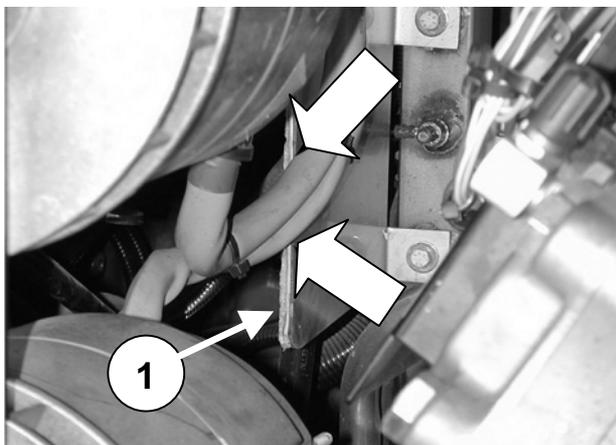
1. On the above-mentioned units, it is necessary to inspect the alternator B+ harness installation and possibly have the wiring repaired in order to improve the reliability of the system.
2. It has been determined that the alternator B+ cables may interfere with the shield, which protects the lavatory slide valve from engine heat.
3. If there is insufficient clearance between the wiring and the heat shield, the insulation of the B+ cables may be subject to chafing, which in turn can lead to arcing and possible shorts.
4. Refer to the procedure in this Bulletin for inspection instructions and guidance on repair arrangements.

- 1) Open the engine compartment rear and side access doors.
Locate the lavatory slide valve heat shield.
- 2) Check the alternator B+ harness protection sleeve and cable for actual or potential damage as shown in 1, Figure 1.

Figure 1: Damage hazard at the lavatory slide valve heat shield (1)

Insulation damage: any damage to the protection sleeves and/or the B+ cable wire insulation should be repaired with heat shrink tubing.

Wire core damage: any B+ cable, of which the wire section has been reduced to less than 0 AWG (50 mm²) should be substituted. New cable should be protected with sleeve and secured with tie wraps.

CAUTION: Alternator B+ cables of which the core has been damaged, should be substituted in their entirety. No attempt should be made to partly replace these cables.

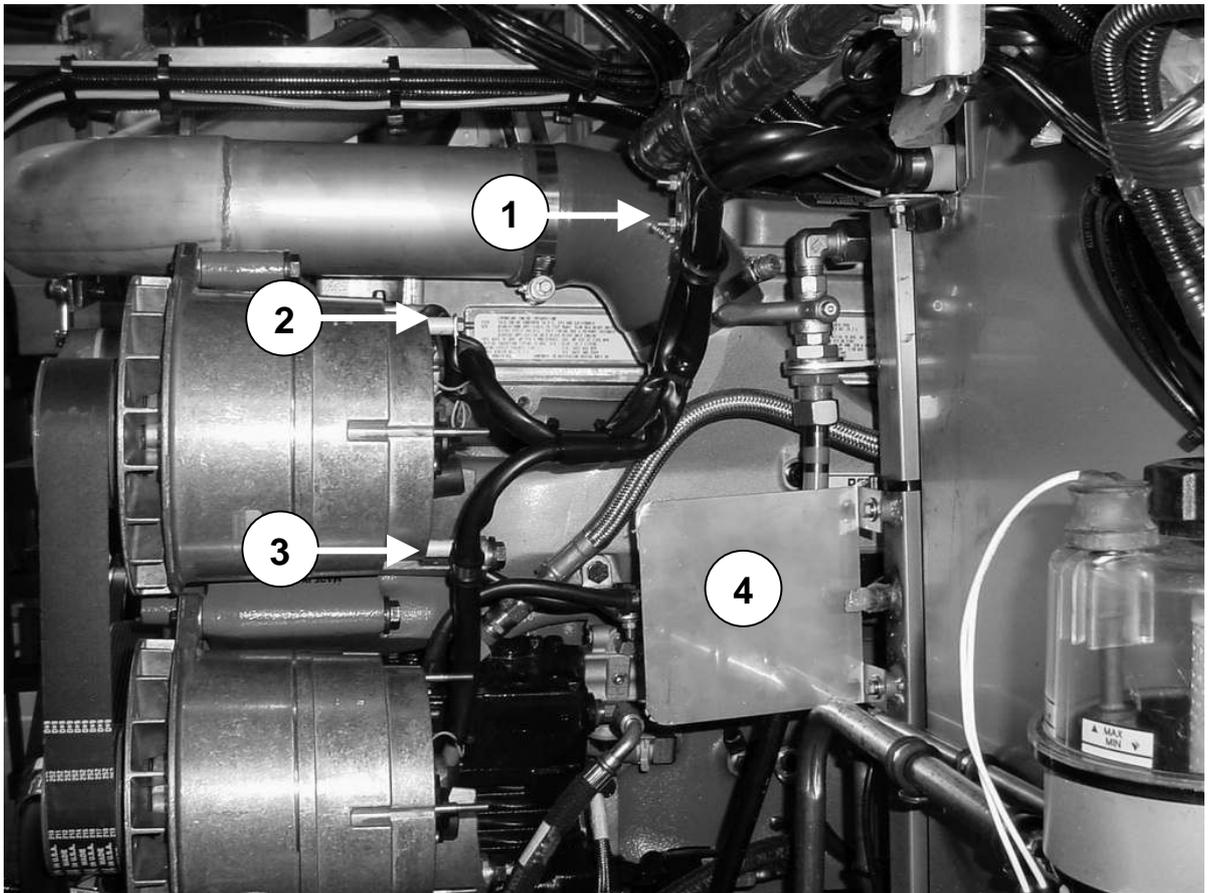
- 3) Check the B+ harness installation to comply with the recommended one shown in Figure 2. Cables should be installed free of strain and be supported only by rubber insulated clamps. Wiring should not be allowed to contact anything that might cause damage to it.

Figure 2: Proper routing of alternator cables and location of heat shield (HVAC compressor not shown):

1. Chassis to B+ harness clamp
2. Upper alternator B+ cable clamp
3. Lower alternator B+ cable clamp
4. Lavatory slide valve heat shield

Note ample heat shield to alternator B+ cable vertical clearance.

- 4) If there is any damage to or poor installation of the alternator B+ cables, contact ABC Customer Care & Parts Source to have the problem rectified.

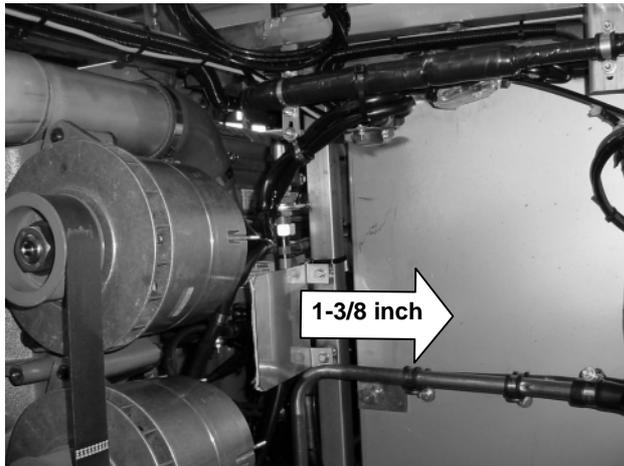
Figure 3: Bending the heat shield to clear the wiring

- 5) As a preventive measure to clear the alternator B+ harness, carefully bend the heat shield 1-3/8 inch (35 mm) towards the lavatory slide valve (see Figure 3).
