# SERVICE BULLETIN No.1122

<b>COACH MODEL</b>	: T900, T2100 and C2000 Series
<b>BULLETIN TYPE</b>	: Service Information
<b>MANUAL &amp; SECTION</b>	: Maintenance Manual: Chapter 4 – Axles, wheels and tires
<b>PARTS BOOK REVISION</b>	: No
<b>DATE</b>	: November 6th, 2003
<b>SUBJECT</b>	: <b>Rear cover weld cracks on 11.36 Dana drive axle housings</b>
<b>TERMS &amp; CONDITIONS</b>	: No claims will be accepted with reference to this Bulletin.

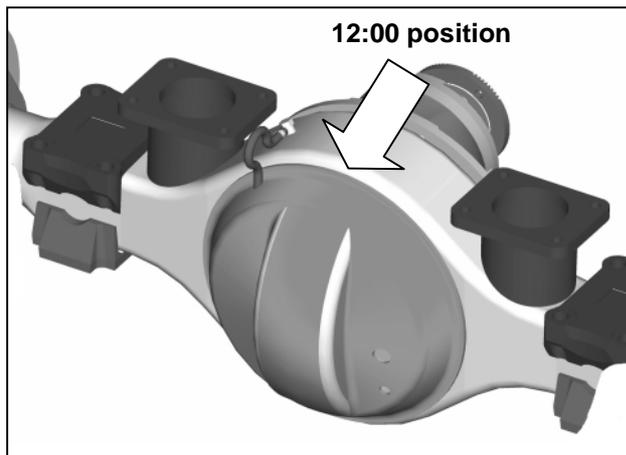
**Figure 1: Affected drive axle area**

1. Dana have identified an issue with housing cover weld cracking at the 12:00 o'clock position on the 11.36 axle housing used in Van Hool coach applications (see Figure 1). This issue has been restricted to Van Hool coaches built from January 1996 to the end of 2001 with model nomenclatures of T940, T945, T2140, T2145 and C2045.

2. As an extension of the B-type 6,000 miles service interval prescribed in the Maintenance Manual, Van Hool coaches built between these dates should not only have the drive axle lubricant level checked, but the axle should also be inspected for cover weld cracks.
3. Refer to the procedure below, which provides detailed instructions for a visual inspection.

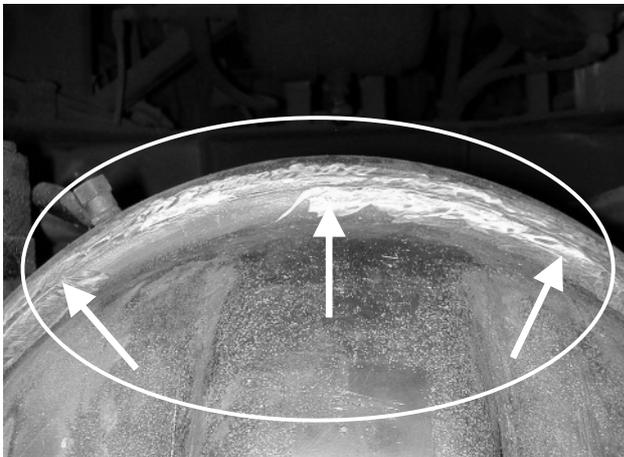
- 1) Visually inspect the housing cover for signs of cracks at the top (see Figures 2 and 3).

**Figure 2: Drive axle housing area to be checked for cracks**

- 2) If in doubt, or if cracks are not clearly visible, thoroughly clean and degrease the drive axle housing cover upper weld area.
- 3) Thoroughly wire brush the weld.
- 4) Using a mirror and appropriate lighting, check the weld for (hair) line cracking.
- 5) If a crack is detected, contact your ABC representative, dedicated for this issue who will advise for repair and warranty submission (see reference box).

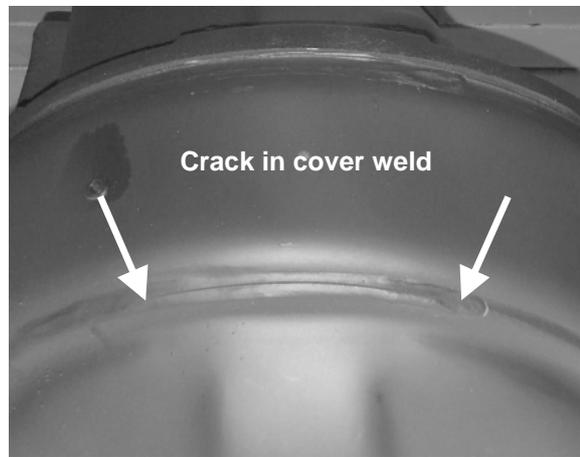
**Figure 3: Weld bead showing hairline crack in the center of the bead**

- 6) Dana confirms that the housing cover cracks experienced in Dana 11.36 drum brake axles assembled on Van Hool models T900, T2100 and C2000, do not affect the structural integrity of the axle housing.
- 7) If no crack has been detected, checks should again be made at every B-type service interval (6,000 miles) to make sure a crack does not appear at a later stage.
- 8) Dana, through Van Hool, have extended the warranty for this failure mode (drive axle housing cover cracks) to 750,000 miles from the first day in service of the coach and for 5 years after the fix date.
