SERVICE BULLETIN

SB1207

COACH/BUS MODEL : T and C coaches w/ Cummins engine

SUBJECT : Turbocharger – compressor discharge elbow change

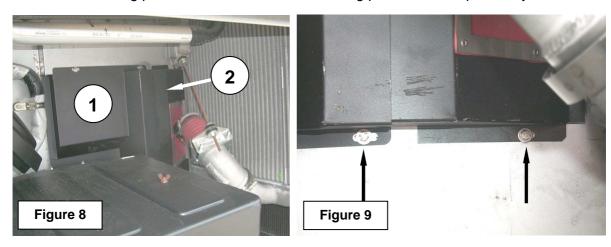
7) Take note of the engine compartment closing panel installation. Starting with #1 panel (1, Figure 8), undo and remove the retaining bolts and washers. Figure 9 shows some installation details. Remove both #1 and #2 panels.

Recover #1 closing panel and all fasteners. #2 closing panel will be replaced by a new one.
