SERVICE BULLETIN

ADDRESSEES	: Owners and operators of coaches listed under 'Application'
COACH/BUS MODEL	: T2100 Series and C2045 w/ Detroit Diesel Series 60 DDEC V engine
BULLETIN TYPE	: Service Information
SECTION/CHAPTER	: Section 3 – Drive train Chapter 2.2 Traction engine – control systems
DATE	: October 7, 2009
SUBJECT	: Vehicle interface harness – chafing issues
TERMS & CONDITIONS	:-

DESCRIPTION:

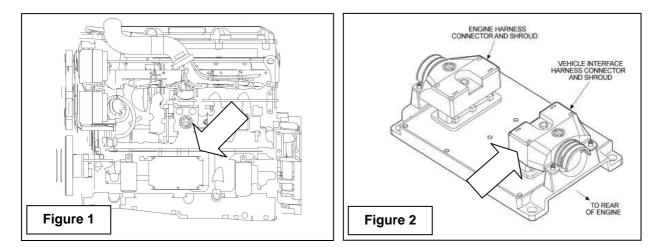
1. Van Hool has determined that, on the above-mentioned units, a defect may occur with respect to the vehicle interface harness connector and shroud that connect to the engine ECU (Figures 1 and 2).

3. When regular maintenance inspections are performed the defect may go unnoticed as the shroud completely covers the connector and conduit. As a precautionary measure and in order to ensure system performance, it is therefore necessary to purposely check, and if necessary, improve the protection of the vehicle interface harness wires as described by the procedure further in this Bulletin.
