SERVICE BULLETIN

SB1252

VEHICLE MODEL : C2045, CX35, CX45, TX40, TX45

SUBJECT: To change weather strip mounting lip of luggage

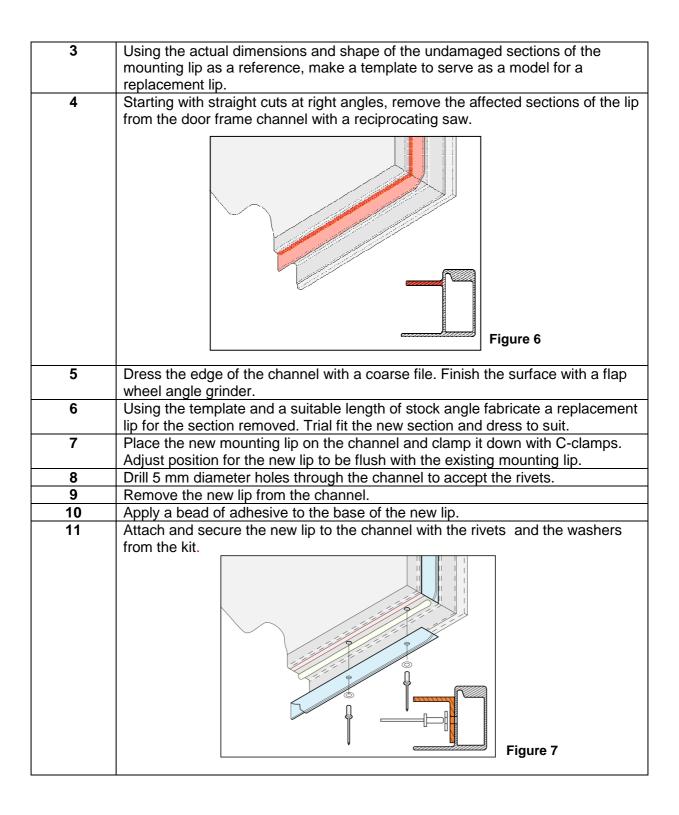
Step	Action
1	Detach the weather strip from the door in its entirety.
2	Determine the extent of the corrosion damage and mark the sections to be removed.
	Figure 5

3. To repair the weather strip mounting lip:
