SERVICE BULLETIN

SB1268

ADDRESSEES	: ABC Customer Care and Parts Source Owners and operators of coaches listed under 'Application'
VEHICLE MODEL	: TX40-TX45
MANUAL SECTION	: Chapter 10.10: Windshield wipers
BULLETIN TYPE	: Field Change Program
DATE	: September 09th, 2014
SUBJECT	: To prevent windshield wiper blades lifting from the windshield
TERMS & CONDITIONS	: Refer to the warranty section further in this Bulletin.

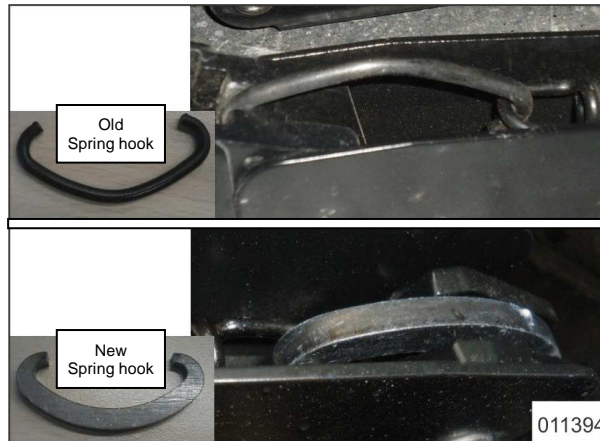
Figure 1

- It has been determined that under certain conditions, it is possible that the wiper blades may lift from the windshield at highway speed.
- To address this issue, DOGA and Van Hool are conducting a Field Change Program, the terms and conditions of which are explained further on under "Warranty".
- Owners and operators of the affected units should follow the procedure below to replace the wiper arms.
- Old and new wiper arms can be identified by the spring hook design located on the inside of the lower part of the arm as shown in Figure 1.

VH Reference	Description	Qty.
10951137	Wiper arm with old spring hook	2

VH Reference	Description	Qty.
11422003	Wiper arm with new spring hook	2
