SERVICE BULLETIN SB1325

ADDRESSEES	: Owners and operators of coaches listed under "Application"
VEHICLE MODEL	: CX35, CX45
SYSTEM/SUBSYSTEM	: 10.06 Exterior lighting and signaling devices – turn signals
BULLETIN TYPE	: Field Change Program
DATE	: August 25th, 2016
SUBJECT	: To modify front turn signal lamps installation
TERMS & CONDITIONS	: Refer to the warranty section further in this Bulletin

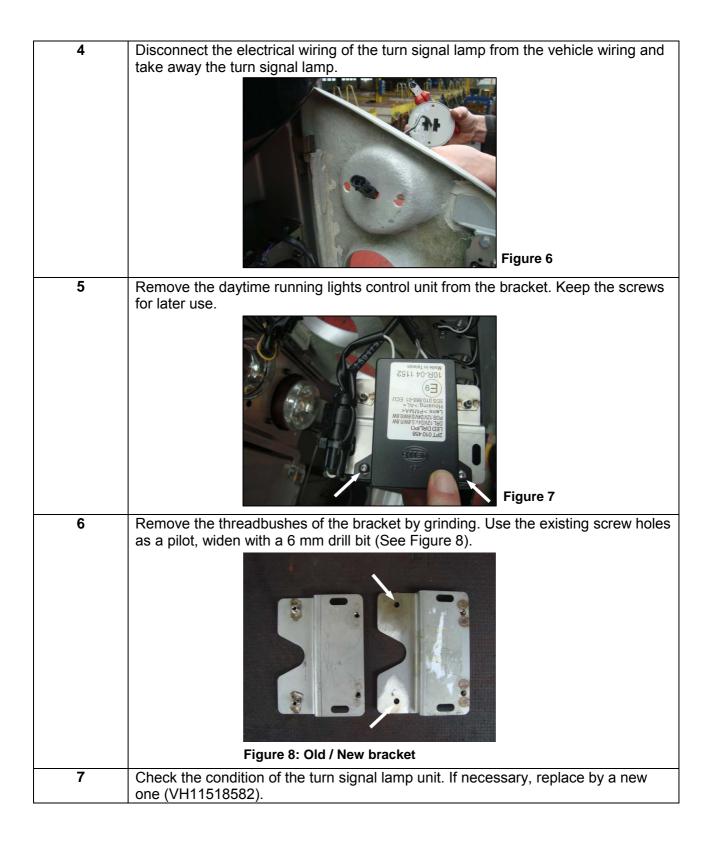
- It has been determined that the front turn signal lamps of the above mentioned vehicles show frequently water intrusion. Investigation has shown that the contact surface for the turn signal lamp in the polyester headlight cluster protective cap is not always smooth. This roughness causes strain in the lamp unit when the fasteners are tightened. It can also bring about cracks in the lamp unit by which water can intrude.
- To address this issue, Van Hool is conducting a Field Change Program, the terms and conditions of which are explained further on under "Warranty". Owners and operators of the affected units should follow the procedure below to modify the front turn signal lamps installation.

Step	Action
1	Remove the protective cap screw.
	Figure 3
2	Swing open the protective cap.
	Figure 4
3	Remove the two screws holding the turn signal lamp to the bracket at the back side of the protective cap.
	Figure 5

8	Install the rubber seal 11507294 from the kit together with the front turn signal
	lamp to the protective cap.
9	Secure the turn signal lamp together with the reworked bracket by using screws 10800208 (2x), nuts 660209902 (2x) and washers 10522071 (2x) from the kit to the backside of the protective cap. Maximum tightening torque: 1 Nm (0.7 ft.lbf).
10	Secure the daytime running light control unit at the bracket by using the original screws. Plug in the electrical connector of the turn signal lamp.
