# SERVICE BULLETIN

SB1365

<b>ADDRESSEES</b>	: Owners and operators of coaches mentioned under "Application"
<b>VEHICLE MODEL</b>	: C2045, CX35, CX45, TX45
<b>MANUAL CHAPTER</b>	: 02.22 Traction engine – Air intake system
<b>BULLETIN TYPE</b>	: Field Change Program
<b>DATE</b>	: June 17th, 2016
<b>SUBJECT</b>	: To check engine air-intake pipe for interference damage
<b>TERMS &amp; CONDITIONS</b>	: Refer to the warranty section further in this Bulletin.

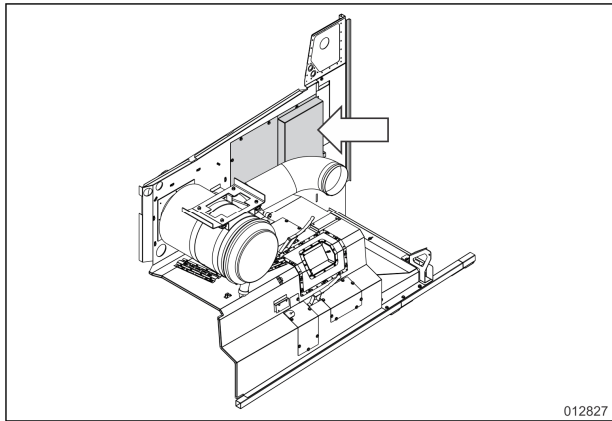
**Figure 1**

<b>Step</b>	<b>Action</b>
<b>1</b>	<p>Open the exterior access door of the radiator compartment, located on the left very rear side. Remove the screws and take the side panel away to get access to the air-intake pipe between the air-cleaner and the turbocharger.</p> <div data-bbox="568 1563 1182 1982">

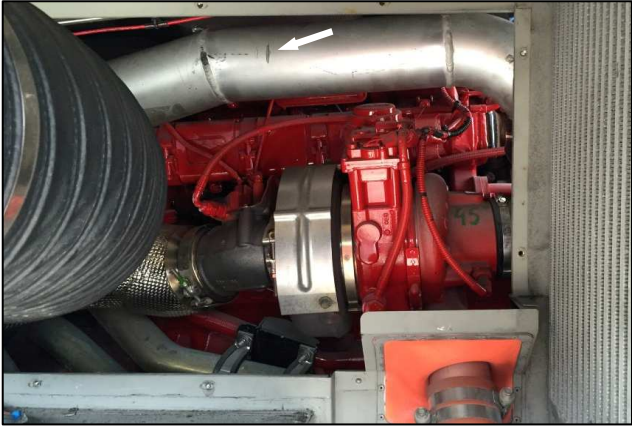
2	<p>Are there any signs of damage on the air-intake pipe?</p> <ul style="list-style-type: none"> <li>• If so, go to step 3.</li> <li>• If not, go to step 4.</li> </ul>
