SERVICE BULLETIN

SB1402

ADDRESSEES	: ABC Customer Care and Parts Source Owners and operators of coaches listed under 'Application'
VEHICLE MODEL	: TD925US, TDX25US
SYSTEM/SUBSYSTEM	: 10.06 Interior lighting equipment
BULLETIN TYPE	: Field Change Program
DATE	: October 12 th , 2017
SUBJECT	: Parcel-rack lighting electrical circuit modification
TERMS & CONDITIONS	: Refer to the warranty section further in this bulletin.

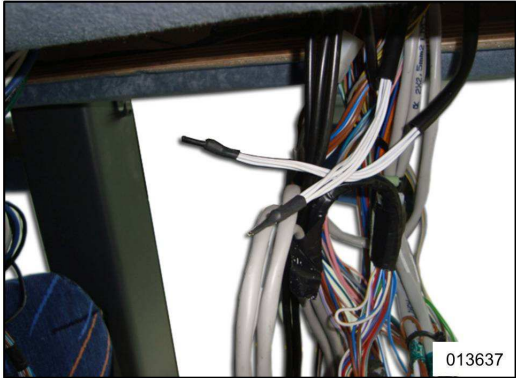
<p>013637 Figure 5</p>
2.2	<p>Separate the 5 white electric wires of one bundle and strip back their ends.</p>

On TD925 vehicles, a connection in the parcel-rack lighting circuit is inadequate. The splicing of the electrical wires has been executed by twisting the strands together and insulating them with electrical tape instead of using a connector. Also neighbouring spare wires were mistakenly put together in the same connection. This situation can result in arching and overheating when the parcel-rack lighting circuit is energized and one of the spare wire ends is grounded. Follow the step-by-step instructions mentioned under "To modify TD925 parcel-rack lighting circuit". The necessary parts are listed in the table on page 2.

Step	Action
2.1	<p>Locate the two bundles of five white electric wires.</p>

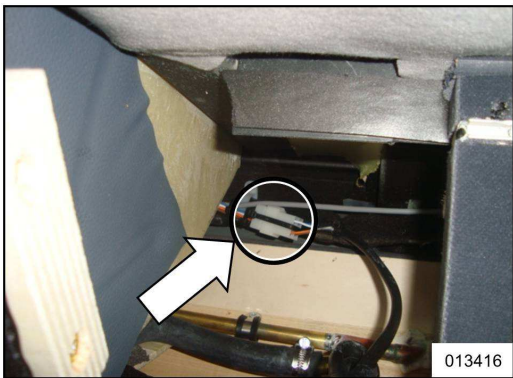
On TDX25US vehicles, a 4-pin connector with loose wires has not been removed as it should have been. This may result in arching and overheating when the parcel-rack lighting circuit is energized and one of the loose wire ends is grounded. Follow the instructions mentioned under "To modify TDX25 parcel-rack lighting circuit". No parts are necessary for TDX25 vehicles.

3	<p>Locate the white 4-pin connector at the back of the compartment.</p>

<p style="text-align: right;">013416 Figure 10</p>
4	<p>Disconnect the 4-pin connector and remove the wires together with the connector plug.</p>
5	<p>Notify ABC Companies by mail. Write the text "SB1402 executed for VIN....." in the mail and send the mail to warranty@abc-companies.com.</p>
6	<p>For ABC Companies only: register through the registration button located behind the Service Bulletin on the Van Hool customer portal. Write the text "SB1402 executed"" in the field "Remark". Labor allowance will only be awarded after Van Hool has received the registration.</p>
