ADDRESSEES	: ABC Customer Care and Parts Source Owners and operators of vehicles mentioned under "Application"
VEHICLE TYPE	: CX45 and TX45 with Detroit Diesel DD13 EPA2016 engine
CONFIGURATION GROUP	: 2.22 Traction engine – Air intake system
BULLETIN TYPE	: Service Information
DATE	: November 29th, 2017
SUBJECT	: To check security of engine air intake pipe bracket
CONDITIONS	: This service bulletin does not entitle to any reimbursement.

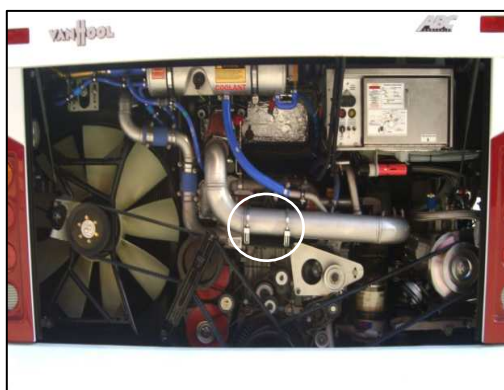
Figure 1: Location of bracket

It has been determined that on a number of vehicles the engine air intake bracket (refer to figure 1 for location of bracket) is possibly not properly secured to the engine. Due to production tolerances, the 25 mm (1 inch) long screws can bottom out before the screw head is tight against the bracket.

To address this issue it is necessary to check the security of the bracket during the next service interval at the latest in order to ensure system performance.
