# SERVICE BULLETIN

SB1464

**VEHICLE TYPE**: Vehicles with Allison WTB500 transmission

SUBJECT : Transmission routine inspections on leaks

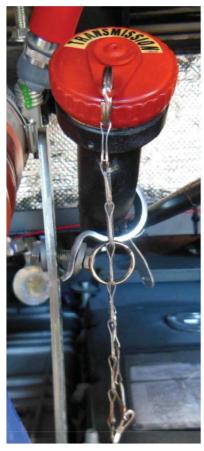
Figure 8: Fill tube requiring modifications

- With all the clamps loose, verify the tube does not need to be forced down to clear the top of the engine compartment.
- The fill tube should lay on all the mounting supports and not require any force to secure it.
- If the fill tube does require force to be secured properly, then it must be removed and modified. Refer to Figure 8 for a tube requiring modification.
- If modification to the pipe is required, replacement of the grommet must also be performed while it is removed.

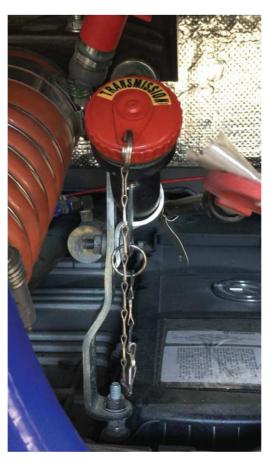
Figure 9: Modified fill tube
