ADDRESSEES	: Owners and operators ABC Customer Care and Parts Source
VEHICLE MODEL	: TD925US
MANUAL SECTION	: 14.10 Electricity – wiring
BULLETIN TYPE	: Field Change Program
DATE	: December 09th, 2019
SUBJECT	: To optimize power supply of fuse holder ZB3 in junction box EKA
TERMS & CONDITIONS	: Refer to the warranty section further in this Bulletin.

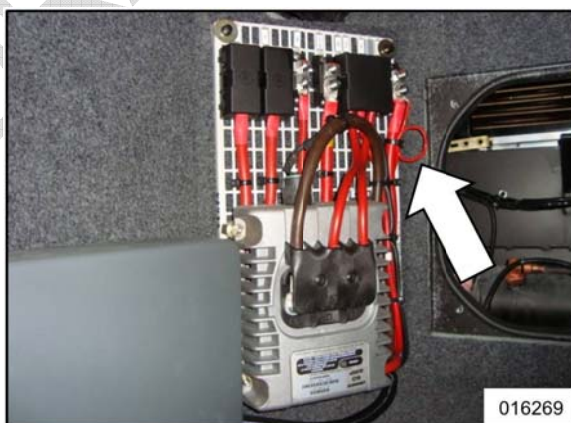
It has been reported that the red 6 mm² power supply wire connected at stud “MP+24V” in junction box “Vanner” is not protected by a fuse. This wire runs from stud “MP+24V” to terminal block DVB in junction box EKA, from there the wire continues to fuse holder ZB3 in junction box EKA to power fuses Z83.1 and Z86.

Figure 1: In luggage compartment, location of concerned 6mm² power supply wire on grid panel of junction box “Vanner (orientation of Vanner and grid panel may vary)

This service bulletin gives step-by-step instructions how to install an additional 30A MIDI-fuse in junction box “Vanner” to make sure that this wire is protected against overheating in case of overcurrent.

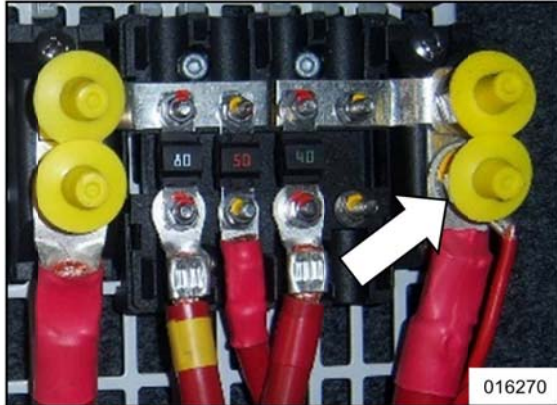
<p>Figure 4: Location of “MP+(24V)” stud (marked with a tag)</p>
4	<p>In junction box “Vanner”: install the 30A MIDI fuse from the kit on the free position next to “MP+ (24V)” connecting stud.</p> <ol style="list-style-type: none"> Cut off the original cable lug from the red 6 mm² wire. Strip the end of the red 6 mm² wire over a distance of 8 mm. Crimp the red 6 mm² wire to cable lug 11060885 from the kit by using the recommended crimping tool/die set. Remove the protective cover from the fuse block next to the “MP+ (24V)” connecting stud. Remove the nuts and install the 30A MIDI fuse from the kit. Secure the cable lug of the red 6 mm² wire to the stud. Re-install the nuts on the studs of the fuse holder. Tighten the nuts to a torque of 4.5 Nm (40 in.lbf). Seal the nuts with a drop of paint as indication that the nuts are properly torqued. Re-install the protective cover.

3	<p>In junction box “Vanner”: disconnect the 6 mm² wire from the “MP+ (24V)” connecting stud.</p> <ol style="list-style-type: none"> Remove the yellow protective cap from the “MP+(24V)” stud to which the concerned 6 mm² wire has been secured. Remove the nut securing the 6 mm² wire. Withdraw the 6 mm² wire from the stud. Re-install the nut on the “MP+(24V)” stud. Tighten the nut to a torque of 35 Nm (26 ft.lbf). Seal the nut with a drop of paint to indicate that the nut is properly torqued. Reinstall the protective cap.
