ADDRESSEES	: Owners and operators of vehicles listed under “Application” ABC Customer Care and Parts Source
VEHICLE MODEL	: CX35, CX45, TX45, TD925US, TDX25US, AG300
MANUAL CHAPTER	: 02.10 Engine – Fuel system
BULLETIN TYPE	: Safety Recall NHTSA 21V-385
DATE	: July 06 th , 2021
SUBJECT	: High pressure fuel rail assembly may leak fuel
CONDITIONS	: -

***** IMPORTANT SAFETY RECALL *****
NHTSA Recall No. 21E-032
Cummins Campaign #C2423

Technical Service Bulletin: TSB210113	Released Date: 30-Jul-2021
Fuel Rail Assembly Inspection and Repair Procedure: External Fuel Leaks

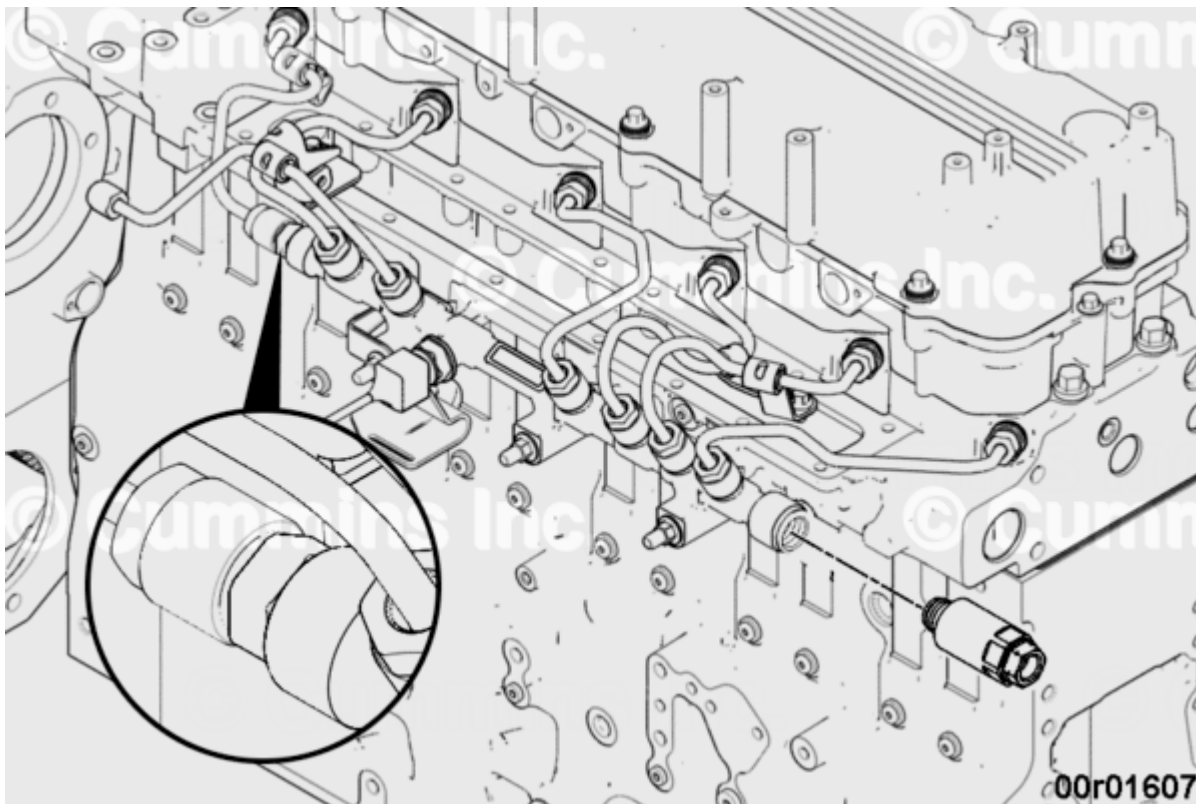
Figure 1, Removing the pressure relief valve and the high pressure fuel fitting.

- Remove the pressure relief valve and the high-pressure fuel fitting from the fuel rail.

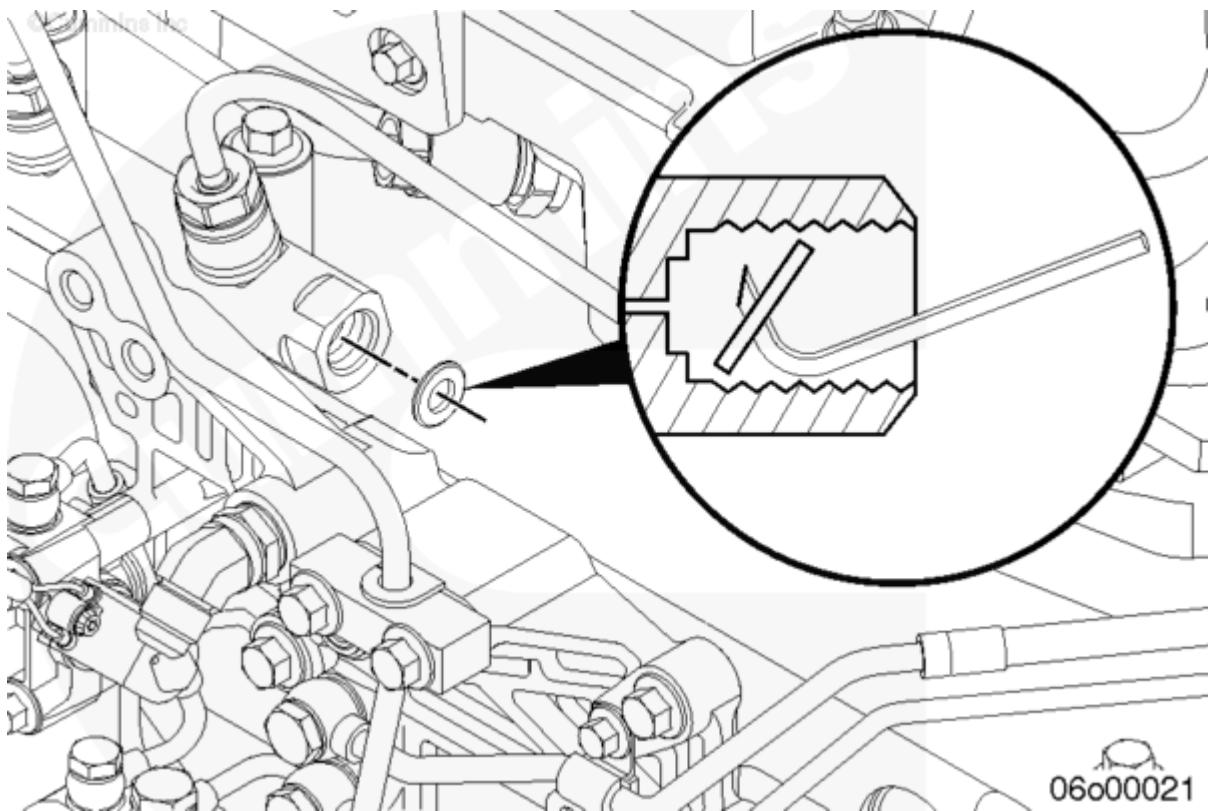
Figure 2, Removing Sealing Washer from Fuel Rail.

- Remove and discard the sealing washers. The procedure below outlines how to remove the sealing washers.

- A special tool **must** be created for the removal of the sealing washers by grinding a 45 degree angle on the short leg of a 1/8-inch or 3/16-inch Allen wrench, so that the wrench is no longer than 13 mm [½ in] long (measured from the outside of the long leg.)
- This tool acts as a mini heel bar to pry out the sealing washer without damaging the back of the hole.
- Use the modified Allen wrench to pry out the old sealing washer from the threaded hole in the fuel rail. Considerable force is required to remove the sealing washer.

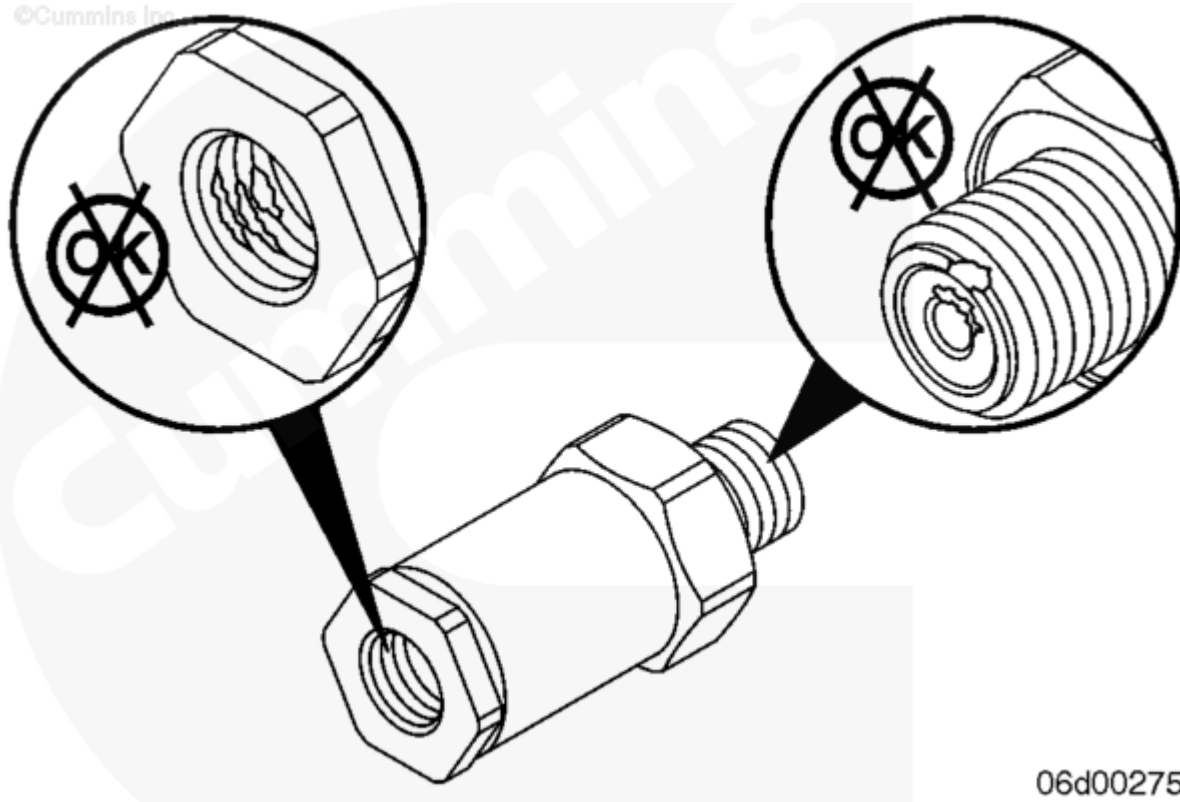
- Visually inspect the thread surfaces of the fuel rail, fuel pressure relief valve and the high-pressure fuel fitting for damage. Review Figures 3 and 4 below for guidance.
- Do **not** reuse components if the threads or sealing surfaces are damaged.

Figure 3, Threads That Do Not Meet Reuse Guidelines.

- If the threads or sealing surfaces are damaged, replace the fuel rail assembly. See corresponding Service Manual. Reference Procedure 006-060, 006-061 in Section 6 and Technical Service Bulletin, New Fuel Rail, High Pressure Injector Supply Lines, Fuel Supply Line, and Fuel Supply Line Braces, TSB210055 for directions.
- If the threads or sealing surfaces are **not** damaged, install the pressure relief valve and the end fitting with the following procedure:

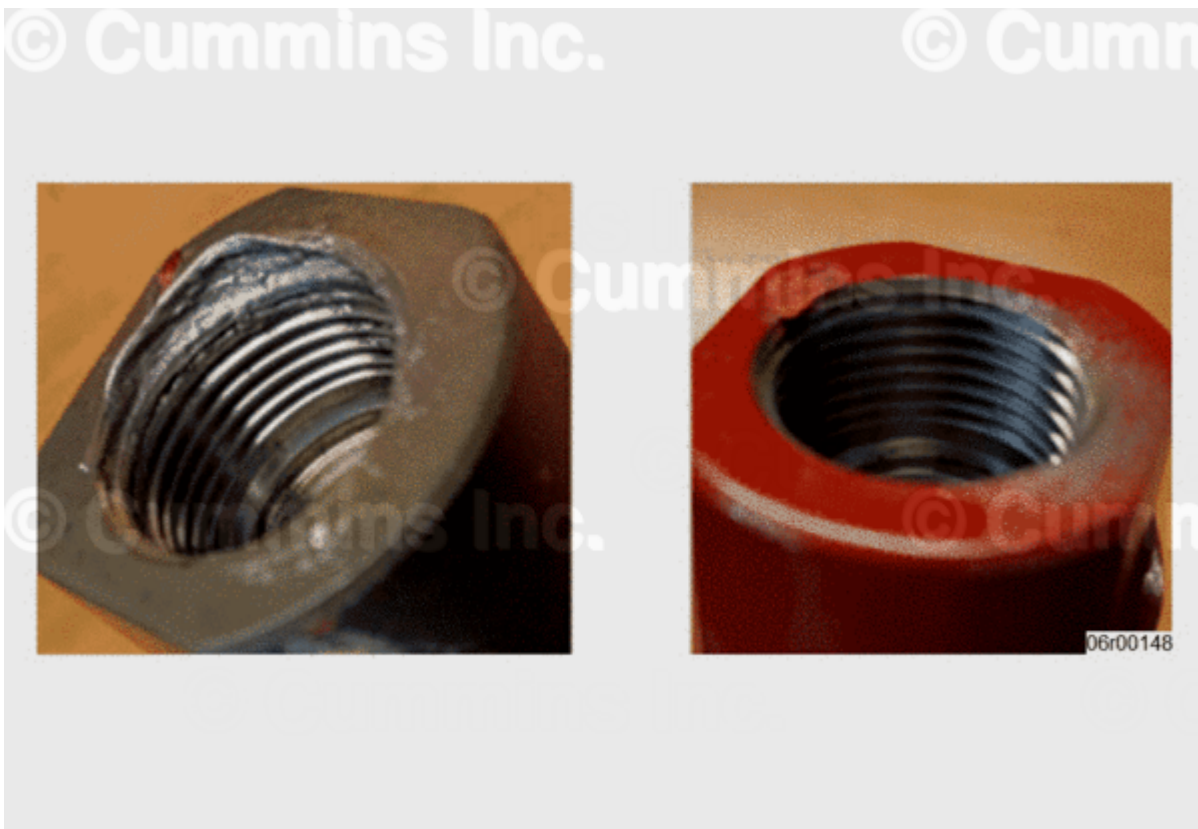
Figure 4, Left: Not Acceptable For Reuse, Right: Acceptable For Reuse.

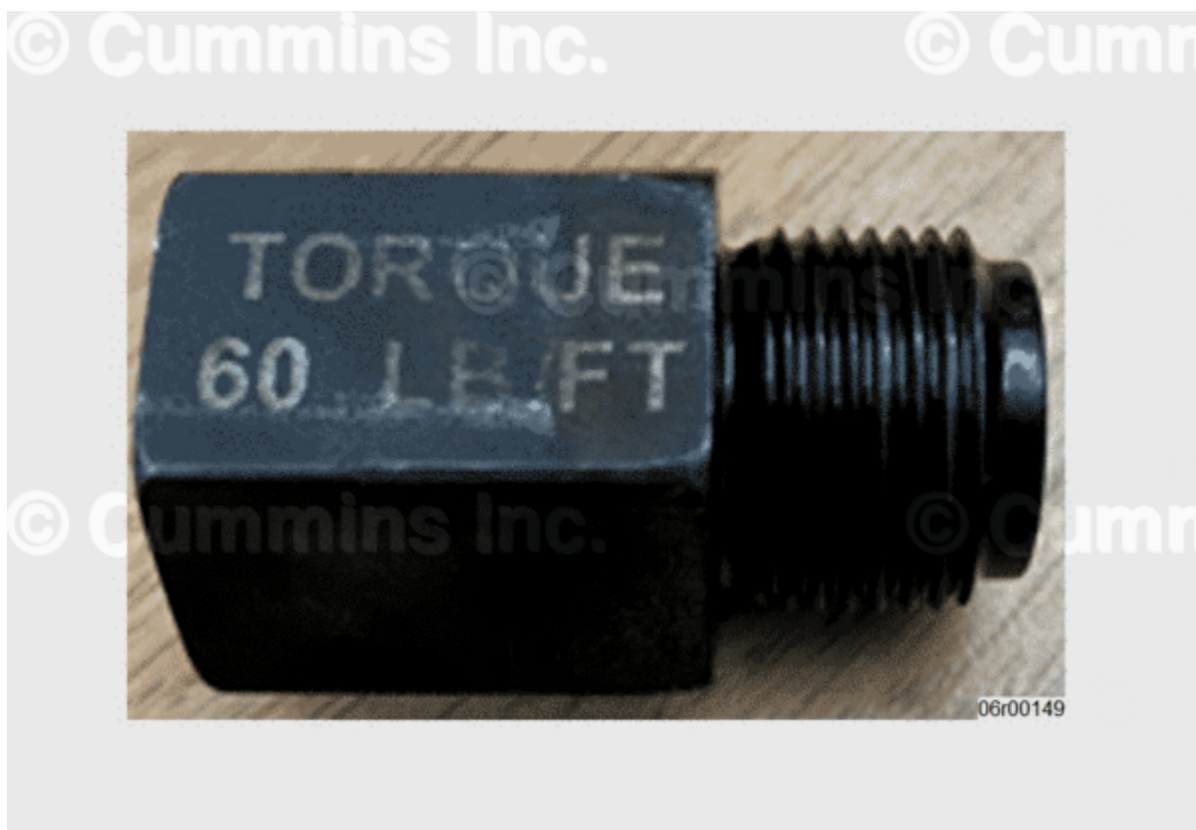
Figure 5, New Seal Installer Tool, Part Number 5573487.

- A new seal installer tool, Part Number 5573487, is now available for this repair.

- The new seal installer tool **must** be available for all repairs requiring the installation of pressure relief valve or the high pressure fuel fitting on the fuel rail. See Service Instructions section below.

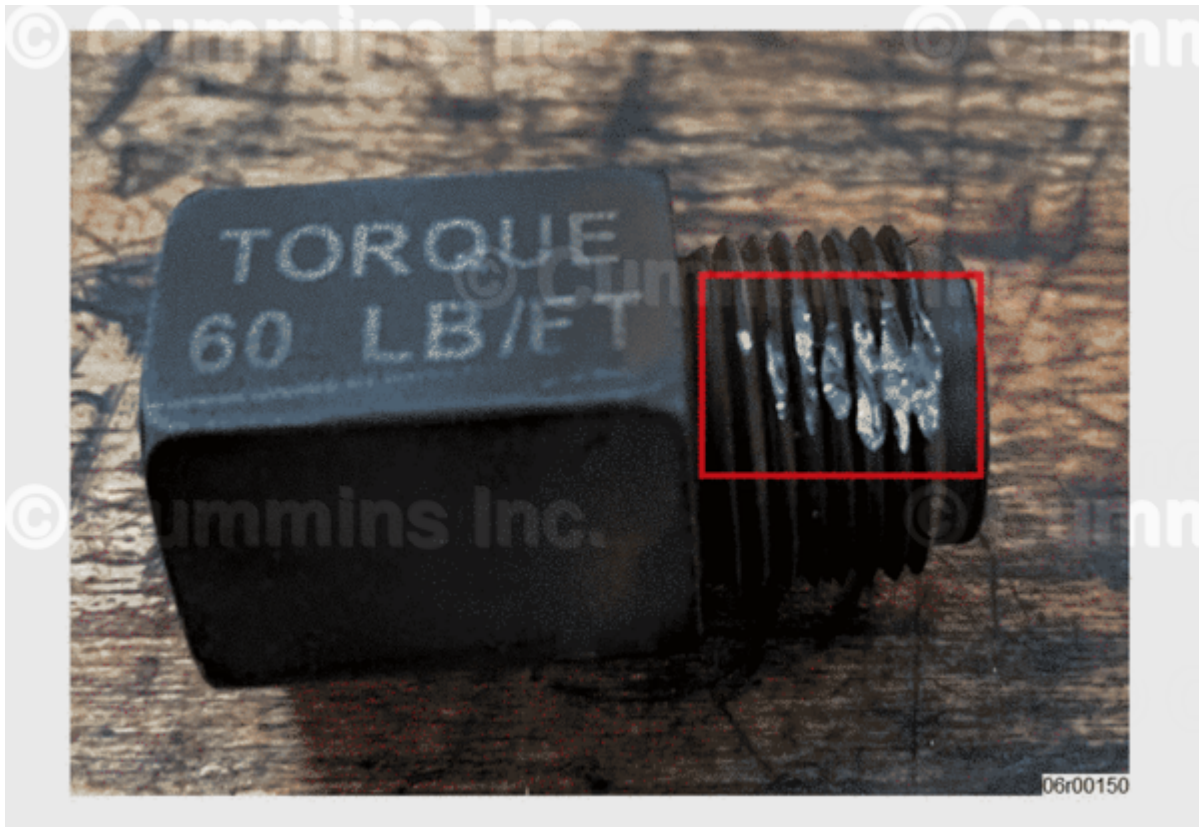
Figure 6, Seal Installer Tool Threads Not Acceptable for Use.

1. Inspect the seal installer tool for damage on the threads or sealing surfaces. Do **not** use the seal installer tool if the threads or sealing surfaces are damaged.

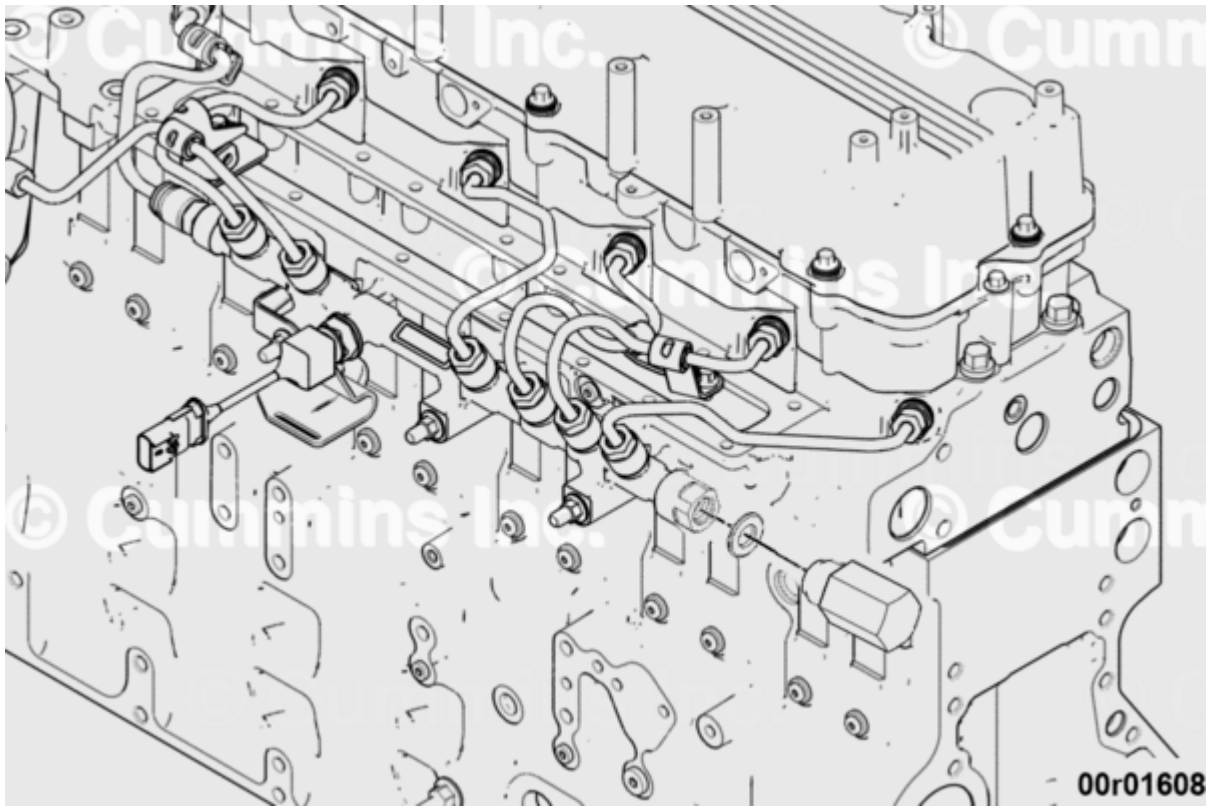
Figure 7, Installing Sealing Washer with The Seal Installer Tool.

2. Install a new sealing washer on the pressure relief valve bore in the fuel rail. Use assembly lubricant, Part Number 3163087, or equivalent, on the threads and the face of the seal installer tool. Use seal installer tool, Part Number 5573487, to seat the sealing washer fully in the fuel rail bore.

3. Torque the seal installer tool.

Torque Value: 81 n•m [60 ft-lb]

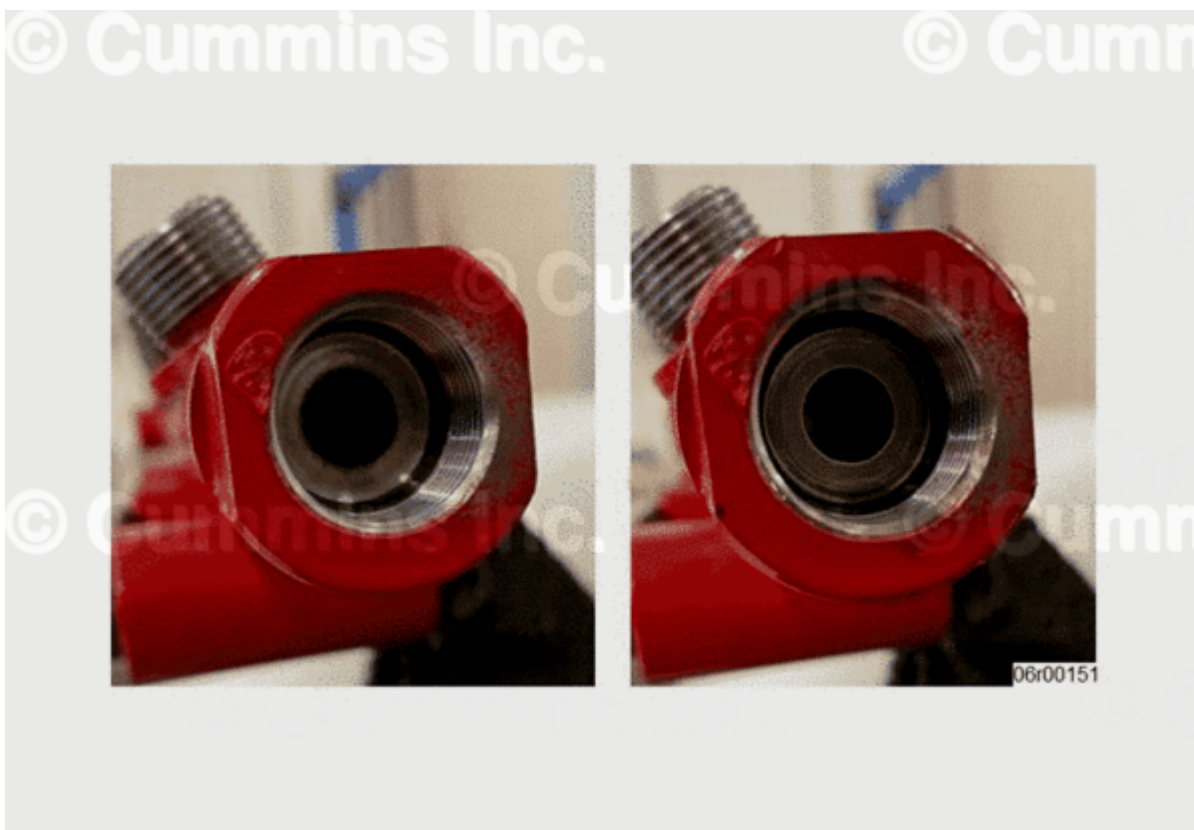
Figure 8, Left: Sealing Washer Not Installed, Right: Sealing Washer Installed Correctly.

4. Remove the seal installer tool after the sealing washer has been installed. Verify that the sealing washer remains seated inside the fuel rail after the seal installer tool is removed.

9. If either of the sealing washers do **not** remain seated inside the fuel rail after the seal installer tool has been removed, use of seal installer tool is not required. Install washer in bore.
