Service Bulletin No. 1063

COACH MODEL	: T2100 Series
BULLETIN TYPE	: Service information
MANUAL & SECTION	: Maintenance Manual : Chapter 10 - HVAC System Chapter 12 - Maintenance Schedule of Appendices
DATE	: January 31st, 2001
SUBJECT	: Corrosion of front unit flap actuator pivot point
TERMS & CONDITIONS	: No claims will be accepted with reference to this Bulletin.

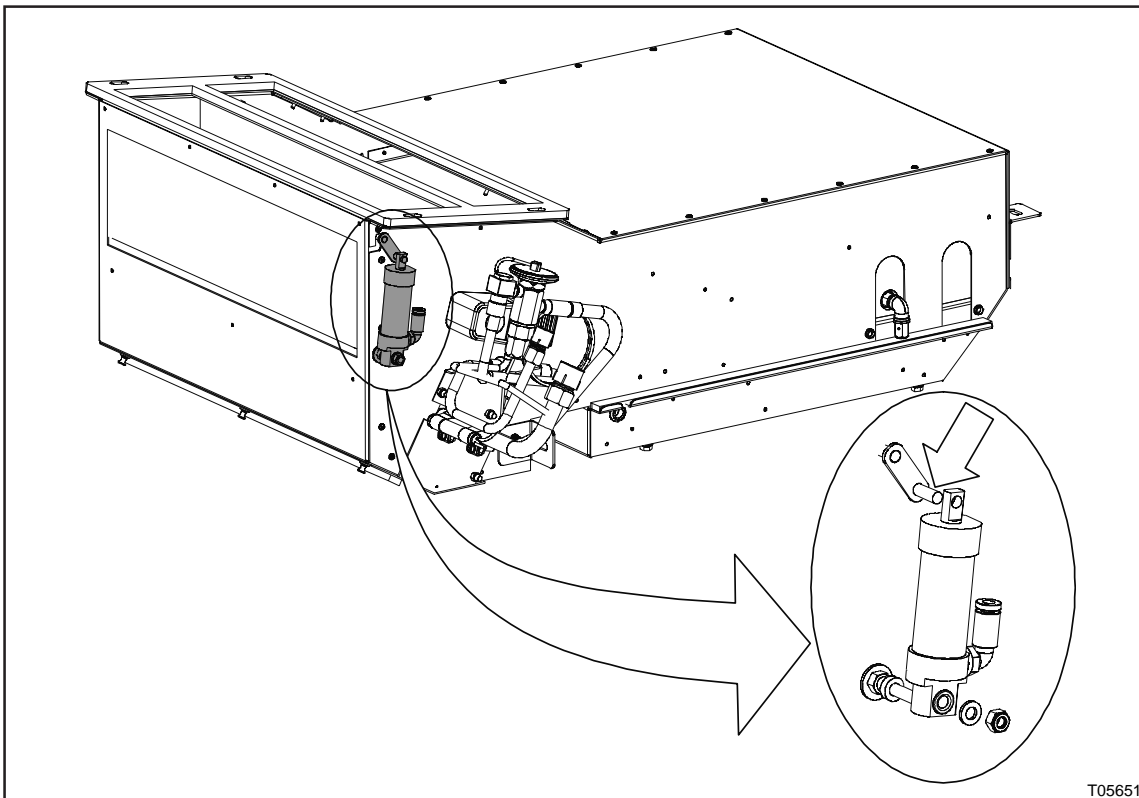
There are specific service requirements for the T2100 fresh air flaps. Every 60,000 miles, during the HVAC E type maintenance interval, air flap operation needs to be checked. This includes the roof top flaps, but also the flap of the front unit. For the latter, particular attention should be paid to the upper pivot point of the flap actuator (see Figure 1), which is located just behind the trim moulding between the headlights. In spite of a rubber shield fitted in front of the actuator, this pivot point has been known to corrode on earlier coaches, preventing proper operation of the flap. On later coaches the low carbon steel pivot has been replaced by a stainless steel one to eliminate this problem. The guidelines below explain how corroded pivots can be treated.

Figure 1 : Front unit with fresh air flap actuator and pivot points

2. Lubricate the upper actuator pivot point generously with penetrating oil, such as CRC or WD40, and allow to work in.
3. Operate the flap of the front unit a couple of times by means of the air flap control switch on the instrument panel to free the pivot.
4. Undo and remove the self-locking nut and plain washer of the lower actuator pivot point with a 10 mm box wrench.
5. Carefully remove the actuator from both pivot points.
6. Remove all corrosion from the upper pivot point with emery cloth and penetrating oil.
7. Repeat step 6 for the pivot hole in the actuator pushrod.
8. Grease the upper pivot point with Molycote GN+.
9. Refit the actuator with the pushrod pointing up.
10. Refit the plain washer and self-locking nut to the lower pivot point. Tighten for a loose fit.
11. Refit the trim moulding between the head lights.
