Service Bulletin No. 1076

COACH MODEL	: T800 Series, T900 Series, T2100 Series, C2000 Series
BULLETIN TYPE	: Product improvement
MANUAL & SECTION	: Maintenance Manual : Chapter 10 - HVAC system
DATE	: May 31st, 2001
SUBJECT	: Introduction of a new O5G compressor crankshaft seal
TERMS & CONDITIONS	: No claims will be accepted with reference to this Bulletin.

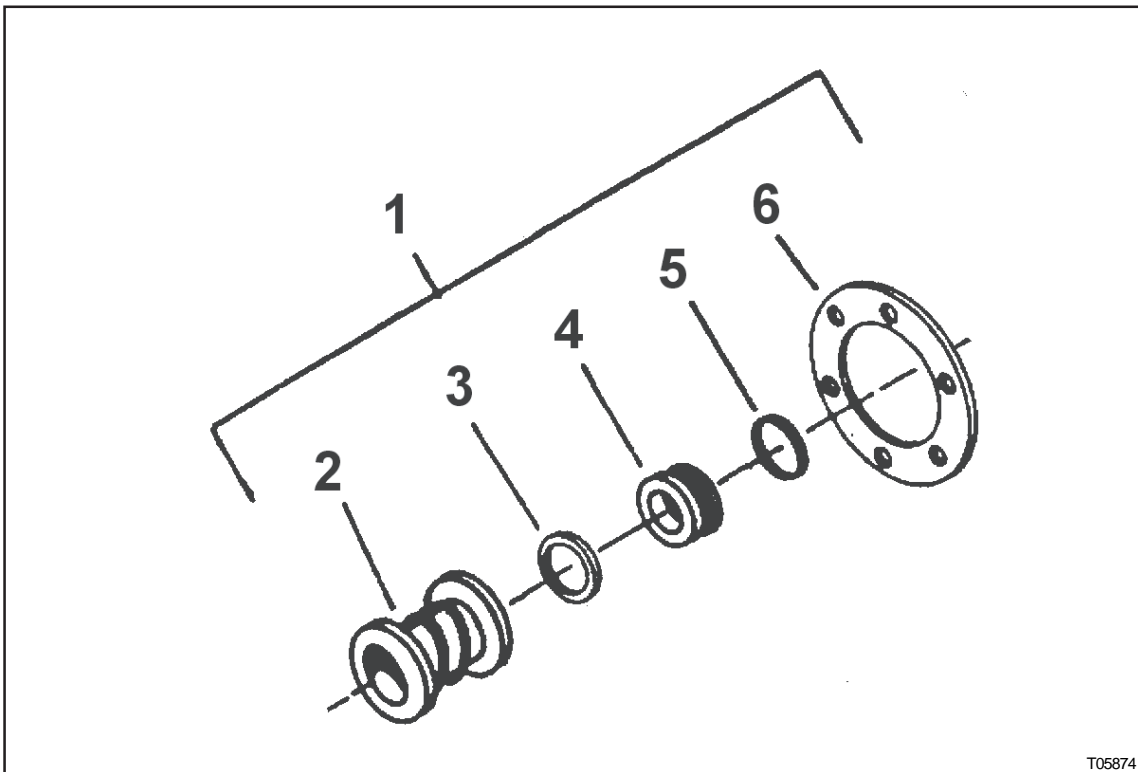
Figure 1: Compressor crankshaft seal assembly for housing mounted clutch

In an effort to improve the O5G compressor service life, Carrier/Sütrak have released a redesigned crankshaft seal assembly, which has been introduced in new compressors starting with serial number 4198J00661 ; and replacement compressors starting with serial number 1699Maxxxx. Compressor serial numbers are stamped on the compressor identification plate, which is located below the left-hand cylinder bank.

The compressor seal assembly consists of a springloaded bellows, a carbon washer, a wear ring, an O-ring and a steel gasket. The springloaded bellows contained in new seal package #17-44145-00 is a three-piece unit, which will be supplied fully assembled only. The individual parts will not be available separately. The new seal package, which includes fitting instructions, will automatically replace the old 17-44130-00 package. The seal bellows and carbon washer remain unchanged.

Should a seal assembly need replacing, always replace the complete assembly. For more information on compressor crankshaft seals refer to Carrier transicold service training manual # 62-50400-01.
