# Service Bulletin No. 1039

**MODEL** : T900 Series, T2100 Series, C2045

**SUBJECT** : D3 disc brake adjustment

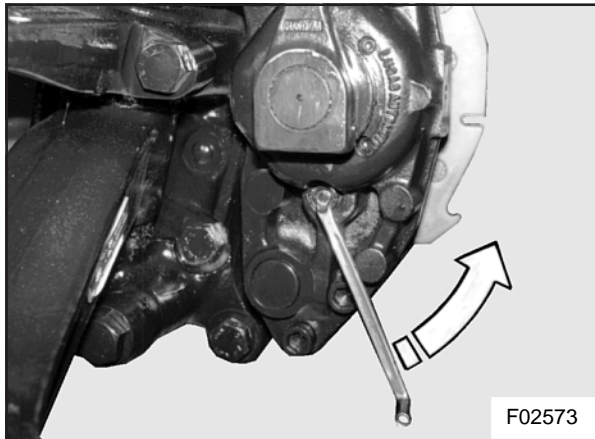
Figure 1 : Turning the adjuster stem in the direction opposite the direction of operating lever movement.

1. Check that, with the brake pads renewed, the adjuster stem locknut is backed off as far as possible, the adjuster stem is completely pushed in to engage the adjuster wheel, and the spreader plate is fully withdrawn.
2. Turn the adjuster stem in the direction opposite the direction of movement of the operating lever during brake application, until both pads are in contact with the disc (see Figure 1). When the pads contact the disc, the effort to rotate the adjusting stem will increase. Do not exceed a torque of  $6 \pm 2$  ft.lbf. to avoid damage to the hexagon end. The adjuster stem should then be turned back  $\frac{1}{2}$  to  $\frac{3}{4}$  of a revolution to achieve the necessary lining-to-disc clearance.

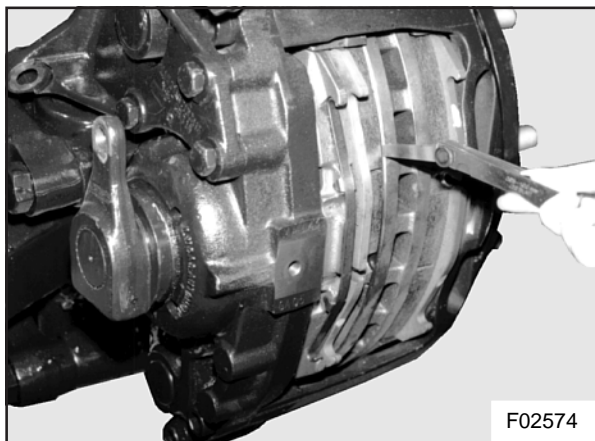
Figure 2 : Checking lining-to-disc clearance.

3. At the operating lever side of the caliper, measure lining-to-disc clearance with a feeler gauge (correct total clearance : 0.6 to 0.75 mm/0.025 to 0.030 inch. See Figure 2). Adjust by turning the adjuster stem in the proper direction.

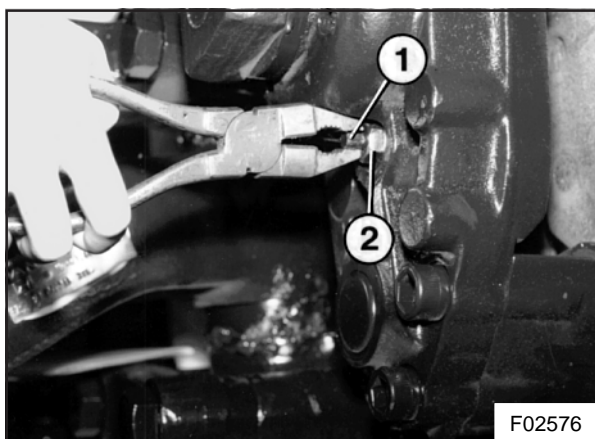
Figure 3 : Pulling back the adjuster stem with combination pliers

1. Adjuster stem
2. Locknut

4. Pull the adjuster stem back (1, Figure 3), until a stop is felt.

**PREVENT ROTATION OF THE ADJUSTER STEM (1) BY USING A 7 MM WRENCH, WHEN TIGHTENING LOCKNUT (2).**

While holding the adjuster stem (1) steady, tighten locknut (2) to a torque of 10 + 2 ft.lbf.
