Service Bulletin No. 1067A

COACH MODEL	: T2100 Series ; C2000 Series
BULLETIN TYPE	: Service information
MANUAL & SECTION	: Maintenance Manual : Chapter 10 - HVAC System
DATE	: February 28th, 2001
SUBJECT	: Refrigerant charge - change of procedure
TERMS & CONDITIONS	: No claims will be accepted with reference to this Bulletin.

THIS BULLETIN SUPPLEMENTS BULLETIN 1067 FOR PDI PURPOSES ONLY

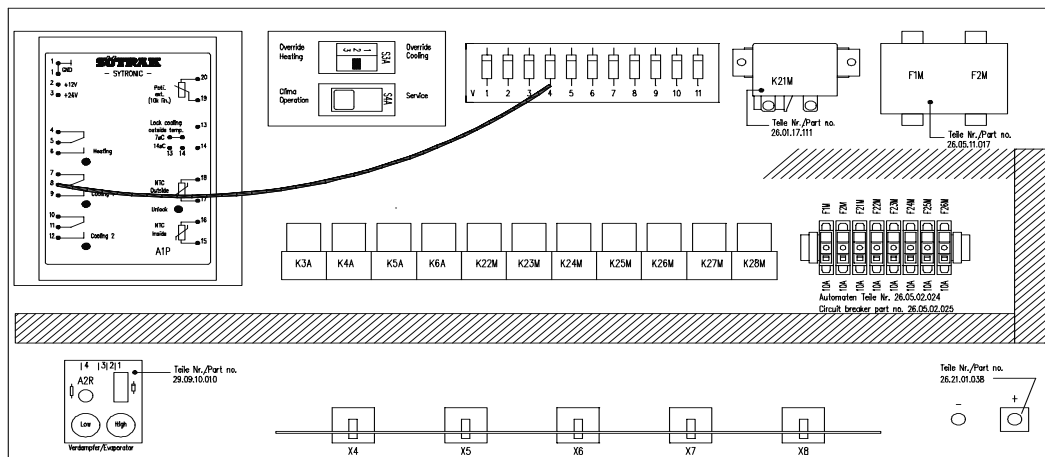
Figure 1: Jumper wire installation on the HVAC switchboard for PDI purposes (T2145 - Sytronic)

An alternative method to keep the interior temperature steady, is to install a jumper wire in the HVAC junction box as indicated in the chart below :

Coach type	Model	Controller type	Controller terminal #	Diode #	Refer to
Touring	T2145	Sytronic	8	4	Figure 1
Commuter	C2045	Sytronic 2	11	4	Figure 2

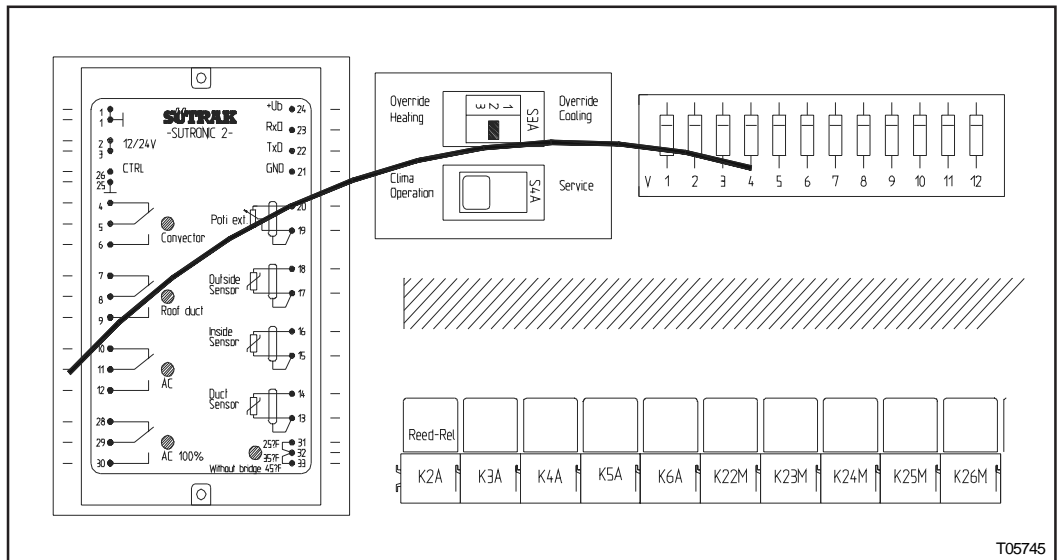
Figure 2: Jumper wire installation on the HVAC switchboard for PDI purposes (C2045 - Sytronic 2)
