SERVICE BULLETIN

SB1246

ADDRESSEES	: Owners and operators of coaches listed under 'Application'
VEHICLE MODEL	: C2045, T2140, T2145
SYSTEM/SUBSYSTEM	: Electrical system
BULLETIN TYPE	: Safety Recall NHTSA 12V-495/ TC 2012-344
DATE	: November 12, 2012
SUBJECT	: Alternators mounted on Detroit Diesel engine – To add ground cables
TERMS & CONDITIONS	: Refer to the warranty section further in this Bulletin.

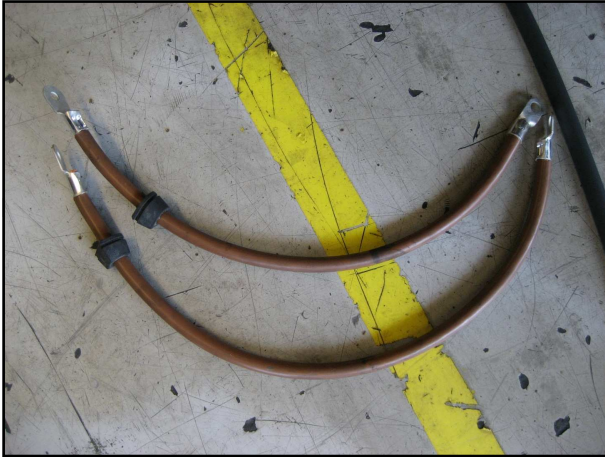
Figure 1: Alternator ground cables

VH reference	Description	Qty.
11271513	Set of two ground cables (with grommets)	1
660224301	Screw	1
660627920	Washer	1
