SERVICE BULLETIN

SB1249

ADDRESSEES	: ABC Customer Care and Parts Source
VEHICLE MODEL	: T2100
SYSTEM/SUBSYSTEM	: Glass, windows and mirrors
BULLETIN TYPE	: Service Information
DATE	: April 25, 2013
SUBJECT	: Passenger emergency window closing rubber – To address stretch issues
TERMS & CONDITIONS	: Parts will be provided free of charge. A Service repair time of 5 minutes is determined for the coaches under warranty.

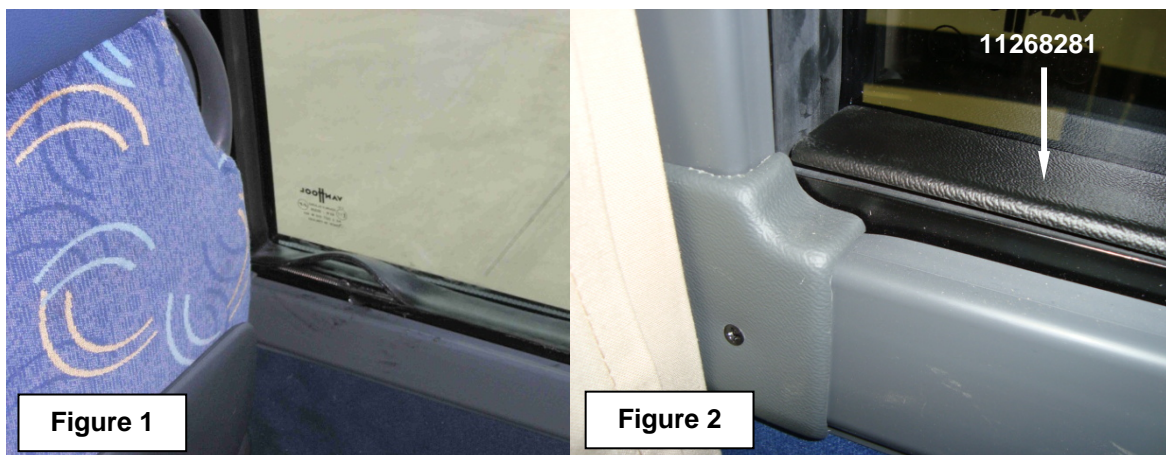
1. The open side of the channels that compose the passenger emergency window frame has been finished with a closing rubber which covers, among other, the emergency release mechanism.
2. This design has always been reliable, but recent field reports indicate that in some cases the rubber may stretch, exposing the release mechanism (Figure 1).

3. To address the issue, excess closing rubber material may be removed to suit and an ABS enhancement cover fitted to stabilize the rubber (part #11268281, Figures 2 and 3).
4. Should the above-mentioned issue occur, you may carry out this fix as described.
