SERVICE BULLETIN

SB1355A

ADDRESSEES	: Owners and operators of coaches listed under "Application"
VEHICLE MODEL	: CX45
SYSTEM/SUBSYSTEM	: 01.09 Complete vehicle - Automatic fire suppression system
BULLETIN TYPE	: Field Change Program
DATE	: September 08th, 2016
SUBJECT	: To change routing of extinguishing agent hose and check routing of linear detection wire
TERMS & CONDITIONS	: Refer to the warranty section further in this Bulletin

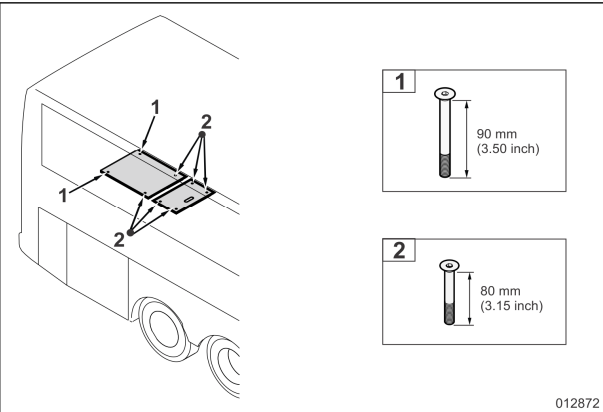
Step	Action
1	<p>On the inside of the vehicle, open both the floor traps above the engine.</p> <p><i>NOTE: Pay attention to the place of the screws that are used. Do not mix them up at reinstallation!</i></p>

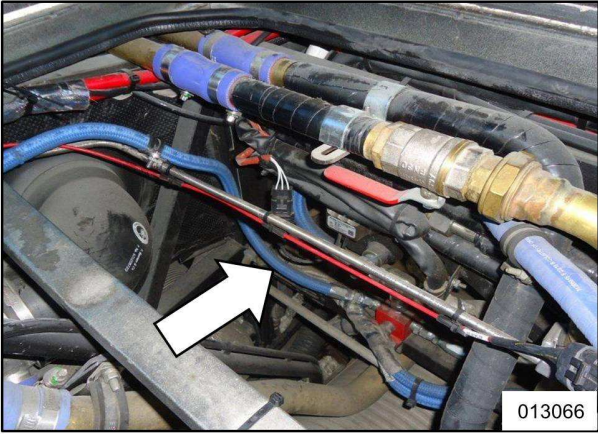
013066 Figure 2
2.2	Remove both cable ties and remove the blue hose out of the protection sleeve.

Step	Action
2.1	Disconnect the blue hose indicated in the figure at the adapter of the distributor block.

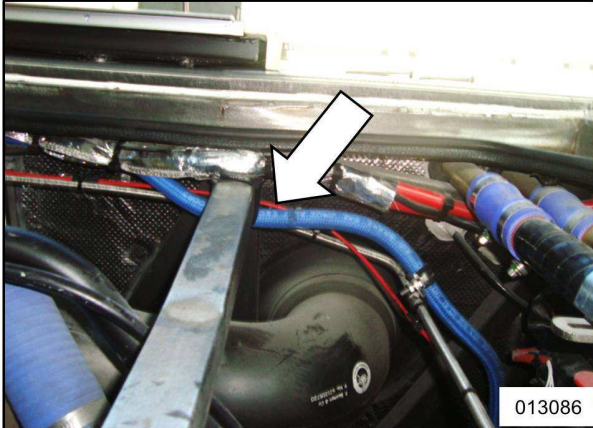
Step	Action
3.1	<p>Is the red linear detection wire routed under the cross-member as indicated in the figure?</p> <ul style="list-style-type: none">• If so, continue with step 4 of the procedure.• If not, go to step 3.2.
