ADDRESSEES	: ABC Customer Care and Parts Source Owners and users of vehicles mentioned under "Application"
VEHICLE TYPE	: T2100, C2045, CX..., TX..., TD925US
CONFIGURATION GROUP	: 7.06 Steering – front-axle steering
BULLETIN TYPE	: Safety Recall NHTSA 17V-064/TC 2017-064
DATE	: February 15 th , 2017
SUBJECT	: Replacement of front axle steering system bevel gear
TERMS & CONDITIONS	: Refer to the warranty section further in this Bulletin.

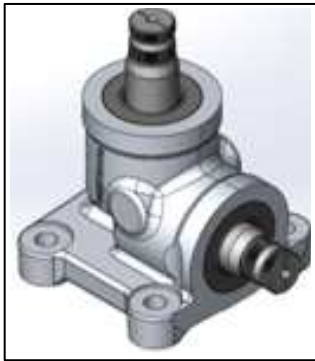
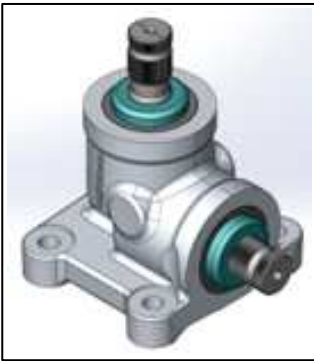
First generation Pailton bevel gear	Second generation Pailton bevel gear (additional dust cover at input and output shafts) (*)

(*) The additional dust covers are colored in green in order to clarify, in reality they are black.

- Owners and operators of coaches equipped with a Pailton bevel gear should first identify their bevel gear. If the vehicle is equipped with a first generation Pailton bevel gear, it must be replaced by a corresponding ZF bevel gear. **The Pailton bevel gears of the second generation are not affected!**
