COACH MODEL : C2045, T2140, T2145
DATE : 01/03/2012
SUBJECT : Leveling valves slow to respond.

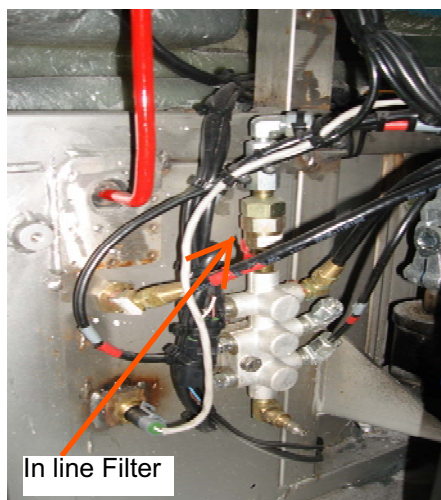
If coach leveling system is slow to respond in either the front, rear or both. Locate the inline filters as shown in pictures below.

The front in line filter is located on the drivers side door below the drivers window next to bumper release.

Release pressure from air system by actuating drain valve on accessories air tank. For the location of the air tanks refer to "Location of air tanks" in chapter 13.17.

Disconnect air line from filter body and remove filter.

Disassemble filter body in vise.

Clean or change filter screen.

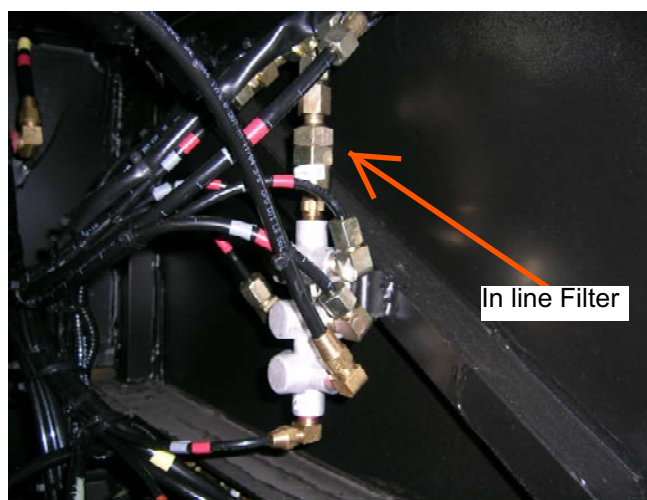
The rear inline filter is located on the front wall of the drive axle cavity above the drive axle service brake relay valve
