COACH MODEL : CX prior to VIN# 48984 with Bitzer Compressor's
DATE : 9/16/2015
SUBJECT : AC Clutch Circuit Breaker Z505 for CX Troubleshooting.

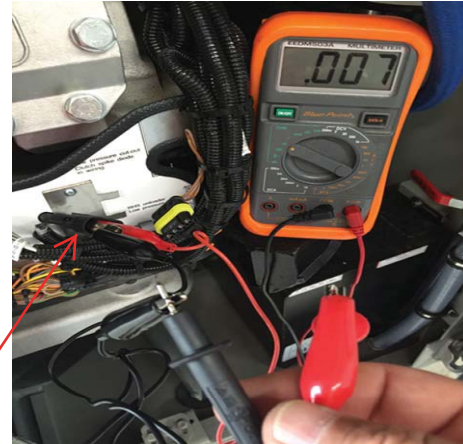
Figure 2

Step 2:
Unplug the connector from Figure 1 and check the clutch coil resistance between pins 1 & 2 (two black wires) on the male side of the plug. The Bitzer clutch coil resistance should be within 7 - 9k ohms. If resistance falls outside of this range, replace the coil. If resistance falls within this range, proceed with checking the diode in step 3.

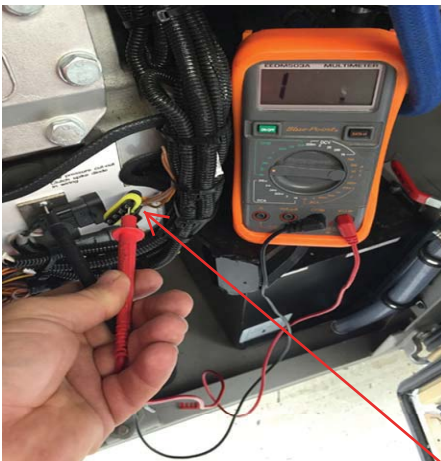
Figure 3

Step 3:
Check continuity between pin 1 (orange wire with yellow stripe) of the female connector and a ground source as shown in Figure 3. This should be open circuit. If continuity is present this indicates a failed diode, proceed to step 4.
