SERVICE BULLETIN

SB1223

ADDRESSEES	: ABC Customer Care and Parts Source
COACH/BUS MODEL	: C2045
BULLETIN TYPE	: Product Improvement
SECTION/CHAPTER	: Section 11 – Body and accessories Chapter 10.54 Exterior parts
DATE	: October 7, 2009
SUBJECT	: Thermoplastic rear bumper – to address distortion issues
TERMS & CONDITIONS	: -

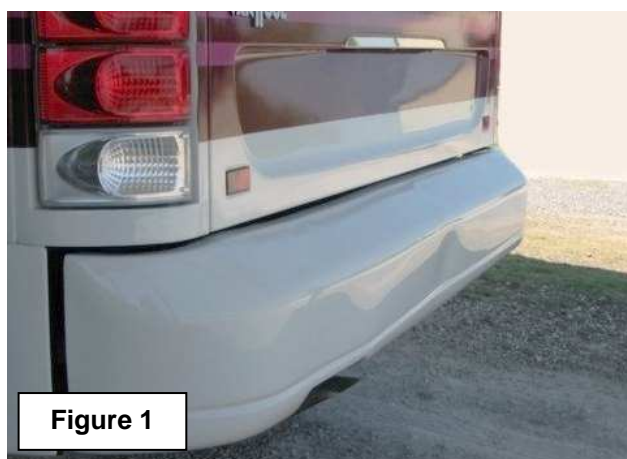
Figure 1

1. Rear bumper distortion has been reported on some of the above-mentioned units after they had been in service for some time (Figure 1).

2. Investigation indicates that here are two possible causes for this issue:

- The distortion may be caused by the difference in expansion rate between the thermoplastic bumper shell and the aluminum back-up beam to which it is bolted. When the shell has been secured too tightly to the beam and the ambient temperature rises considerably, the travel of the faster expanding shell is restricted by the slower expanding beam, resulting in buckling of the shell.
- The above-mentioned process may be magnified by the heat from the exhaust tailpipe(s), and to a lesser degree by the heat radiating from the engine.

This Service Bulletin has been released so distortion issues can be addressed by applying one or more of the procedures listed below.

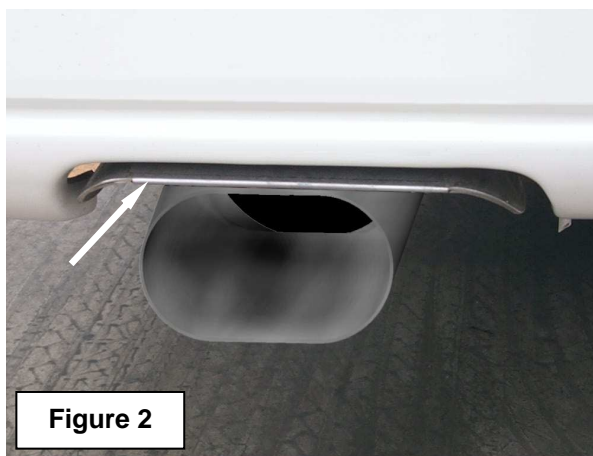
- The first procedure explains how to check that the shell has been properly attached to the back-up beam and what should be done to correct the installation.
- The second procedure provides instructions on how to install an exhaust heat shield similar to the one that is standard equipment on model 2008 coaches (Figure 2).
- The third procedure shows how a finisher can be fitted to the top section of the bumper as a reinforcement and stiffener (Figure 3), should distortion hamper the opening of the engine compartment door.

Final installation is shown in Figure 2 (single tailpipe shown).

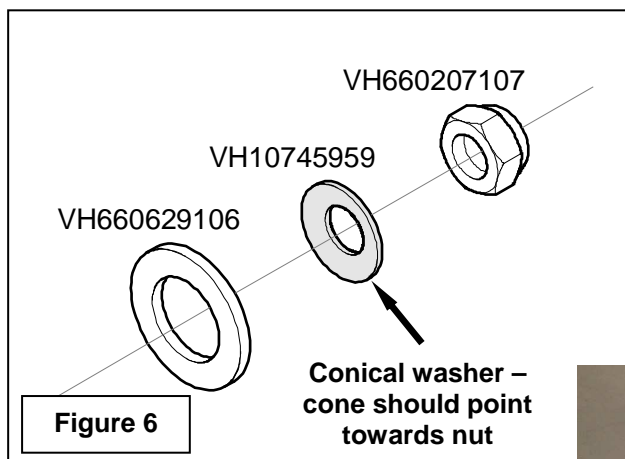
- 1) Check that the retaining nuts and washers have been properly installed.
The purpose is to make sure that that shell is anchored to the beam at the center and that movement is allowed at the ends.

- The fasteners should be fitted in the right order as shown in Figure 6.
 - The fasteners in the center (Figure 7) should be tightly secured.
 - The fasteners next to the left- and right-hand V blocks (Figure 8) should be tightened so that the washers fitted between the nut and the beam can hardly be shifted by hand.

- 2) If required, tighten the nuts in the center as follows:
 - Run-up the nuts and compress the washers until they can no longer be shifted by hand.
 - Tighten each nut further through 180°.
The conical washers are now properly tightened.

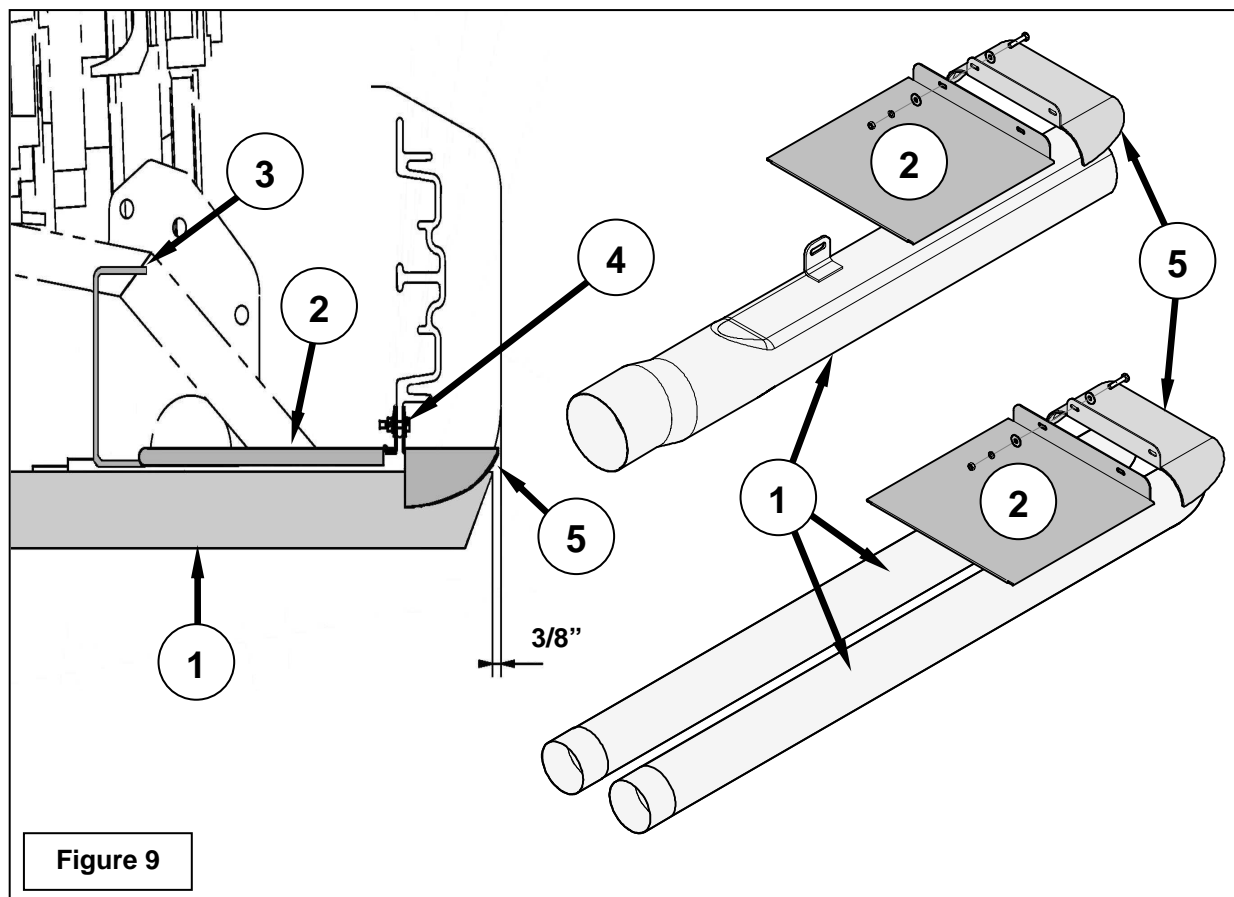
Reference is made to Figure 9. The exhaust heat shield sits approximately 9/16" above the tailpipe(s) (1) and comprises of two parts: a flat plate (2) that fits between the left hand rear-most U-channel (3) and the lower lip of the bumper beam (4), and a curved shell (5) that sits under the bumper and bolts to the beam and the flat plate.

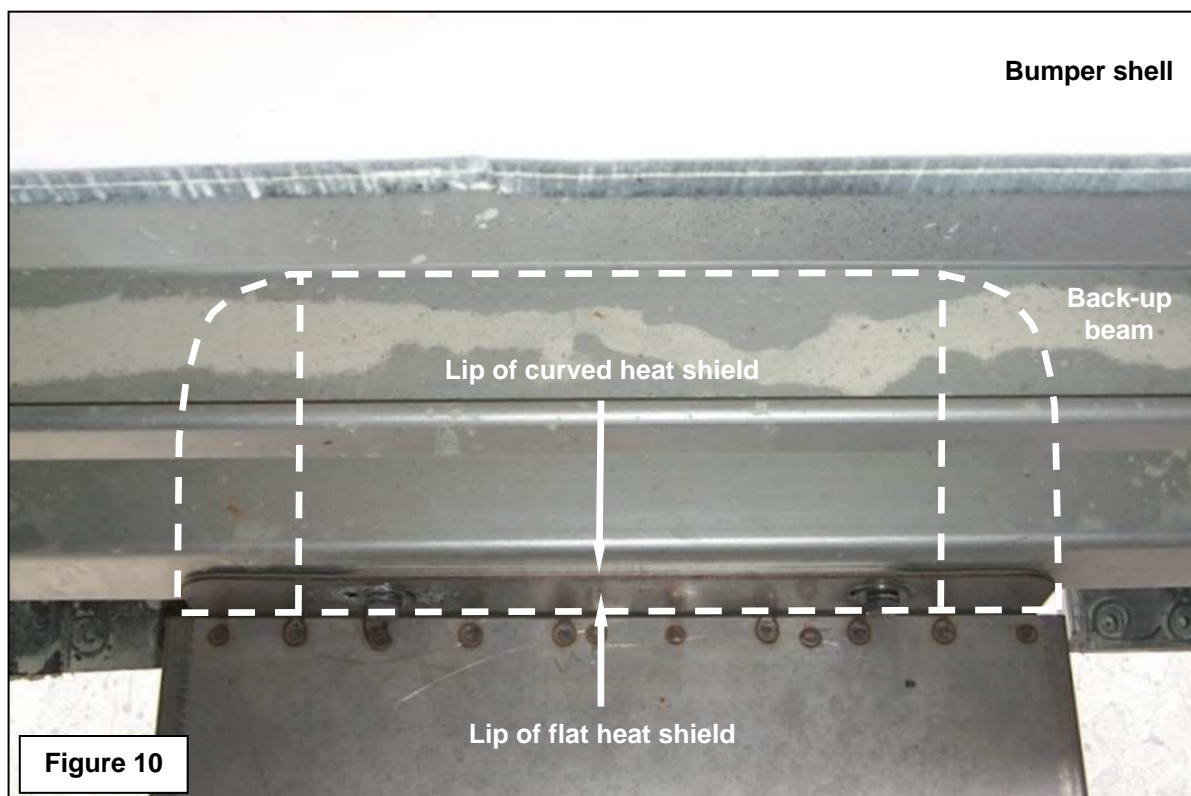
- As shown in plan view, (Figure 10), attach both loosely to the beam lower lip using the hardware from the parts list.
- Note that both the flat and curved shield mounting lips are on the engine side of the beam.

- 4) Working inside the engine compartment, assemble and attach the curved and the flat heat shields with the heat resisting cloth facing down to the bumper beam.

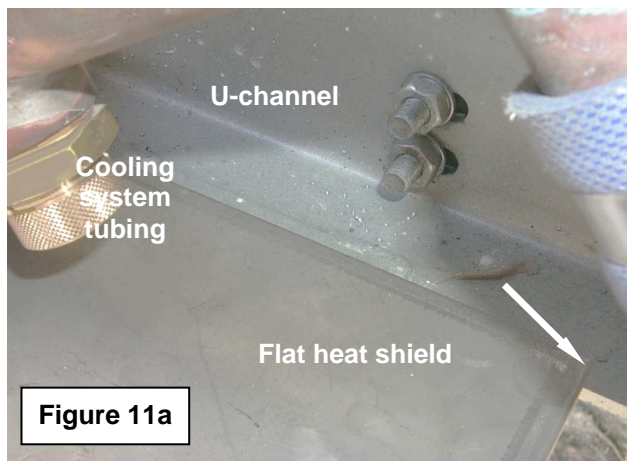
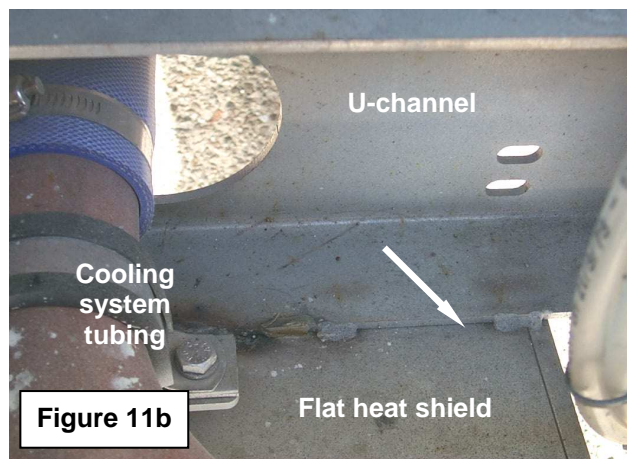
- 5) In production the radiator side of the flat shield is attached to the chassis U-channel by welding (Figures 11a and 11b).
- When retrofitting this shield in the field, it may be either bolted or riveted to the U-channel. Depending on the space available with respect to the engine cooling tubing, the shield can be fitted either resting on (Figure 11a), or hanging from the U-channel flange (Figure 11b).

- 6) At the back-up beam, run-up the nuts and tighten the heat shield retaining bolts to a torque of 80 in.lbf (8.6 Nm).
- 7) At the U-channel attach the shield by bolting or riveting, whichever is the most suitable.
- 8) Reinstall the tailpipe(s) in reverse order to removal.

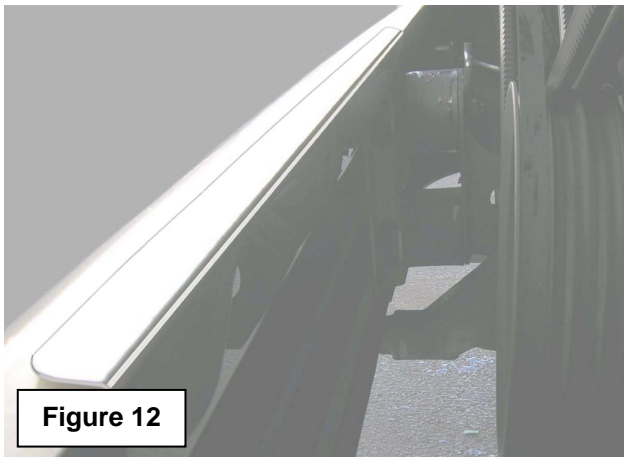
Description: Rear bumper finisher VH 11105209 is a mirror-polished stainless steel reinforcing channel that fits over the top edge of the bumper (Figure 12) and bolts to the rear of the back-up beam (Figures 13a and 13b).

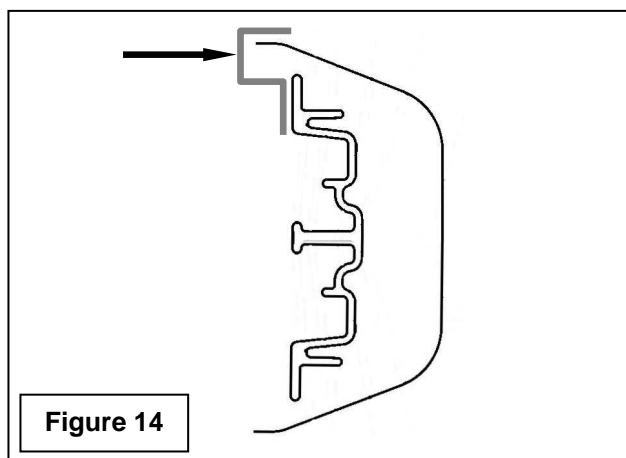
- 1) Reaching behind the bumper, undo and remove the two upper inner most nuts and washers securing the upright rubber spring supports to the back-up beam (1 and 2, Figures 13a and 13b).
- 2) Trial fit the finisher by placing it over the upper lip of the bumper shell (Figure 14) with the polished surface facing the engine.
The finisher is directional with a tapered section to clear the left-hand bumper springs. This ensures that the finisher sits right in the center of the bumper when installed.

- 3) Align the finisher slots with the studs in the back-up beam.
If fitting issues arise, the upper edge of the bumper shell may be dressed through careful use of a heat gun.
Make sure not to damage the paint.
- 4) Reinstall the fasteners previously removed.
Tighten the nuts to a torque of 15 ft.lbf (21 Nm).
