<b>ADDRESSEES</b>	: Owners and operators of coaches listed under 'Application'
<b>VEHICLE MODEL</b>	: T2145 and C2045 with Detroit Diesel DDEC VI engine
<b>VEHICLE SECTION</b>	: Exhaust system
<b>BULLETIN TYPE</b>	: Field Change Program
<b>DATE</b>	: March 30, 2010
<b>SUBJECT</b>	: <b>Exhaust pipe support bracket change</b>
<b>TERMS &amp; CONDITIONS</b>	: Refer to the warranty section further in this Bulletin.

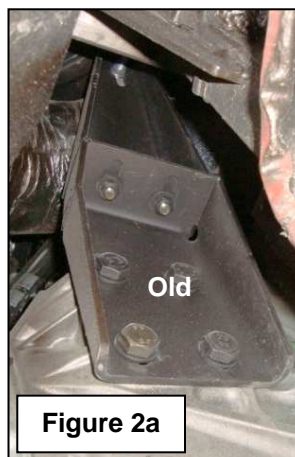
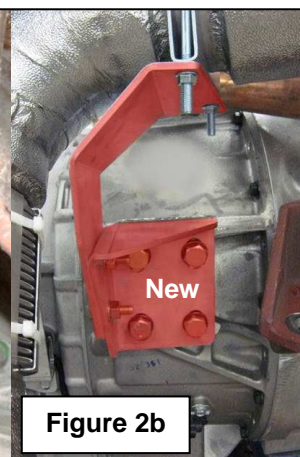
- On the above-mentioned units it is necessary to replace the (transmission mounted) exhaust pipe support bracket assembly (Figures 1 and 2a) by a more flexible design (Figure 2b). The latter is better suited to compensate for the changes in pipe length during the heating-up/cooling-down cycles.

**CAUTION:** Failure to replace the OE fitted rigid bracket assemblies by flexible ones may result in the exhaust pipe cracking at the fuel doser valve.

- In order to avoid damage to the exhaust pipe and restore its useful service life, please replace the OE fitted bracket assemblies on your coach by new, referring to the materials list and the step-by-step instructions further in this Bulletin.

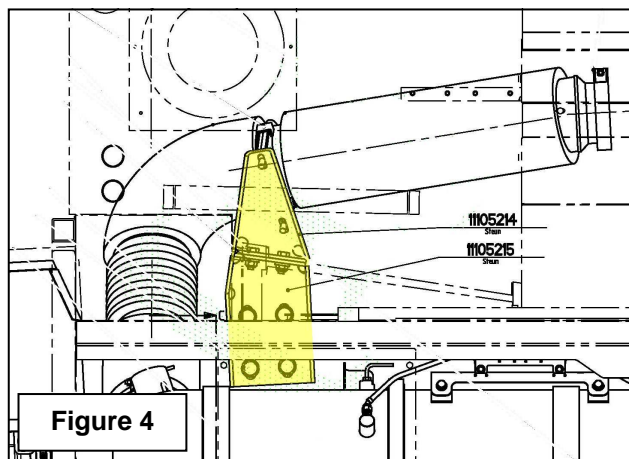
**Old parts (Figure 4, installation on units with Allison transmission shown)**

VH reference	Description	Qty.	Application
11105214	Bracket, exhaust pipe support, upper	1	Units w/ Alison B500 transmission
11105215	Bracket, exhaust pipe support, lower	1	
11077918	Bracket, exhaust pipe support	1	Units w/ AS Tronic transmission

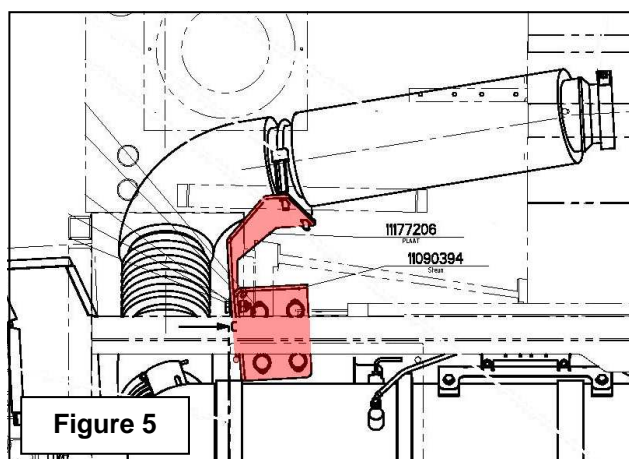
**New parts (Figure 5, installation on units with Allison transmission shown)**

VH reference	Description	Qty.	Application
11177206	Bracket, exhaust pipe support, upper	1	Units w/ Alison B500 transmission
11090394	Bracket, exhaust pipe support, lower	1	
660226601	Bolt, M12 x 1.75 x 35 mm, grade 8.8	2	
660207406	Nut, M12 x 1.75, grade 8.8	2	
660629203	Washer, M12, 13 x 30 x 6 mm	4	
11177914	Bracket, exhaust pipe support	1	Units w/ AS Tronic transmission

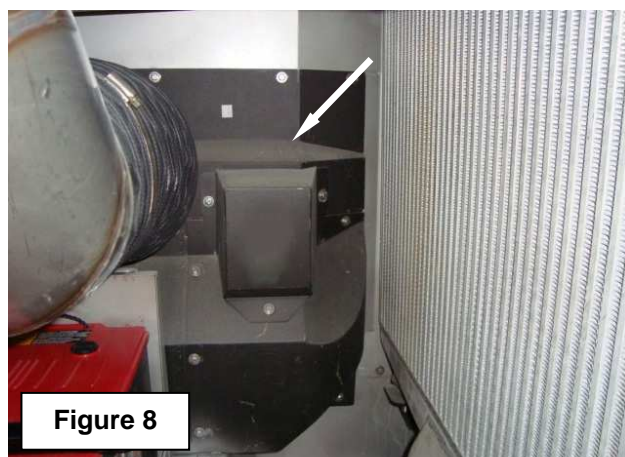
- 4) Undo and remove the fasteners securing the turbocharger cowling (Figure 8) to the back wall of the compartment.  
Recover the fasteners.  
Remove the cowling from the compartment.

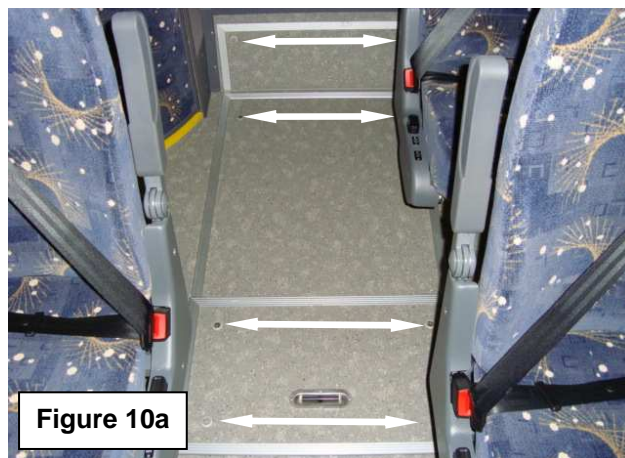
- 6) Inside the coach, undo and remove the flathead Allen bolts securing the trap door in front of the rear bench (Figure 10a). Remove the trap door, exposing the air intake pipe and the exhaust pipe (Figure 10b).

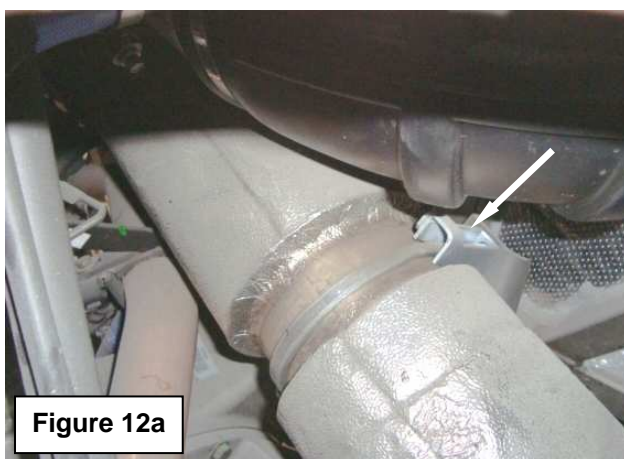
Figure 12a

- 1) Working through the aperture of the trap door inside the passenger compartment, locate the guillotine clamp assembly securing the center part of the exhaust pipe (Figure 12a).

**NOTE:** The guillotine clamp assembly comprises of a U-clamp, a saddle and two nuts.

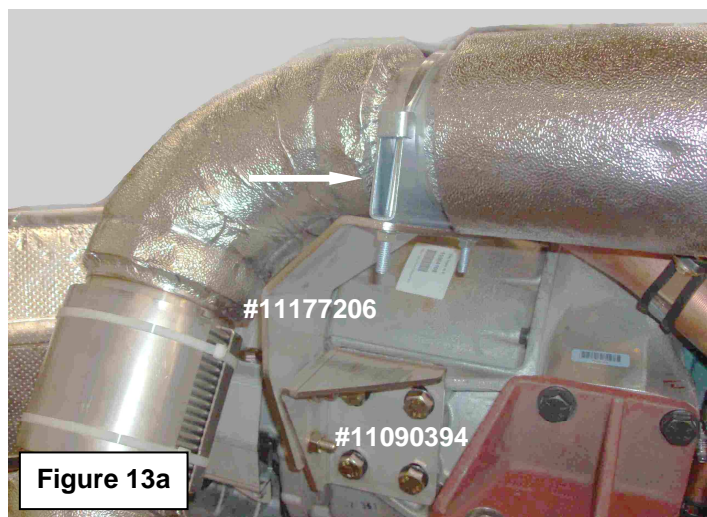
**Figure 13a**

- 3) Pre-assemble brackets #11177206 and #11090394 for a loose fit as shown in Figures 13a and 13b using the M12 fasteners from the material's list.  
Make sure the bolt heads face the compensator (arrow, Figure 13b).

- 4) Attach the new bracket assembly to the transmission for a loose fit using the recovered M16 bolts. Make sure to use some form of ant-seize compound on the threads.
- 5) With bracket #11177206 in its lowest possible position, assemble the guillotine clamp by first installing the saddle between the bracket assembly and the pipe, then by having an assistant slip the U-clamp over the pipe (arrow, Figure 13a).  
Run-up the U-clamp nuts until the clamp and saddle fit snugly on the pipe.
- 6) Adjust the vertical position of brackets #11177206 and #11090394 making use of the slots provided in them.  
It may be necessary to install washers between the saddle and the bracket assembly to obtain a perfect fit. The aim is to ensure a stress and strain-free installation of the pipe and the bracket assembly.

Tighten the U-clamp nut to a torque of 18 ft.lbf.  
Tighten the M16 bolts to 133 ft.lbf.  
Tighten the M12 fasteners to a torque of 52 ft lbf.

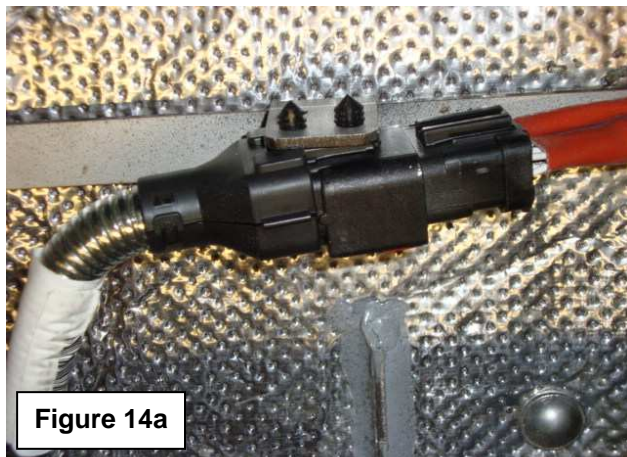
- 1) Locate the sensor cables overhead the after treatment device.  
Detach and disconnect the connectors shown in Figures 14a and 14b.  
Remove cable ties as required to allow the after treatment device to be lowered onto the shop floor.

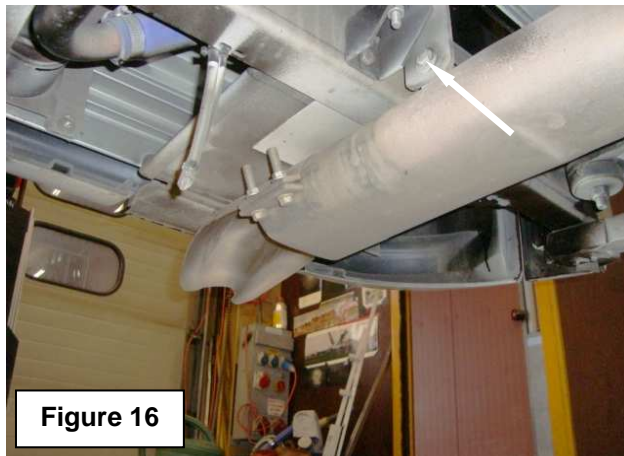
**Figure 16**

- 4) Undo and remove the fasteners securing the tailpipe to its support bracket (Figure 16, overleaf).  
Recover the fasteners.

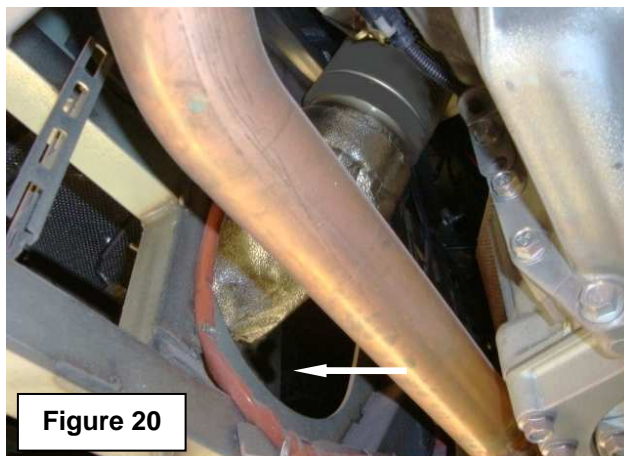
- 8) During this step have an assistant hold the pipe steady with a sling. Remove the guillotine clamp and the exhaust pipe support bracket as explained in section 4. "To replace the exhaust pipe support bracket assembly".
- 9) With the aid of an assistant, carefully remove the pipe from the vehicle through the aperture above the reinforcing plate at the bottom of the chassis (Figure 20).
