SERVICE BULLETIN

SB1245

ADDRESSEES	: Owners and operators of coaches listed under 'Application'
VEHICLE MODEL	: TD925
SYSTEM/SUBSYSTEM	: Body and accessories – driver's seat
BULLETIN TYPE	: Safety Recall Program – NHTSA campaign ID number 12V-323
DATE	: October 25 th , 2012
SUBJECT	: Driver's seat anchorage assembly – Replacement of riser and floor adapter plate
TERMS & CONDITIONS	: Refer to the warranty section further in this Bulletin.

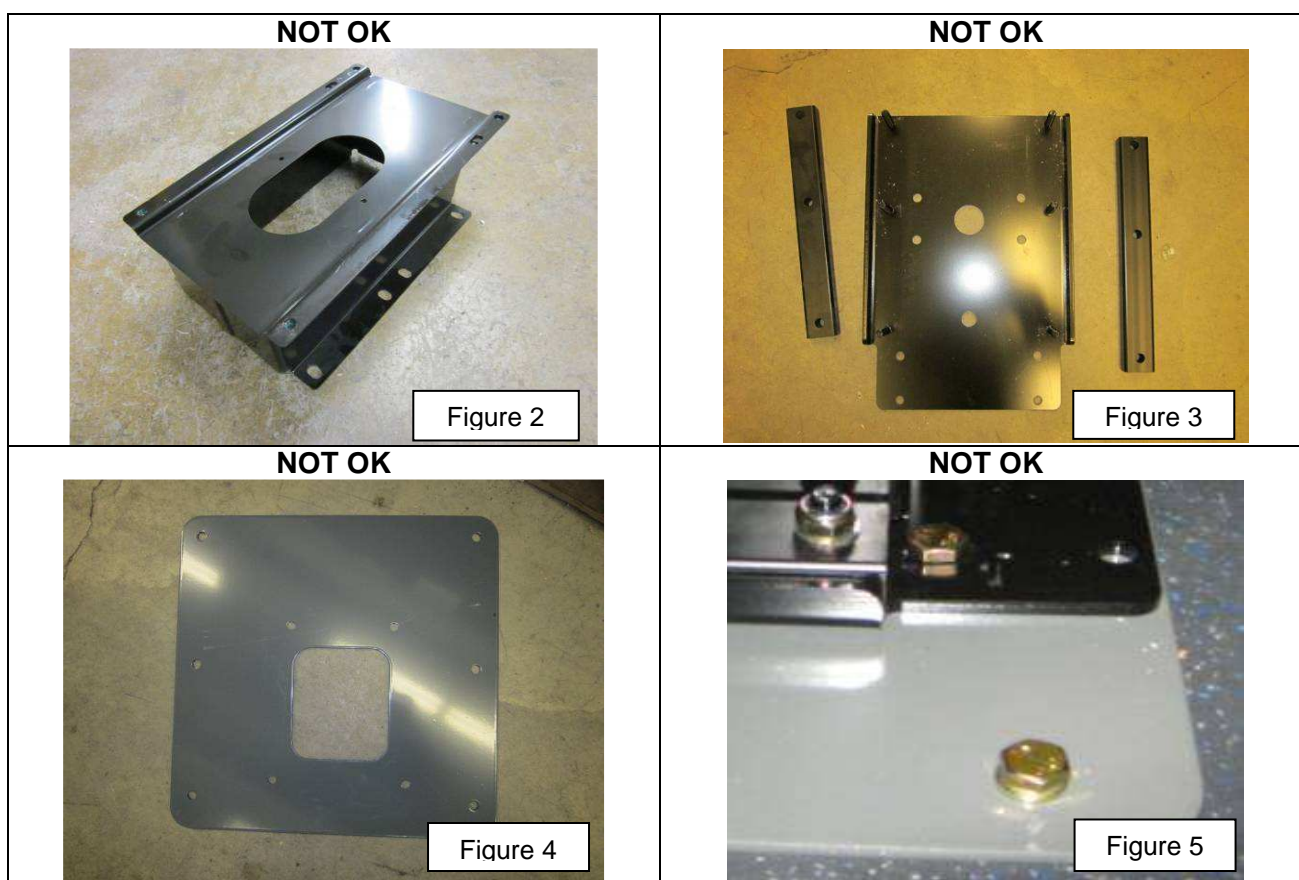
Noncompliant parts: ISRI riser, ISRI adapter plate, Van Hool floor adapter plate and fixation material (Figure 2, 3, 4 and 5)

VH reference	Description of noncompliant parts	Qty.	Refer to
11307654	ISRI riser	1	Figure 2
10672095	ISRI adapter plate	1	Figure 3
11134267	Van Hool floor adapter plate	1	Figure 4
660224503	Screw, M10 x 1.50 x 30, grade 8.8, DIN933	6	Figure 5

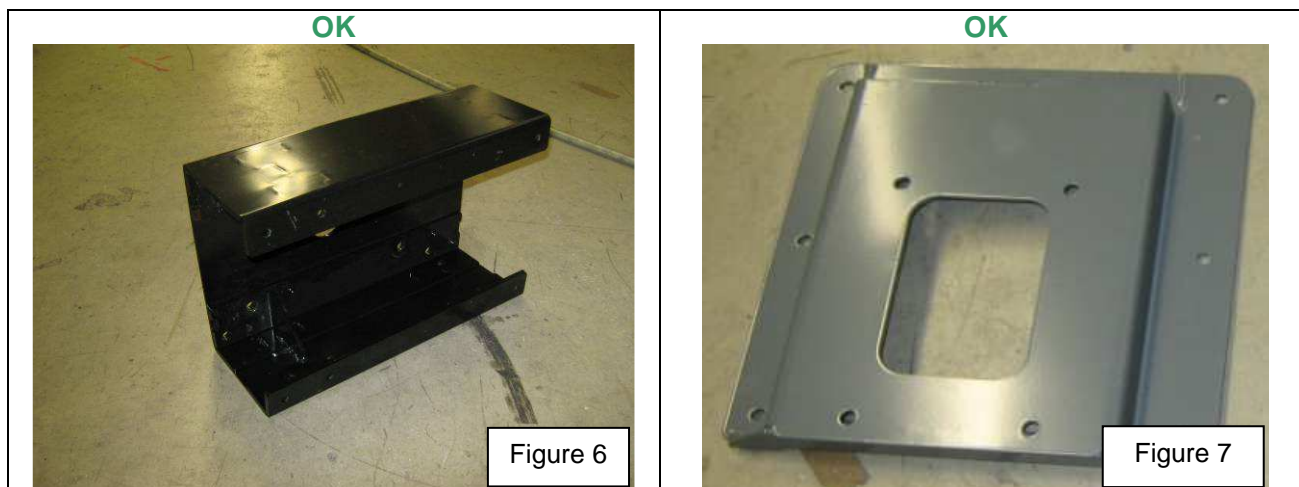
**Compliant parts: ISRI riser, Van Hool floor adapter plate and fixation material
(Figures 6 and 7)**

VH reference	Description of compliant parts (kit VH 11334125)	Qty.	Refer to
11319711	ISRI riser	1	Figure 6
11322918	Van Hool floor adapter plate (color: grey)	1	Figure 7
660222404	Screw, M8 x 1.25 x 25, grade 10.9, DIN 933	6	
660207116	Nut, self-locking, M8, DIN 985	6	
660226606	Screw, M12 x 1.75 x 35, grade 10.9, DIN 933	4	
660629103	Washer, flat, M12, 13 x 24 x 2.5 mm, DIN125	4	
660207406	Nut, self-locking, M12, DIN 980	4	
10527474	Screw, M10 x 1.50 x 35, grade 10.9, DIN933	6

CAUTION: If the compliant ISRI riser, Van Hool floor adapter plate and fixation material are already installed, they are not subject to this recall.

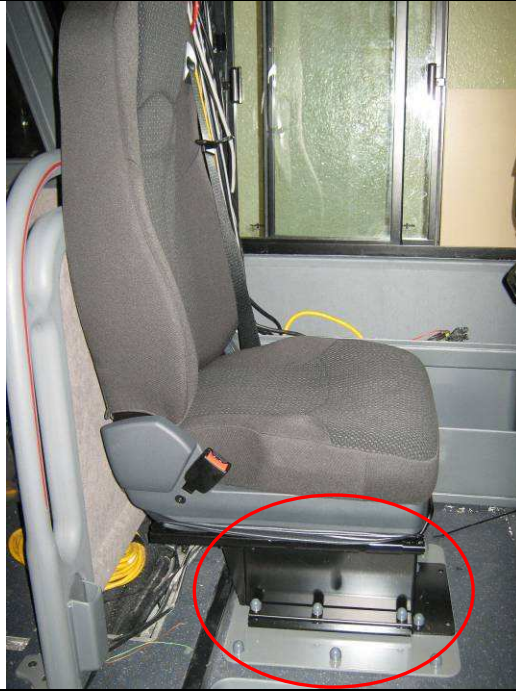
Figure 8

- 1) In the driver's area, locate the noncompliant riser, adapter plate and floor adapter plate.

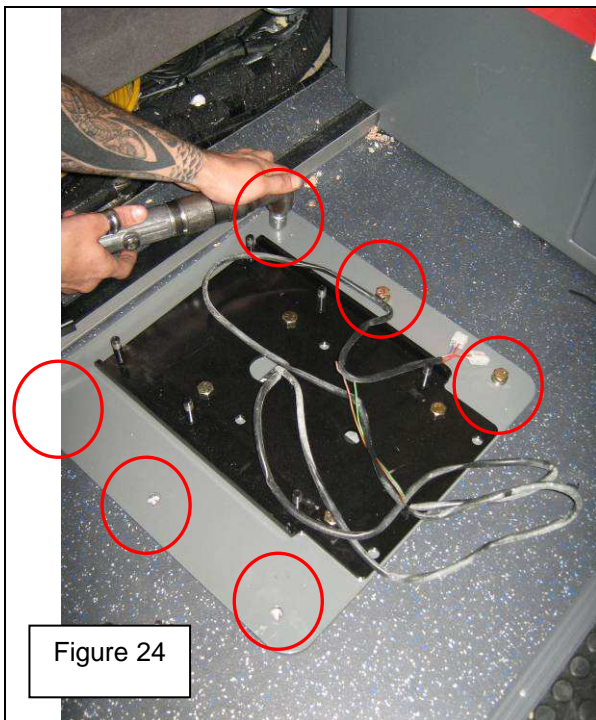
Figure 24

Unscrew the six M10 screws (two sides) (VH660224503). Keep all the washers and lockwashers apart for later re-use.

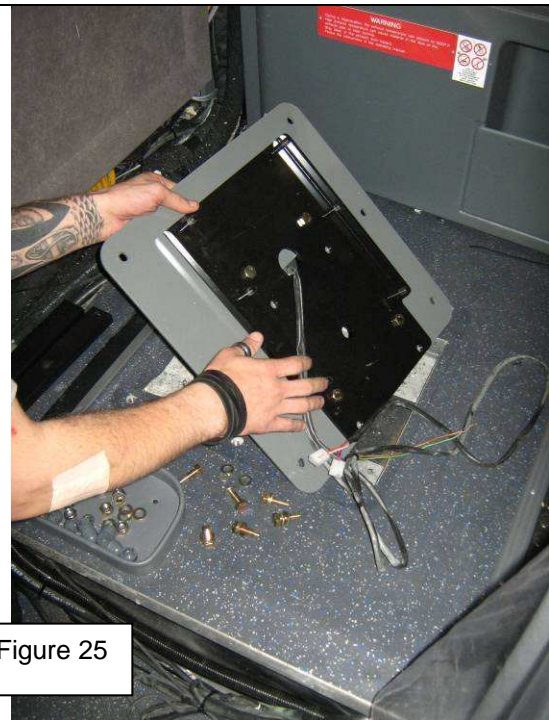
Figure 25

Lift the adapter plates (be careful with electric wires and pneumatic tubes).

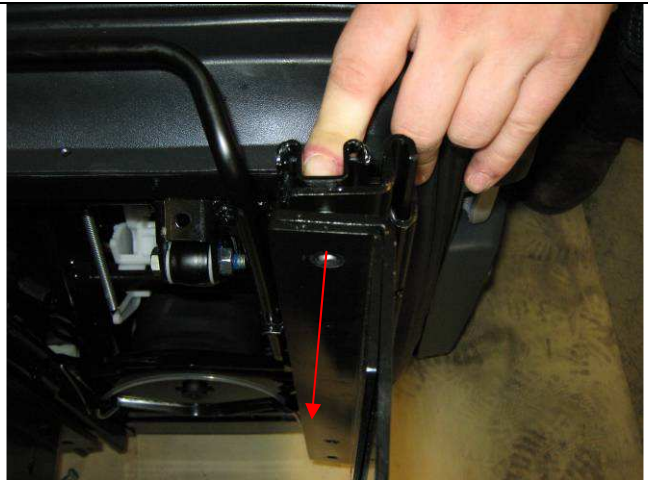
Figure 33

Secure the sliders and metal plates to the compliant riser (VH 11319711). Use two M8x25 grade 10.9 screws (VH 660222404) and two M8 nuts (VH 660207116) (two sides).

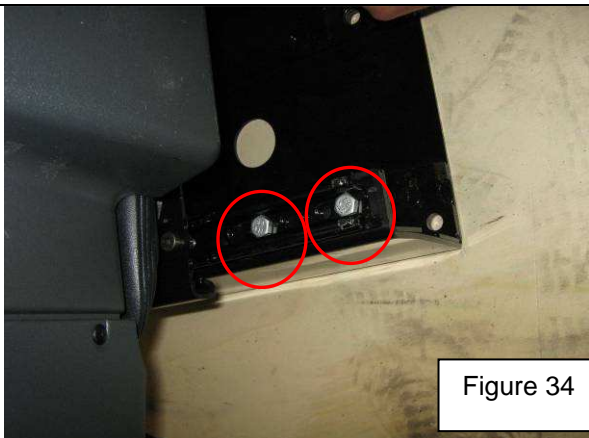
Figure 34

Move the driver's seat to the most forward position and secure the sliders and metal plates to the compliant riser. Use four M8x25 grade 10.9 screws (VH 660222404) and four M8 nuts (VH 660207116) (two sides).

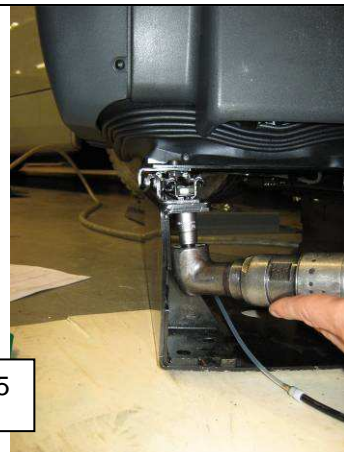
Figure 35

Check all six bolt with a torque wrench. Tightening torque: 25 ± 3.75 Nm (19 ± 2.75 ft.lbf)

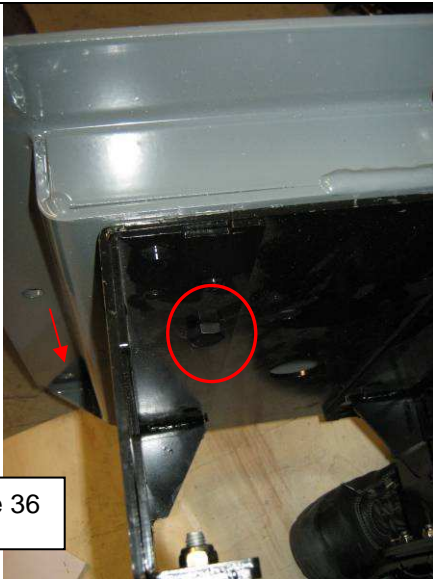
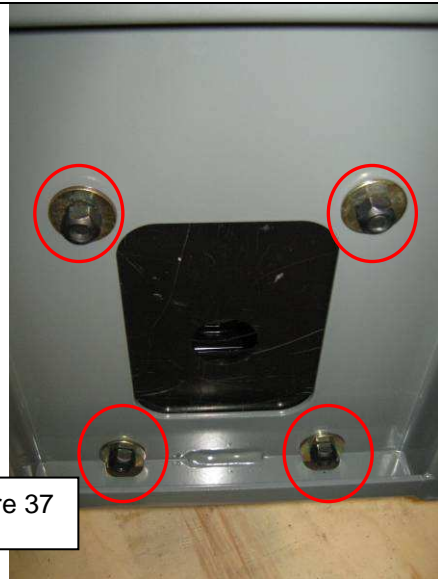
Secure the riser to the compliant Van Hool floor adapter plate (VH 11320020). Use four M12 x 35 grade 10.9 screws (VH 660226606). The triangles of the floor adapter plate should be faced backwards.

Use four M12 nuts (VH 660207404) and four washers (VH 660629103) at the bottom. Tightening torque: 100 Nm (74 ft.lbf)

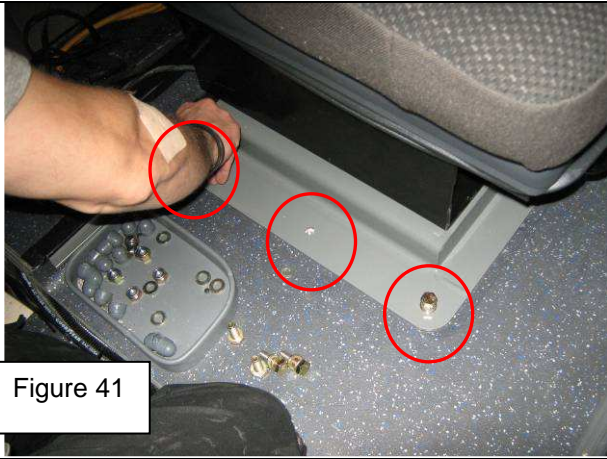
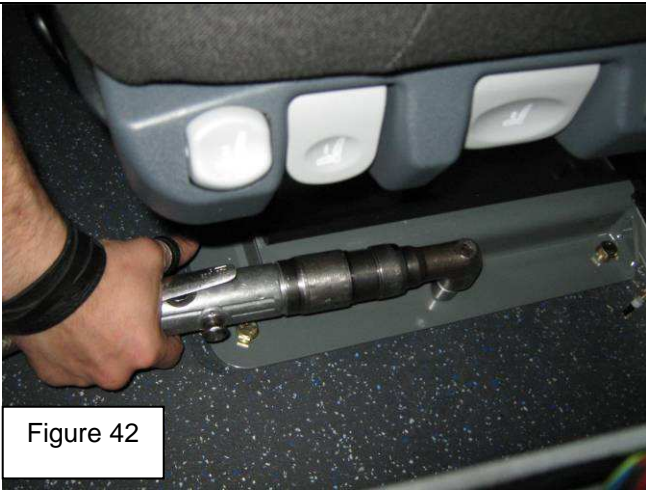
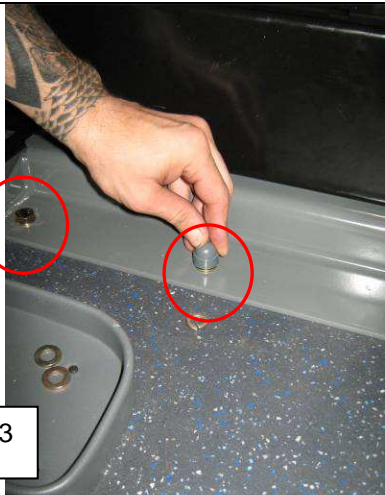
<p>Figure 41</p>
<p>Put the pneumatic tube back in the hole.</p>	<p>Secure the floor adapter plate to the bus floor. Use six M10 x 30 grade 10.9 screws (VH 11149701) together with the washers and lockwashers of figure 24 (two sides).</p>

<p>Figure 43</p>
<p>Tightening torque: 60 Nm (44 ft.lbf).</p>	<p>Re-install the six plastic nut caps of figure 20 (two sides).</p>

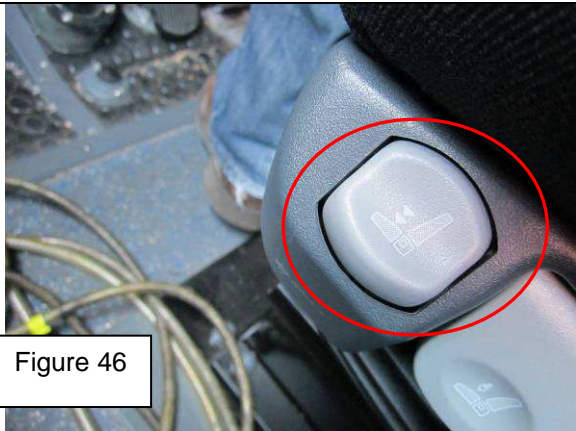
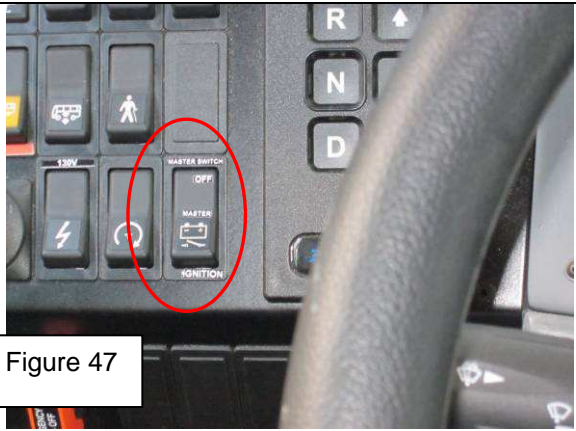
<p>Figure 47</p>
<p>Push the above button at the left side of the driver's seat while sitting on the driver's seat. The seat has to go down. After releasing the button, the driver's seat needs to go automatically up.</p>	<p>Turn on the battery master switch while sitting on the driver seat. First you can feel a vibration at the left side and then at the right side. If the vibration comes in a different order or not at all, the electric connectors are not correctly installed.</p>
