SERVICE BULLETIN

SB1354

ADDRESSEES	: ABC Customer Care and Parts Source
VEHICLE TYPE	: A300L, C2045, T2145, TX45, TDX25, TD925
CONFIGURATION GROUP	: 10.42 Body - Interior
BULLETIN TYPE	: Safety Recall NHTSA 16V-144
DATE	: May 9th, 2016
SUBJECT	: To inspect J-Bracket for missing welds on Recaro drivers' seat and replace J-Bracket if necessary
TERMS & CONDITIONS	: Refer to RECARO campaign documents (see Enclosures)

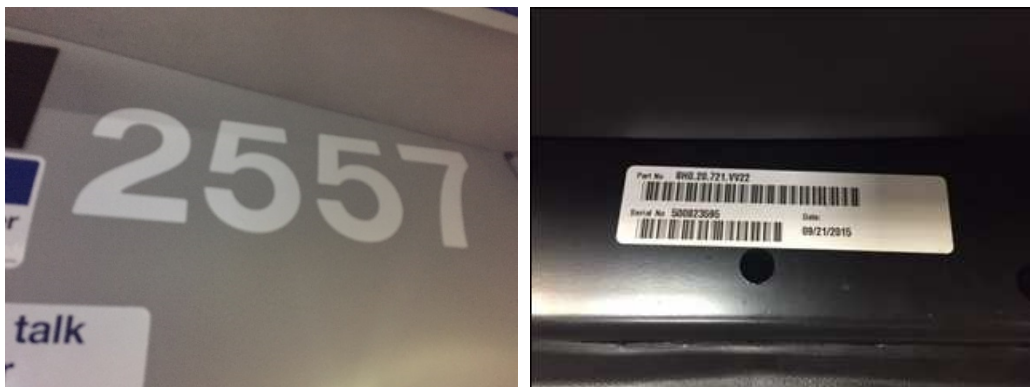
1. Position the seat to “full forward” and “full up” to obtain the serial number on the seat. The serial number decal is located on the back of the seat on the top of the suspension between the seat tracks, shown above. Record the bus number and serial number of the seat.

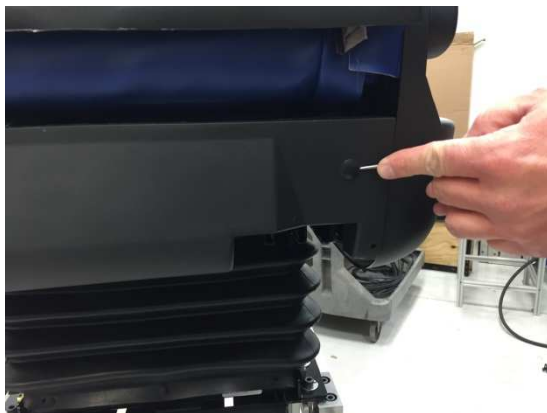
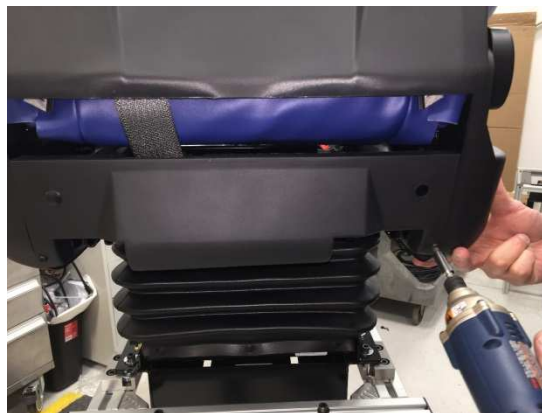
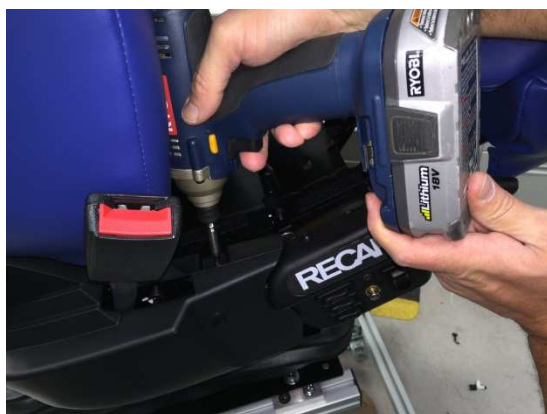
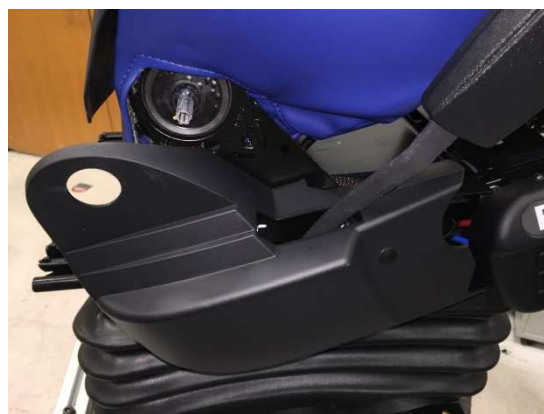
- If J-bracket(s) need to be replaced, remove the 2 hole plugs and 4 screws in the rear trim panel and the mounting screw from the rear corner panel(s). Remove the recliner handwheel.

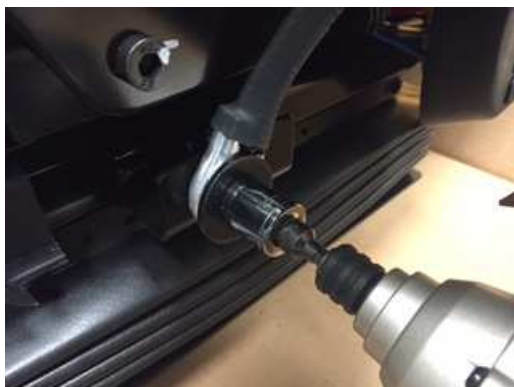
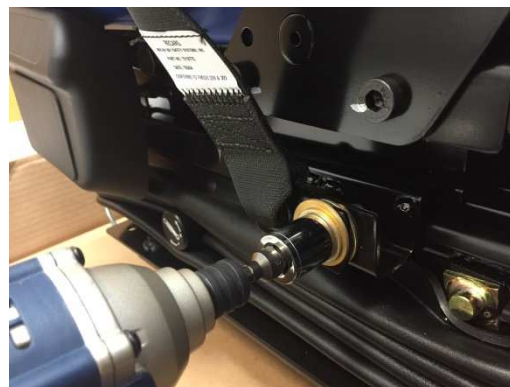
- Remove the belt buckle (or belt retractor/3pt anchor) from the bad J-bracket with a 5/8 socket. Set the removed components aside.

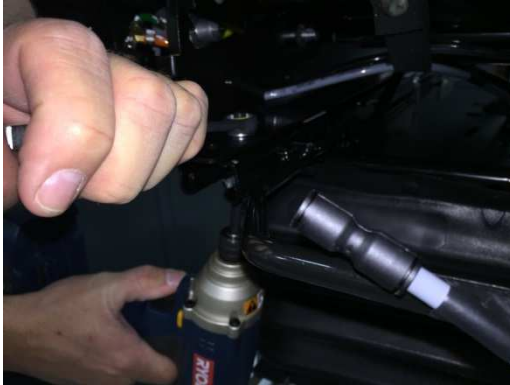
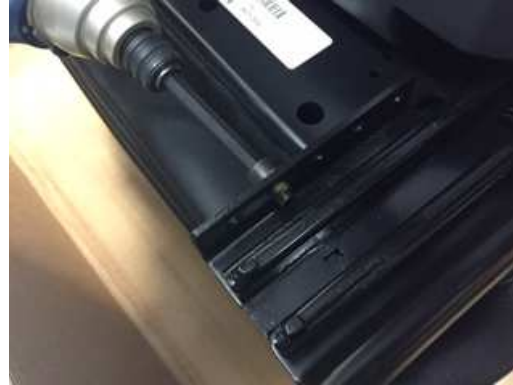
- Position the seat back to "full forward". Unfasten the front track bolt from the cushion frame using a 6mm hex bit and a 13mm wrench. Check the rear of seat for a track stop bolt. If present, remove it with the 6mm hex bit.

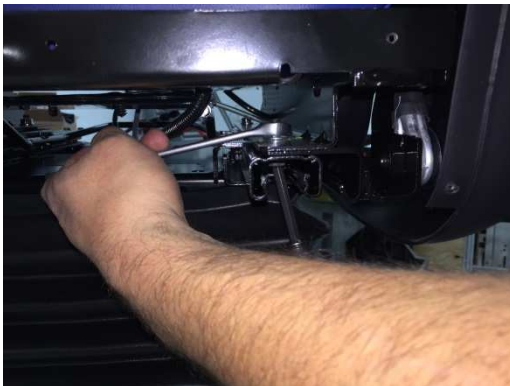
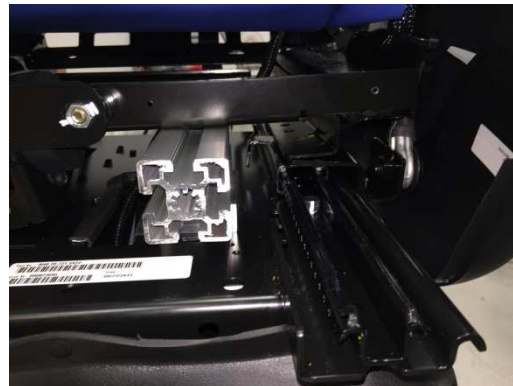
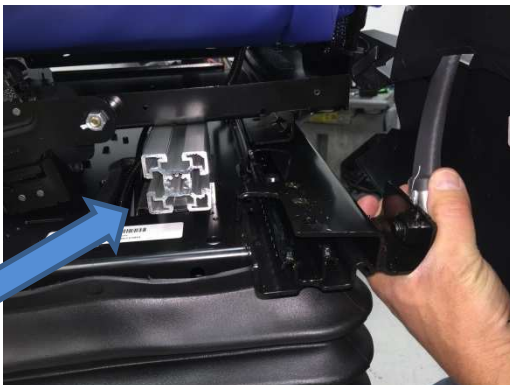
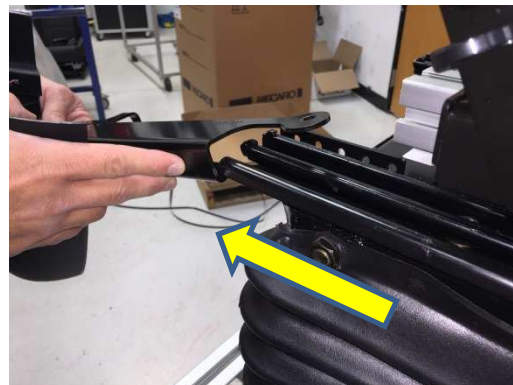
STEP	PICTURES / DESCRIPTIONS	Special Criteria
5.	<p>Position the seat to “full rear”. Unfasten the rear track bolts from the cushion frame using an 6mm hex bit and a 13mm wrench. Place a 2 inch block between the cushion frame and suspension to create just enough clearance to remove the J-bracket by sliding it rearward along the path of the track.</p> <div data-bbox="164 525 802 1005" data-label="Image"> </div> <div data-bbox="826 525 1463 1005" data-label="Image"> </div>

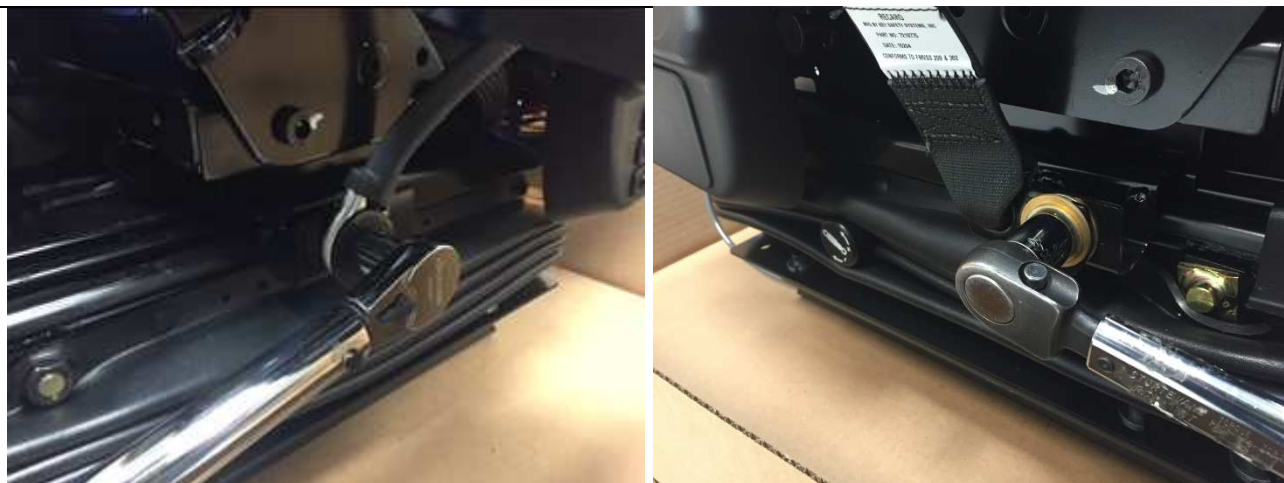
9. Route the buckle through the rear trim panel. Hand start the seat belt buckle bolt into the replacement J-Bracket part now in the seat. Torque to 50 Nm.
10. If needed, replace the other side J-bracket using the same procedure documented in steps 5-10.

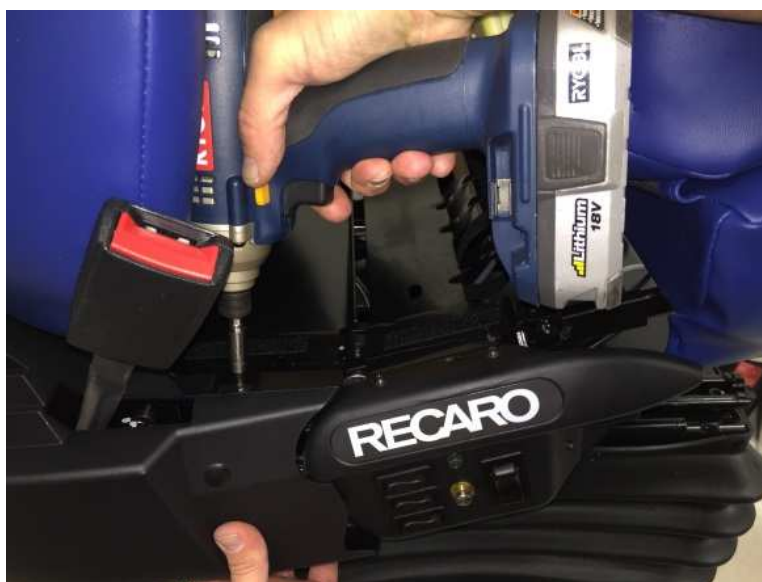
11. Replace the corner panel(s) in original position and secure with the mounting screw(s) previously removed.

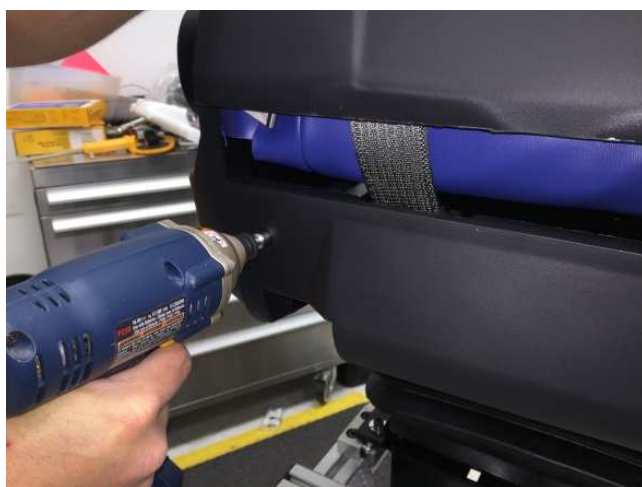
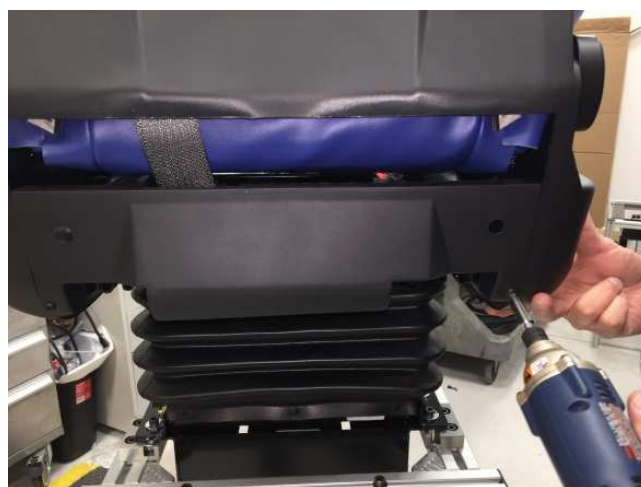
- Position the rear trim panel into its original position and secure with the mounting screws previously removed. Install the hole plugs into the rear trim panel that were previously removed.
