COACH MODEL : C2045, T2145
DATE : 27 Sep 2021
SUBJECT : Water leaking in Luggage bays right side

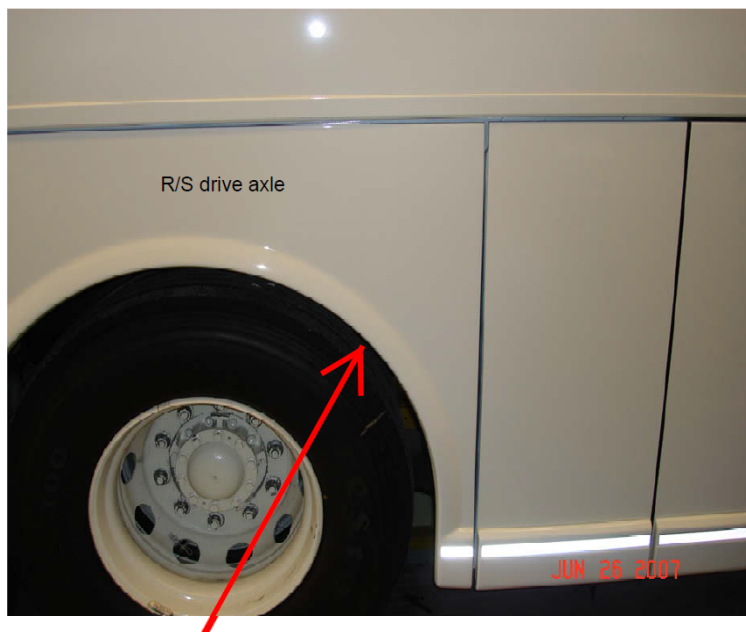
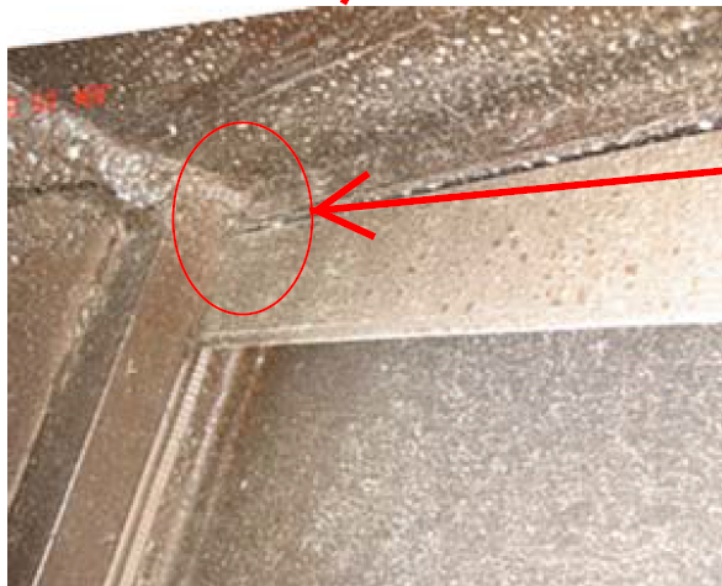
If the water is leaking into the luggage bay you will need to remove the wheel well cover and check to see if the channel in the top front corner of wheel well as shown in this picture is open with no sealer.

To repair the problem inject sealer into the channel, making sure to fill in the area.
