SERVICE BULLETIN No.1095

COACH MODEL	: C2045
BULLETIN TYPE	: Service Information
MANUAL & SECTION	: Maintenance Manual: Chapter 10 - HVAC System Spare Parts Manual: Section 771809 - Heating accessories
PARTS BOOK REVISION	: Yes
DATE	: November 30th, 2001
SUBJECT	: Proheat combustion heater – carbon build-up
TERMS & CONDITIONS	: No claims will be accepted with reference to this Bulletin.

SB0038

Description: Bravo 80 auxiliary heater.

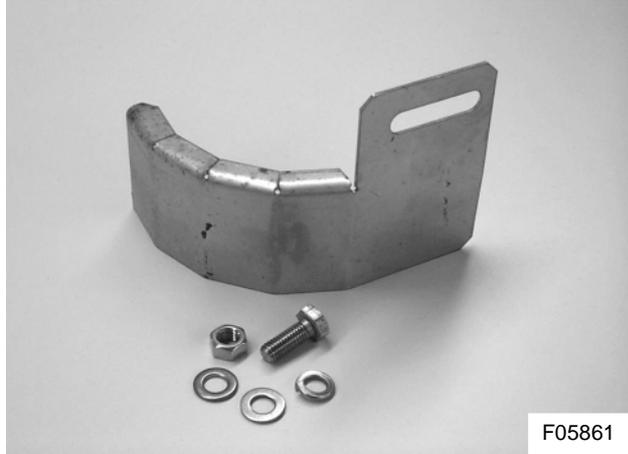
Figure 1: Proheat heat shield VH 10715349 and hardware to be removed

Description	Qty.
Exhaust heat shield VH 10715349	1
Bolt, M8x1.25x20, stainless	1
Flat washer, 8x20x1.5 mm, stainless	2
Lock washer, stainless	1
Nut, M8, stainless	1

- Part VH 10715349 will be no longer offered as service replacement.

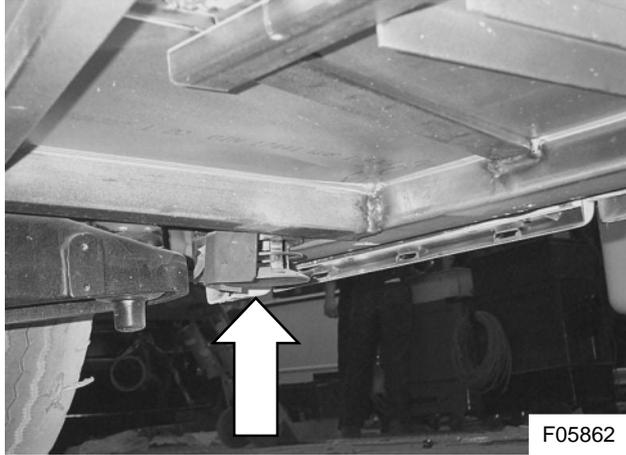
- Refer to the nozzle sealing washer installation procedure if an air leak has been detected.
- Tests at Van Hool have shown that the deflector at the base of the shock absorber behind the exhaust pipe (see Figures 1 and 2) increases the exhaust back pressure, thus reducing the exhaust gas flow and contributing to a certain extent to the carboning also.

Figure 2: Heat shield installation between Proheat exhaust and shock absorber on C-beam

- Removing the shield also increases time between service intervals.
- Van Hool recommend removal of the heat shield during the next service interval to improve combustion heater performance. The procedure in this Bulletin explains how this can be done.

4. To remove exhaust heat shield VH 10715349 (see Figure 2):

- 1) Underneath the coach, locate the Proheat combustion heater exhaust pipe and heat shield (see Figure 2).

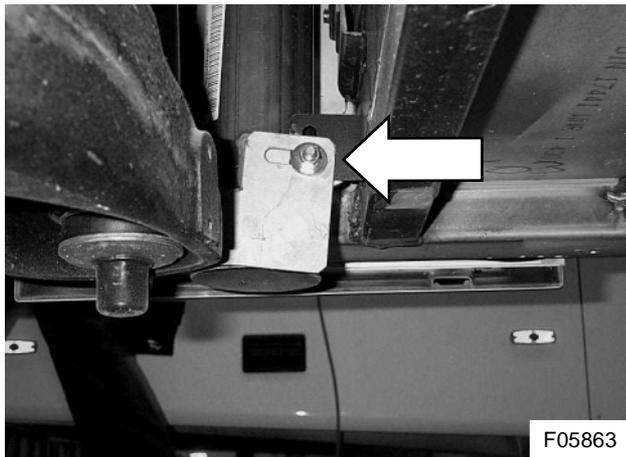
Figure 3: Exhaust heat shield, nut and bolt to be removed

- 2) Using two 13 mm box wrenches, undo and remove the bolt, nut and washers securing the exhaust heat shield to the chassis mounting bracket (see Figure 3).

- 3) Remove and discard the heat shield.

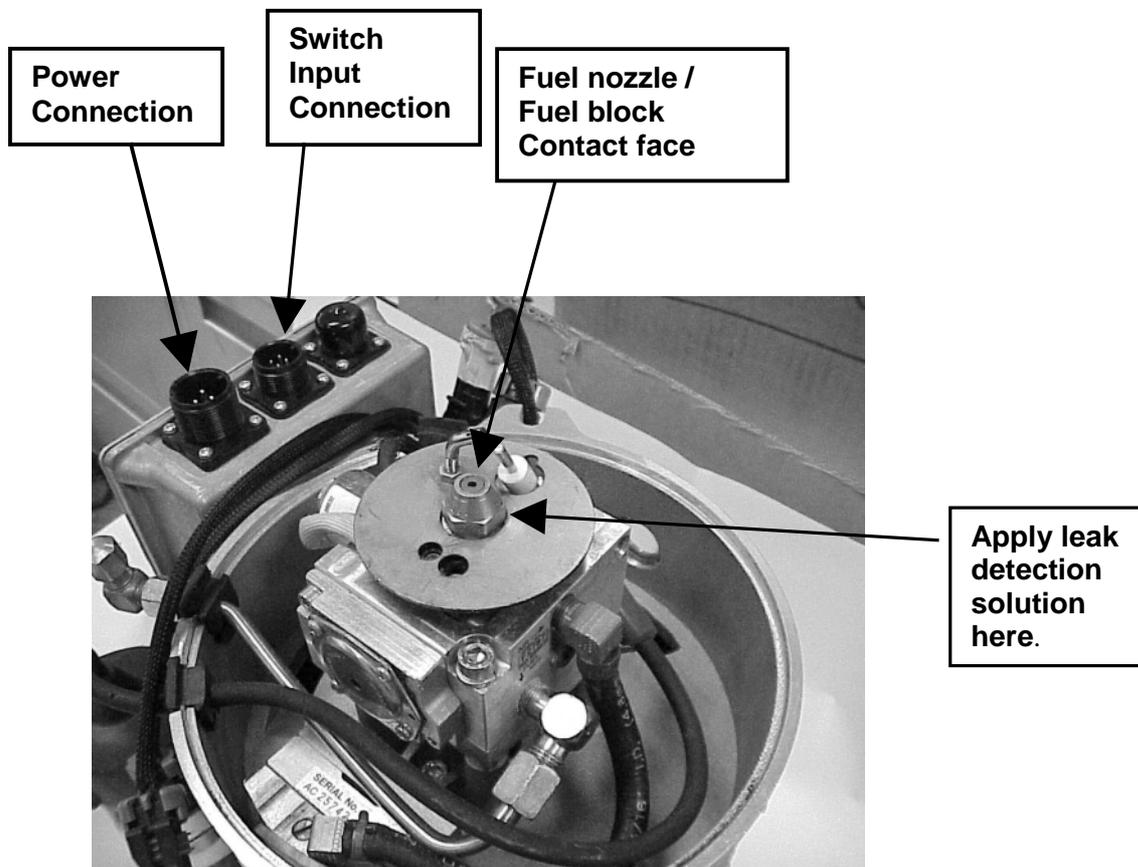
Figure 1

Purpose: Testing for air leaking from between the fuel nozzle and fuel block contact face. See attached picture.

4. While the heater is running in purge cycle (3 minutes), test for air leaking between the back of the fuel nozzle and the fuel block using a leak detection solution. See Figure 1.
 - If an air leak is detected install washer seal PK0361 (c/w Instructions).

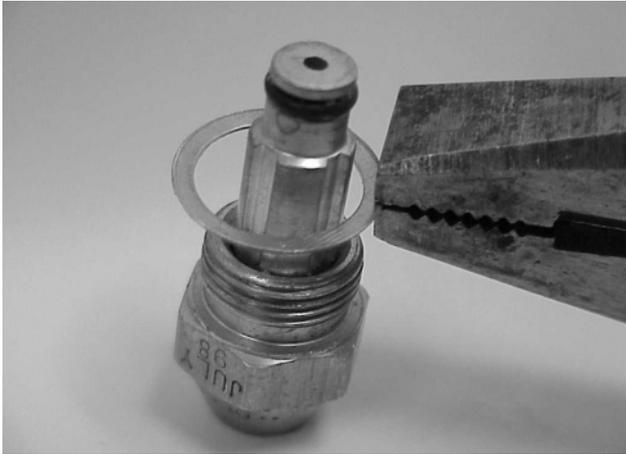
Figure 1

Step 2. Install the washer seal over the nozzle threads as shown in figure 1.

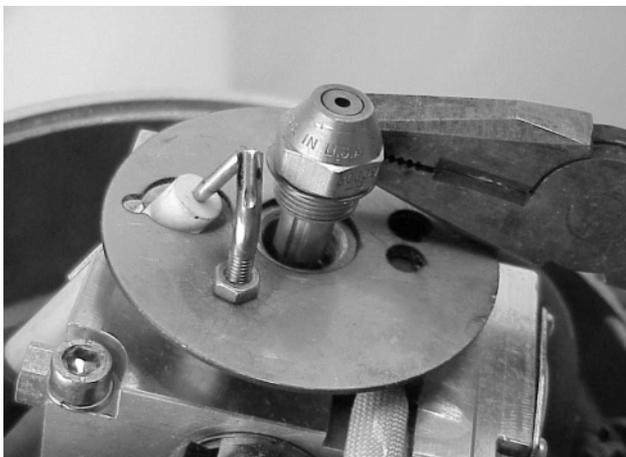
Figure 2

Step 4. Re-install the nozzle in to the fuel delivery unit as shown in figure 2.

Step 5. Torque nozzle to 50 +/- 3 in-lbs.
