SERVICE BULLETIN No.1112

COACH MODEL	: T2145 w/ ADA lift
BULLETIN TYPE	: Field Change Program
MANUAL & SECTION	: Maintenance Manual: Chapter 10 – HVAC System Spare Parts Manual: Section 771609 - Ventilation
PARTS BOOK REVISION	: Yes
DATE	: January 10th, 2003
SUBJECT	: Rear quarter ventilation
TERMS & CONDITIONS	: Parts and labor allowance will be provided as per warranty information in this Bulletin.

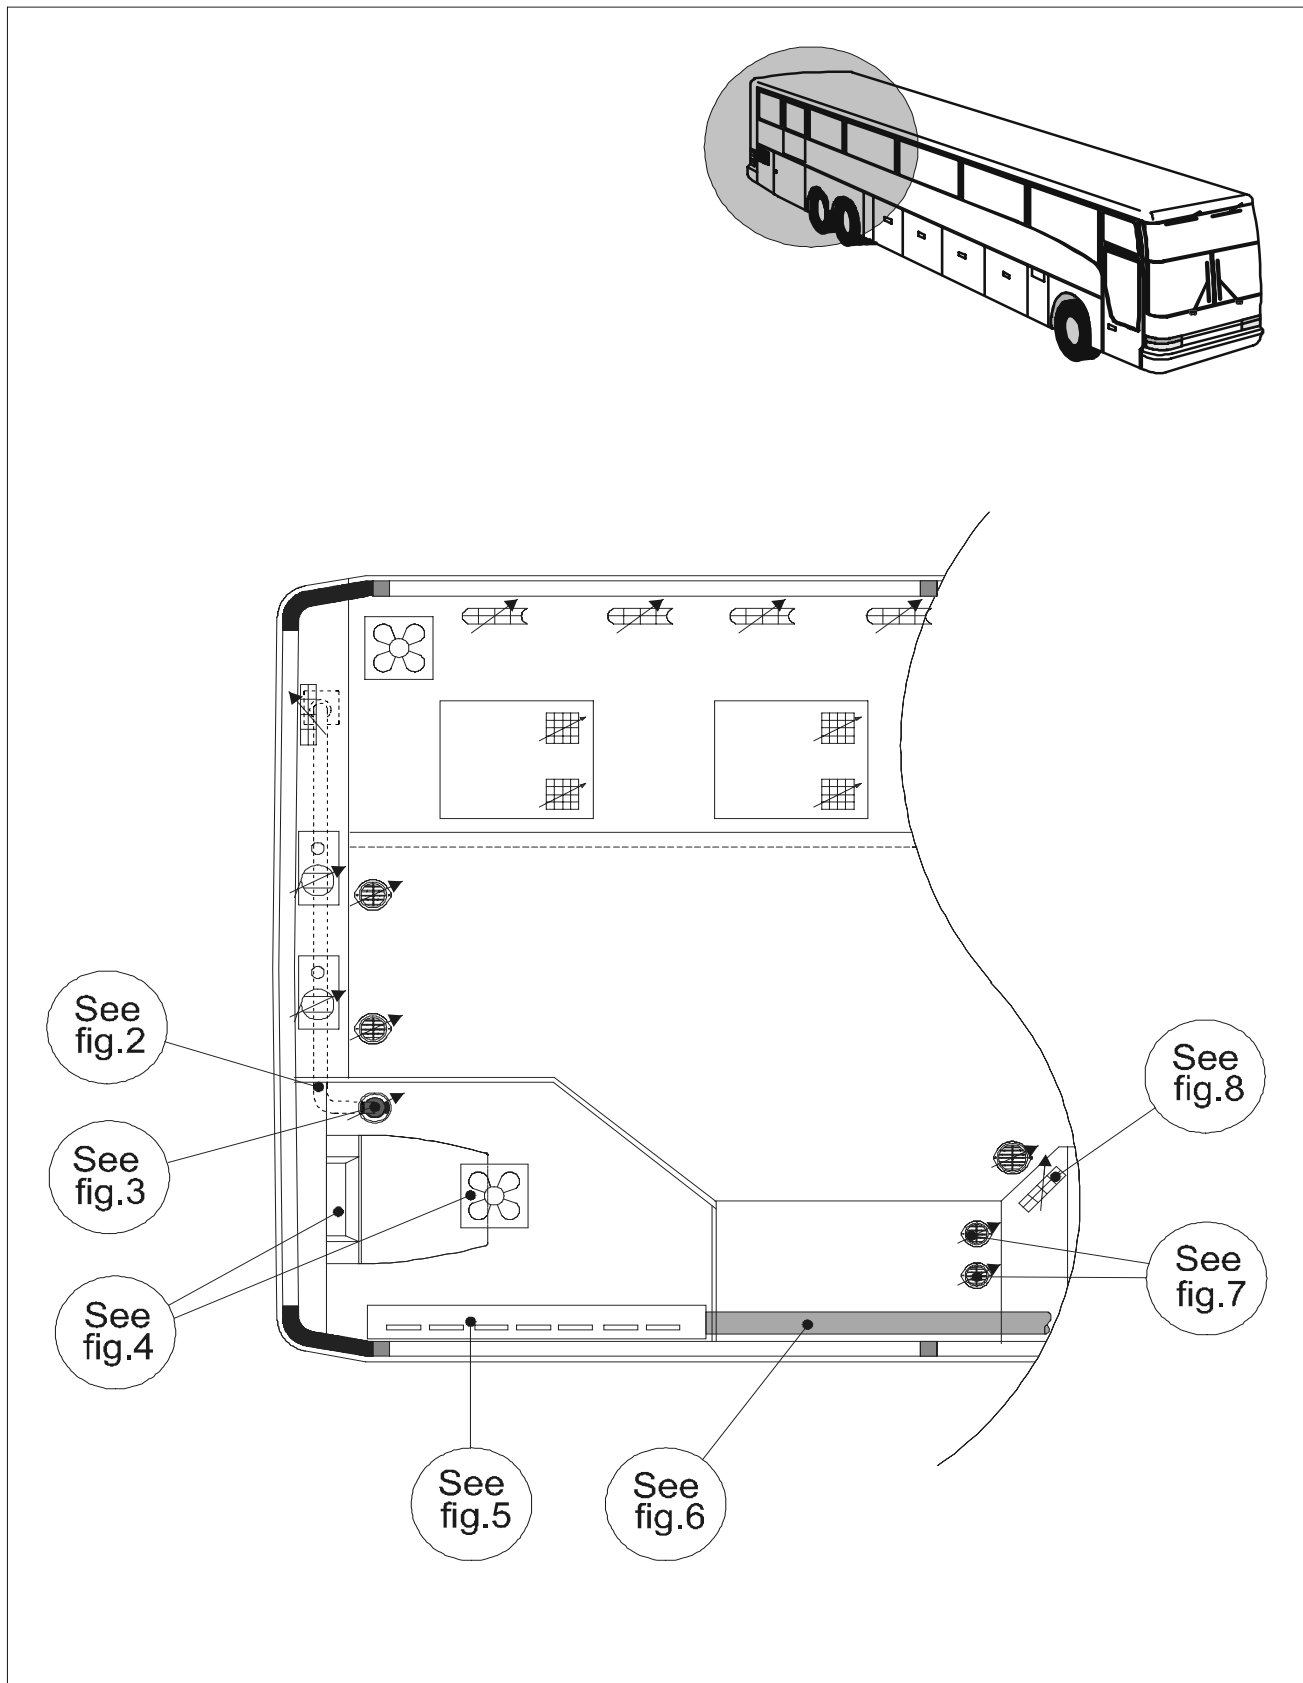
Figure 1: Revised rear quarter ventilation on T2100 Series coaches with ADA lift

Revised ventilation of lift door area and restroom

- To improve ventilation in the rear quarter area, fresh air is taken from the air duct which is hidden by the molding above the rear seats, and which is then supplied to the restroom through a flex tube and an outlet in the restroom ceiling (see Figures 2a, 2b and 3).
- More air is supplied to the restroom through slots in the air outlet molding above the restroom window. This air is taken from the right hand parcel rack duct (see Figures 5, 6a and 6b).
- Used air is removed from the restroom through slots in the trim panel behind the toilet seat (see Figure 4) and evacuated to the outside through a roof mounted extractor fan.
- Additional ventilation in the area next to the rear access door is provided through two additional outlets in the parcel rack bulkhead and one in the parcel rack floor (see Figures 7 and 8).

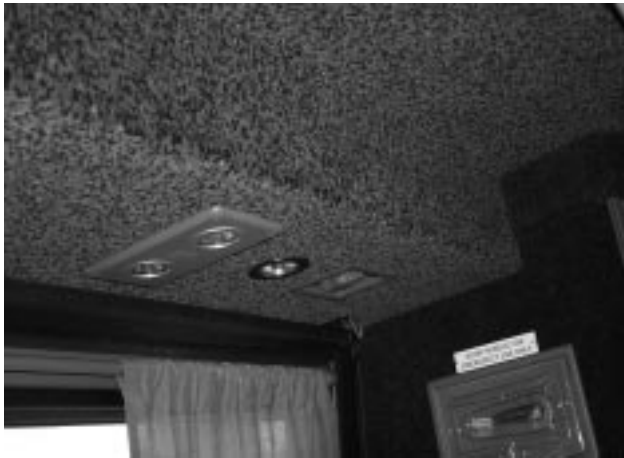
Figure 6b: Parcel rack to restroom flex tube covered by trimmed capping w/ lamp assembly

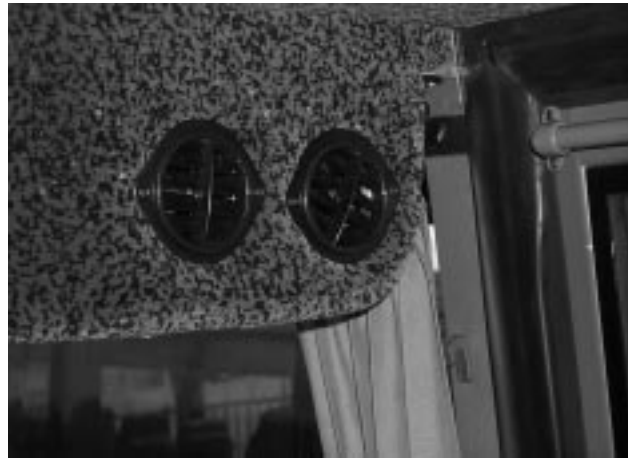
Figure 7: Additional round air outlets VH 660520405 near rear door

- 1) To install round air outlets VH 660520405, make a template for the two holes in the parcel rack bulkhead (see Figure 7 and nominal size chart), using a piece of suitable cardboard and dividers.

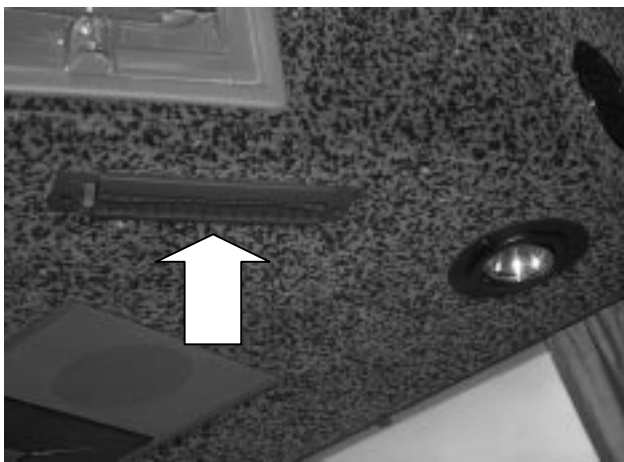
Figure 8: Additional oblong air outlet VH 10627579 near rear door

- 2) Referring to the dimensions in Figure 9, position the template on the parcel rack bulkhead and attach with masking tape.
- 3) With a utility knife follow the circumference of the two outlets, at the same time cutting through the template and the fabric. Remove the template and the wasted cloth.
- 4) Secure the fabric remaining around circumference of the holes with a stapler.
- 5) With a suitable hole saw, cut two holes in the plywood to accept the outlets.
- 6) Install the outlets in the holes and secure them with black self-tapping screws.
- 7) Referring to the installation dimensions in Figure 10, proceed likewise for oblong air outlet VH 10627579, cutting the plywood with a reciprocating saw.

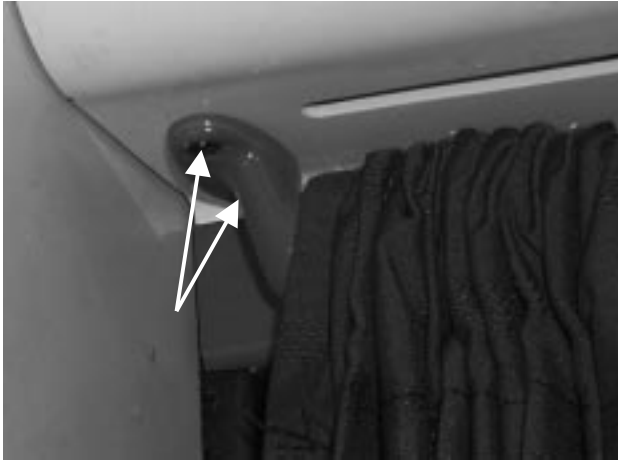
Figure 11: Curtain rail securing screws

- 1) In the restroom, open the emergency window. Move both curtains towards the middle of the curtain rail. Undo and remove the 4 screws securing the upper curtain rail to the air outlet molding above the window (see Figure 11). Withdraw the rail.

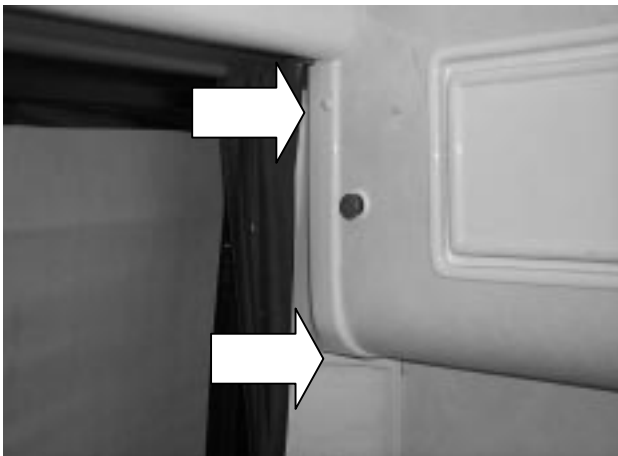
Figure 12: Corner trim molding screws. Note screw head buttons. These need to be removed first.

- 2) Undo and remove the screws securing the upper corner trim molding (see Figure 12). Withdraw the molding.

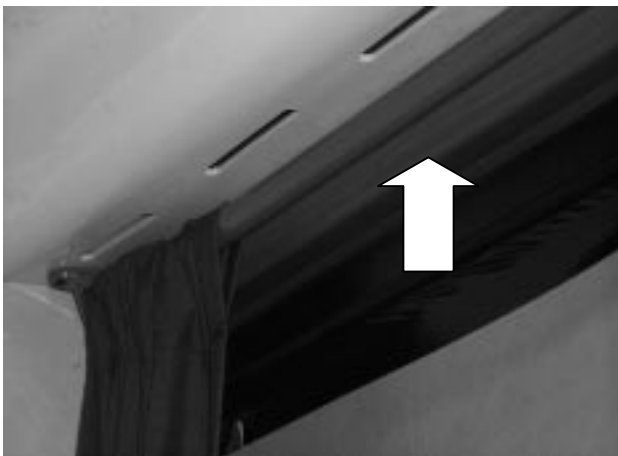
Figure 13: Finishing angle covering mounting screws and upper window rail

- 3) Pry loose and discard the finishing angle just below the white molding (see Figure 13).

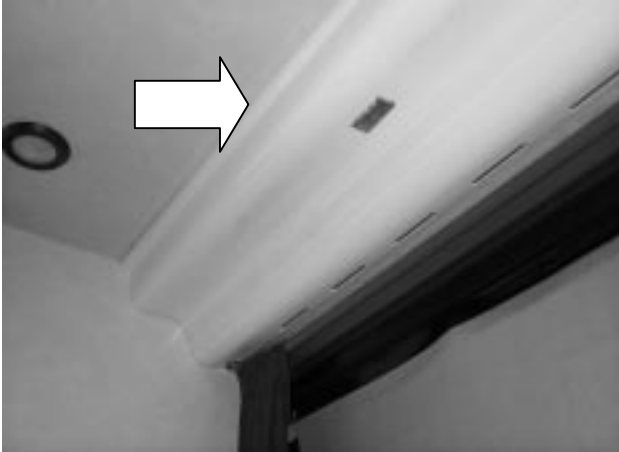
Figure 14: Push the outlet molding towards the window to remove it from the retaining strip.

- 4) Undo the screws securing the air outlet molding to the upper window rail. Push and withdraw the molding from the retaining strip on the ceiling (see arrow, Figure 14).

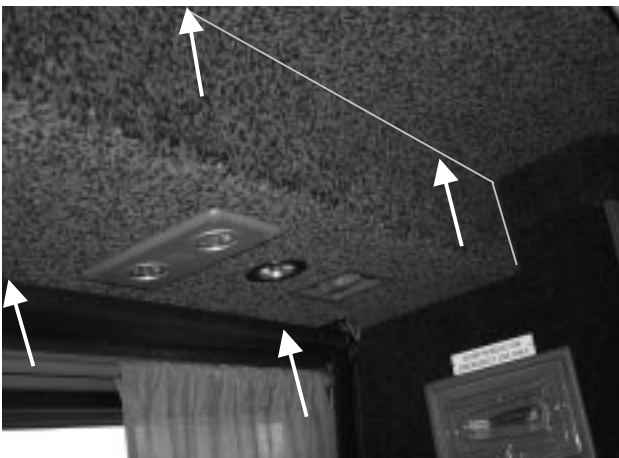
Figure 15: Lift door overhead capping. Approximate location of screws.

- 1) Undo and remove the self-tapping screws securing the lift door overhead capping to the coach body. See Figure 15 for the approximate location of the screws, which are hidden in the fabric. Lower the capping.

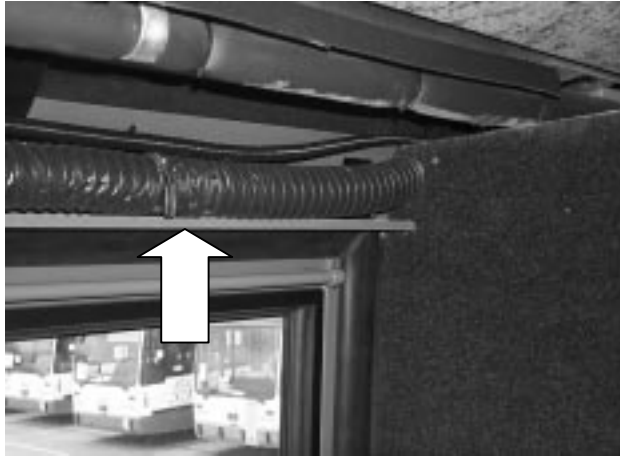
Figure 16: Parcel rack to restroom flex tubing installation

- 4) Cut a suitable length (approximately 3 ft) of 2-11/64 diameter flex tubing VH 660074812 to be connected to the new molding/diffuser, which will be installed in the restroom later in the procedure. Connect one end of this tubing to the sleeve and secure with a tie wrap. Insert the other end through the top opening of the restroom wall making sure the tubing sticks about 1 foot into the room. If no hole is present, make one as per procedure in item 4 of this Bulletin. Secure flex tubing with tie wraps (see Figure 16).

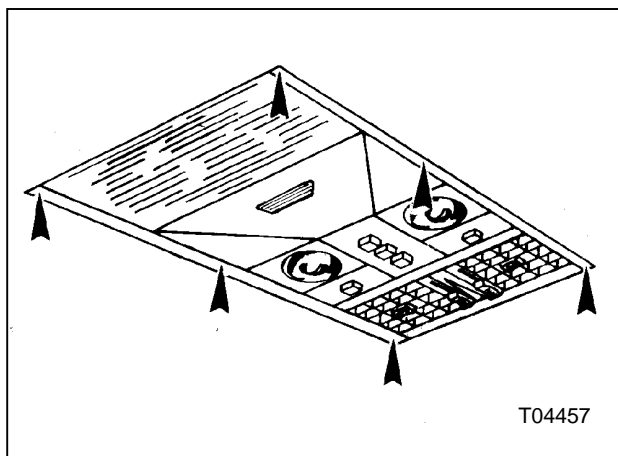
Figure 17: Service module. Location of screws. Remove screw head buttons first

- 1) Inside the recess between the two rear bench reading lights, undo and remove the self-tapping screws securing the rectangular cover plate. Remove the plate.
- 2) Undo and remove the retaining screws of the two rear passenger reading lights/air vents. Pull the light/vent units from the molding and disconnect the terminals.
- 3) Remove the rearmost service module from the left hand parcel rack by withdrawing the six retaining screws (see Figure 17).

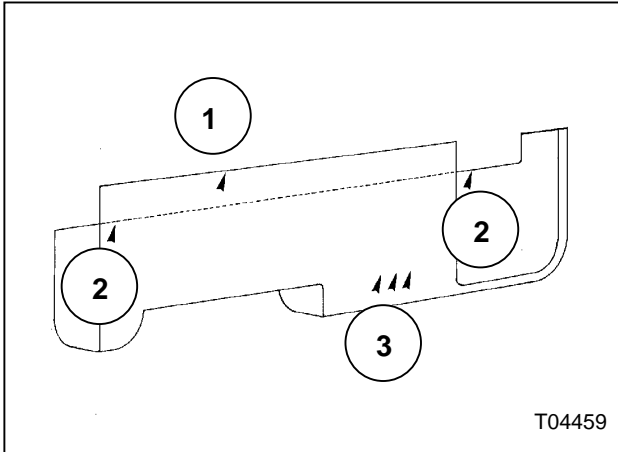
Figure 18: Rear bench ABS molding.
Approximate location of retaining screws

- 4) Mark and disconnect the service module terminals.
- 5) Remove the rearmost left hand curtain by pulling the curtain retaining spring from the eyelet screws.
- 6) Optional: remove the small L-shaped molding end plate between the rearmost passenger window and the parcel rack.
- 7) Using a long cross tip screwdriver undo and remove the retaining screw(s) on the inside of the molding through the opening between the two reading light bowls (1, Figure 18). Undo and remove the retaining screws at the back of the molding (2, Figure 18).

Through the service module opening in the parcel rack, undo the retaining screws at the front of the molding (3, Figure 18). Withdraw the molding by pulling it down.

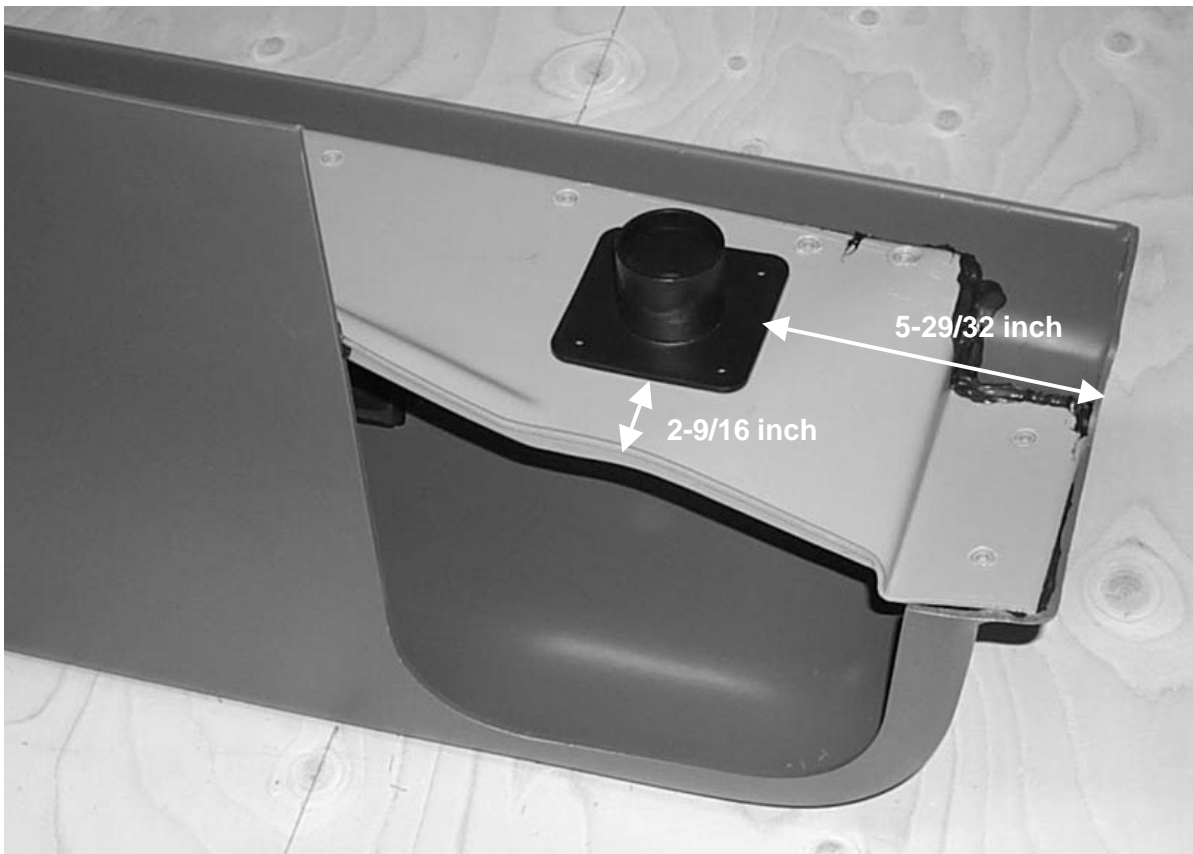
Figure 19: Location of transition duct on rear molding duct

- 8) Install the T-shaped transition duct referring to the dimensions in Figure 19. Start by drilling a 1-5/8 inch hole in the molding duct. Center the hole in the transition duct with the hole in the molding. Secure with Sikaflex 221 or a similar adhesive, rivets at the four corners, and back-up washers.

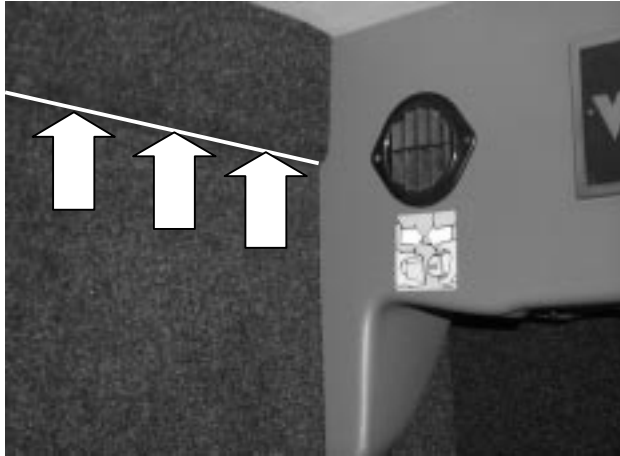
Figure 20: Trimmed plinth covering the gap between restroom ceiling and coach roof

- 1) On the outside of the restroom, adjacent to the coach' roof, is a trimmed plinth. Insert a flat screwdriver beneath it (see Figure 20) and carefully pry it loose.

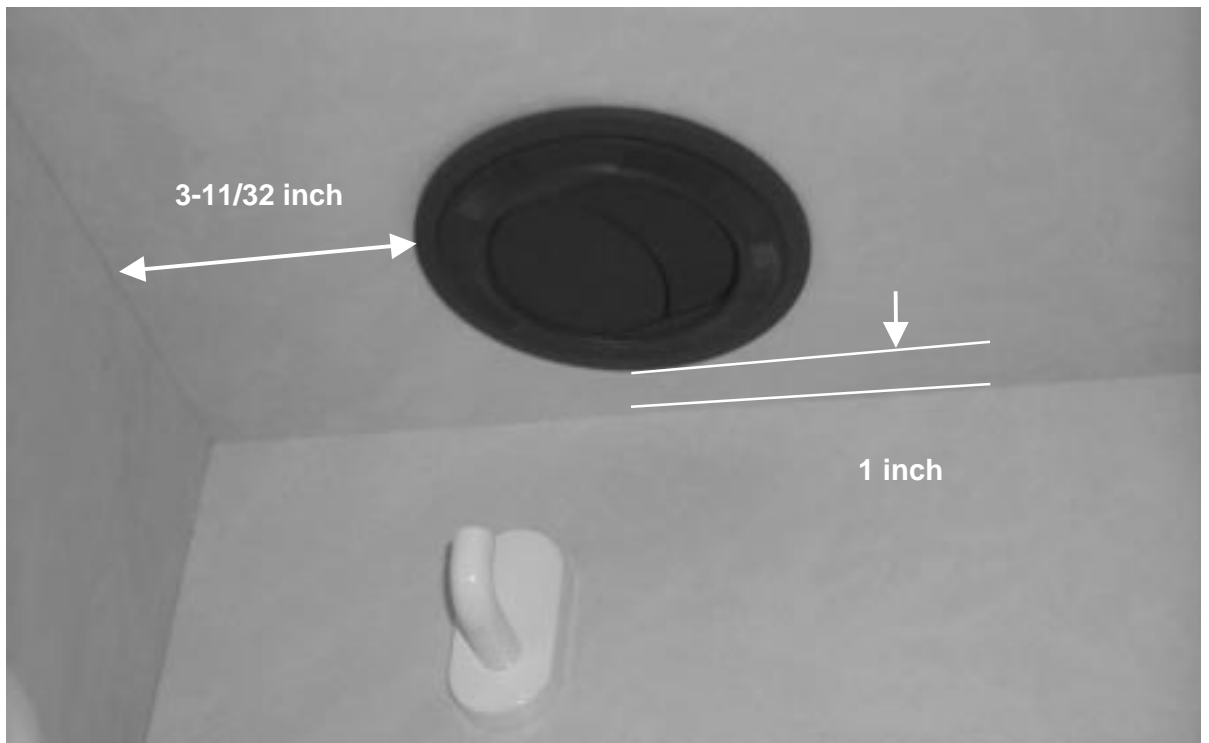
Figure 21: Installation dimensions for air outlet in restroom roof

- 2) In the restroom, cover the area where the air outlet will be installed with masking tape (see Figure 21). Cut a hole through the tape and the ceiling using a 3-inch hole saw. Remove the tape once the hole is finished.

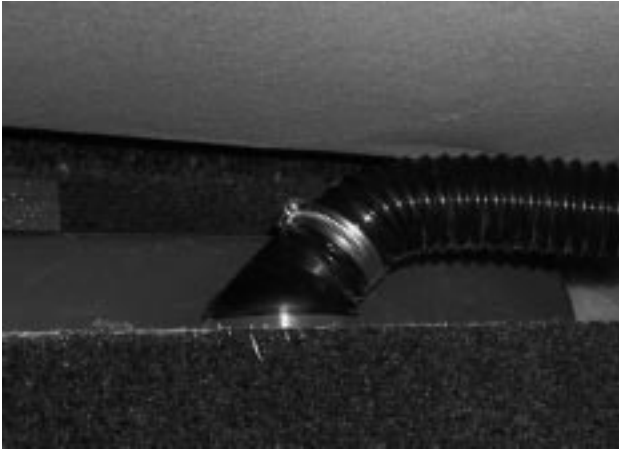
Figure 22: Air outlet/transition duct assembly and flex tube installation

- 3) Assemble transition duct VH660744686 and air outlet VH 660520473 by simply inserting one into the other and pressing both parts together.
- 4) Attach 5 feet of 1-49/64 diameter flex tube VH 660074604 to the transition part of the new assembly. Secure with a 1-3/4 inch + hose clamp.
- 5) Insert the flex tube and assembly through the hole in the ceiling, making sure the transition part of the assembly points towards the rear of the coach. Push the assembly fully home. This installation is press-fit (see Figure 22).

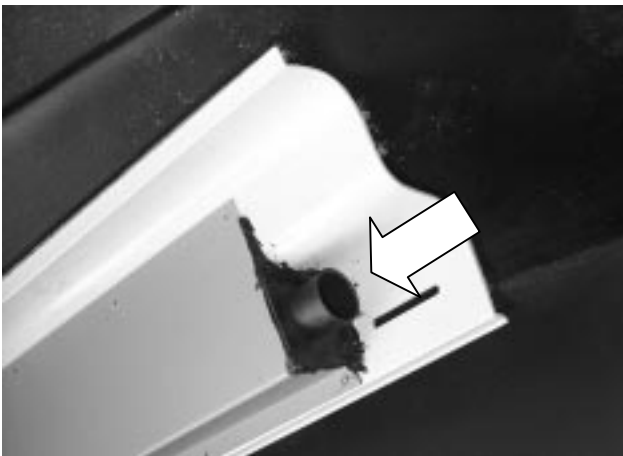
Figure 23: Air outlet molding with built-in diffuser. Note T-transition.

- 1) Attach the flex tubing coming from the parcel rack to the T- transition duct of the diffuser (see Figure 23). Secure with a hose clamp.
