SERVICE BULLETIN No.1126

COACH MODEL	: C2045
BULLETIN TYPE	: Safety Recall Program – NHTSA Campaign number 04V-422
MANUAL & SECTION	: N/A
PARTS BOOK REVISION	: No
DATE	: December 3, 2004
SUBJECT	: Main junction box – top cover
TERMS & CONDITIONS	: Refer to the Warranty Information in this Bulletin.

On the above-mentioned coaches, it is necessary to add a closing panel to the top of the left hand and right hand sections of the main junction box in order to prevent possible damage to electrical components.

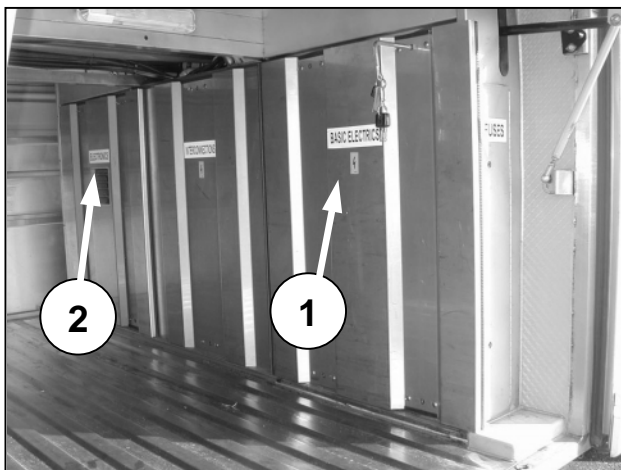
Figure 1: C2045 main junction box

1. "Basic Electrics" compartment
2. "Electronics" compartment

- 1) Open the main junction box door giving access to the "Basic Electrics" compartment (see 1, Figure 1).

- 1) Open the main junction box door giving access to the “Electronics” compartment (see 2, Figure 1).
- 2) Install the left hand top cover of the main junction box, proceeding in a similar manner to the installation of the right hand top cover.
- 3) Close “Electronics” access door.
- 4) Reconnect the batteries.

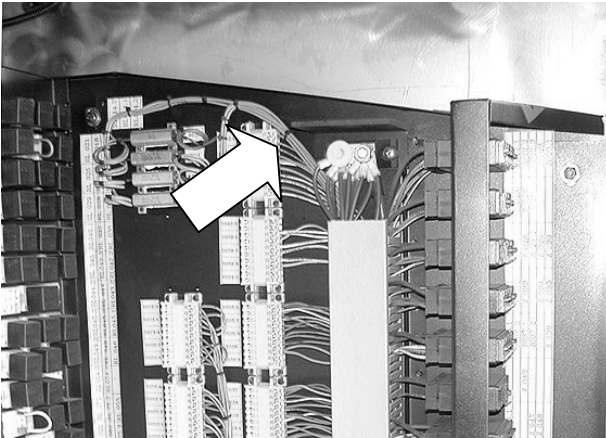
Figure 2: Open top J-box

- 2) Check the junction box for the presence of a closing panel (see Figure 2).
