SERVICE BULLETIN No.1127

COACH MODEL	: C2045
BULLETIN TYPE	: Service Information
MANUAL & SECTION	: Maintenance Manual: Chapter 10 – HVAC System Spare Parts Manual: Section 771809 – Heating accessories
PARTS BOOK REVISION	: yes
DATE	: November 26th, 2003
SUBJECT	: Proheat Bravo 80 – exhaust change and air compressor service recommendations
TERMS & CONDITIONS	: No claims will be accepted with reference to this Bulletin.

Description: Bravo 80 Air Compressor

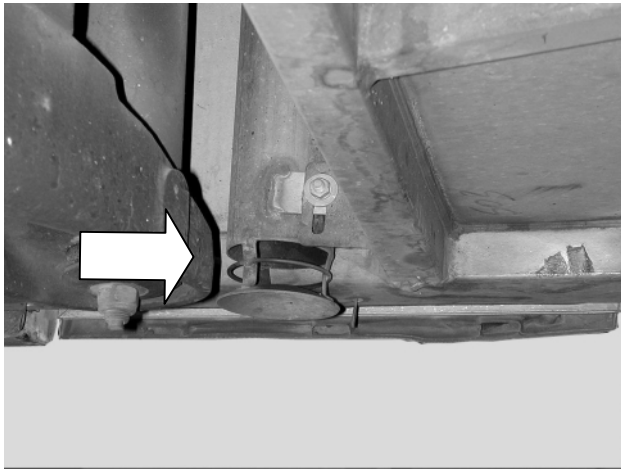
Figure 1: Old style Proheat exhaust for C-coaches

Part No.	Description	Qty.
VH 10692499	Proheat Bravo 80, deflector type exhaust pipe	1

1. In an effort to eliminate burner exhaust back pressure, Van Hool have replaced in production the old deflector type exhaust pipe by a bent open exit type (see Figures 1, 2 and 3).
As the old style exhaust will not be offered as service replacement any longer, the new style retains the same part number.
The exhaust heat shield VH 10715349 has become obsolete in the new installation (re: Van Hool Service Bulletin #1095 dd November 30th, 2001) .
Refer to the parts section in this Bulletin for more information.
2. Proheat have made recommendations regarding the maintenance and adjustment of the auxiliary heater air compressor in order to increase the time between service intervals and improve heater performance.
Refer to attached Proheat Service Bulletin SB0042 Rev. A for more details.

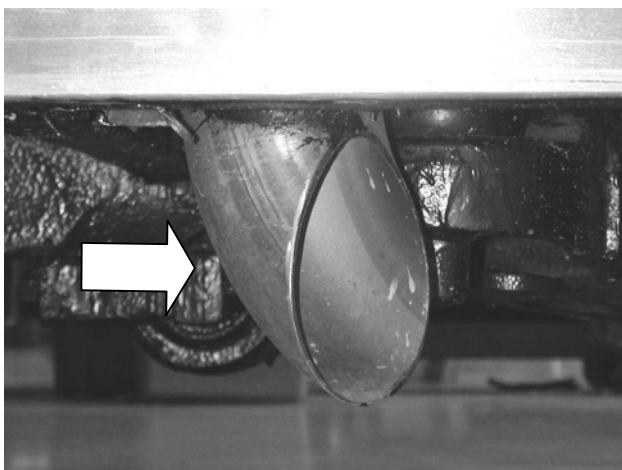
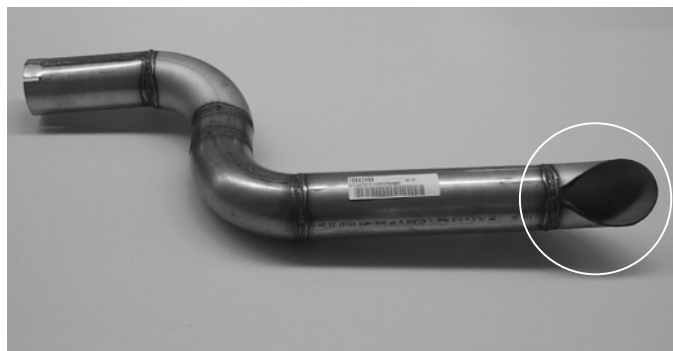
Figure 2 and 3: New style Proheat exhaust for C-coaches

Part No.	Description	Qty.
VH 10692499	Proheat Bravo 80, bent open exit type exhaust pipe	1

- Old and new parts are interchangeable, but only the new will be offered for service replacement.
- The new part will be included in the next Spare Parts Manual update.
- Parts may be purchased from your nearest ABC Customer Care & Parts Source dealership.
- Parts and products disposition: discard according to applicable environmental regulations.

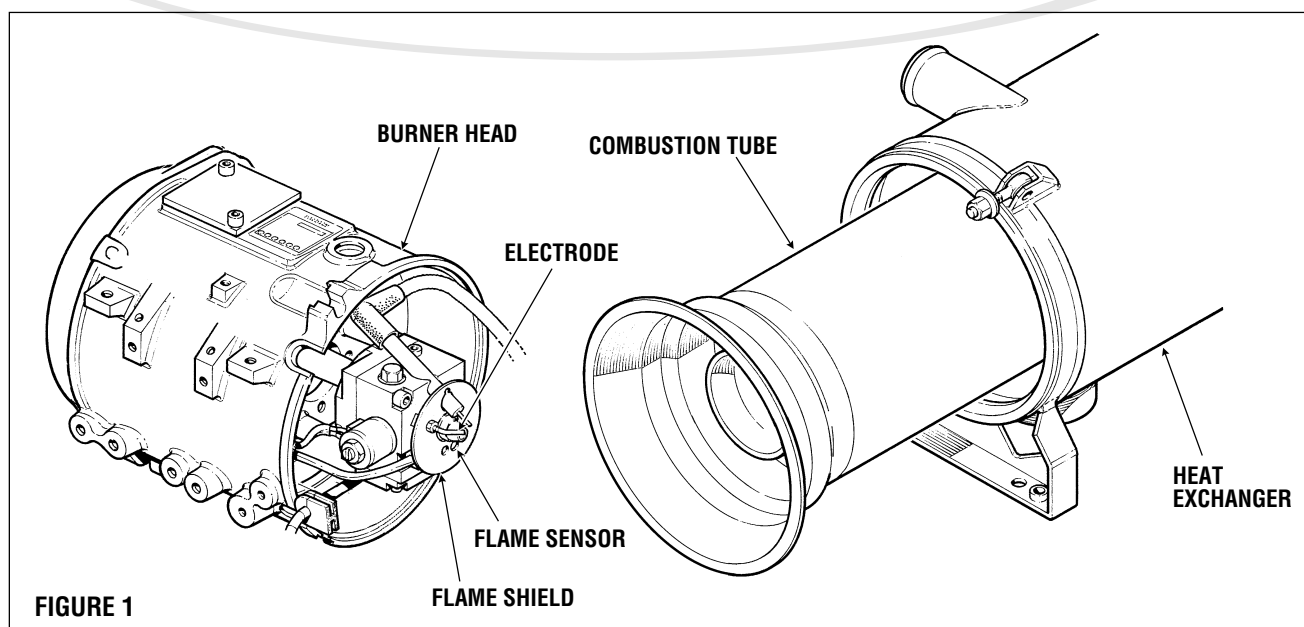
2. Remove heater Burner Head Assembly from heat exchanger.
3. Inspect and clean any carbon build-up on the flame shield, flame sensor, electrode, combustion chamber and combustion tube. (see Figure 1)

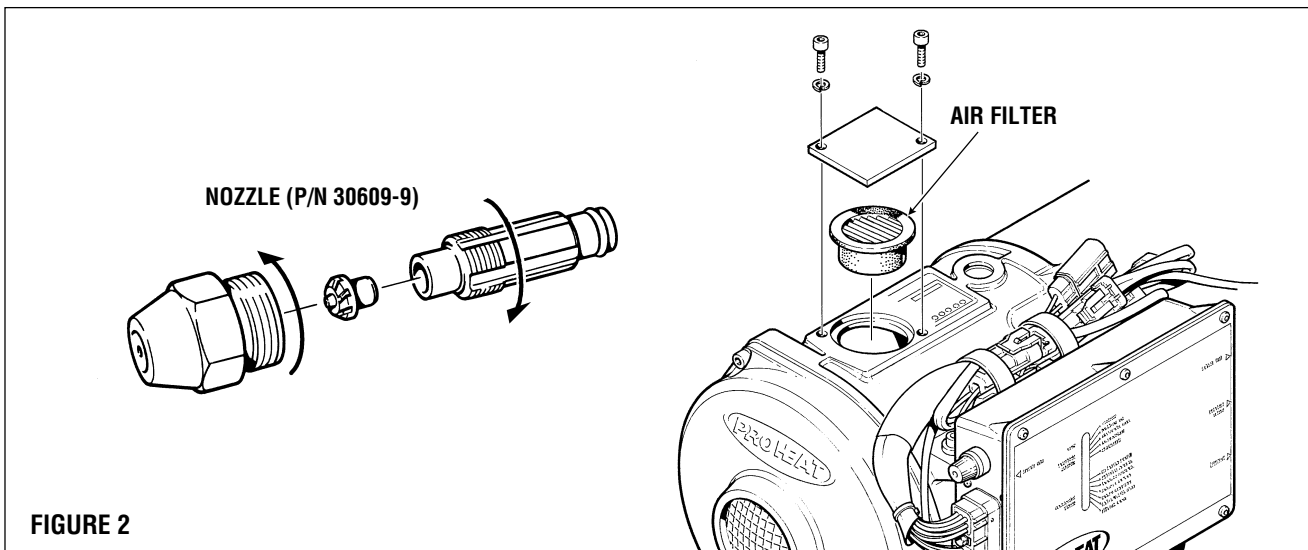
4. Clean nozzle and check air compressor air filter. Replace if necessary. (see Figure 2)

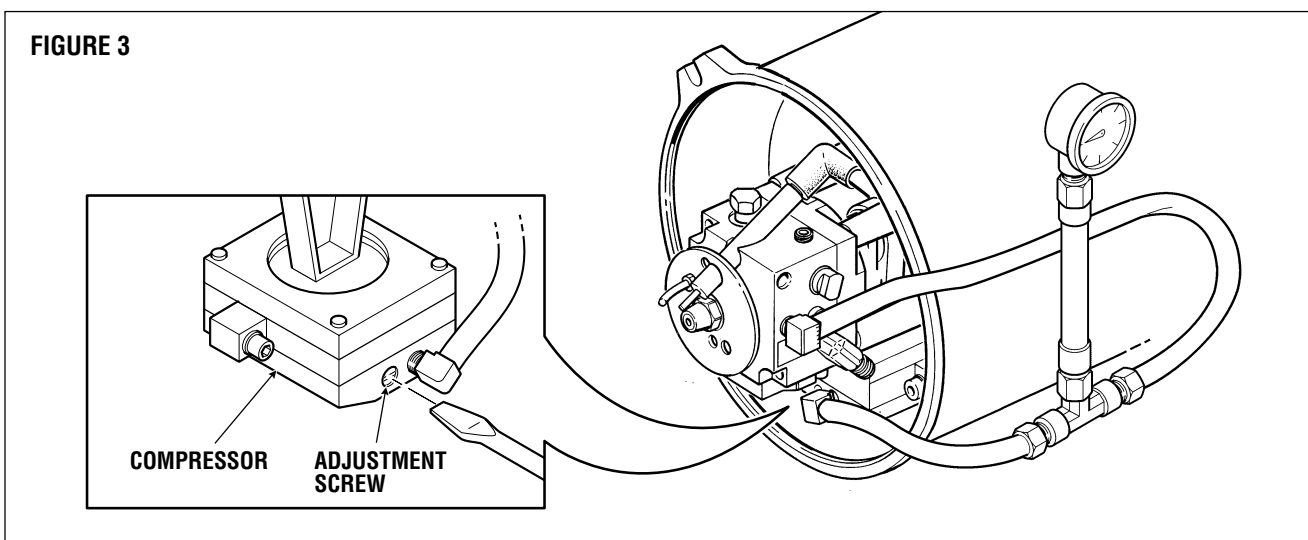
5. Remove air hose from Fuel Delivery Unit and connect pressure gauge (P/N PK0060) inline with air supply line. (see Figure 3)
6. Reconnect Power and Switch Harness only; start heater and read the air pressure on the gauge. (see Figure 3)

7. Adjust pressure as required by turning the pressure adjustment screw. (3.2 psi at 24 Volts). (see Figure 3)

Note: If the screw will not turn, apply a small amount of heat to the adjustment screw area to loosen the loctite. If compressor pressure will not adjust to 3.2 psi, then refer to page 4-18 of the Bravo 80 Service Manual for further instructions.
