SERVICE BULLETIN No.1148

COACH MODEL	: C2045
BULLETIN TYPE	: Service Information
MANUAL & SECTION	: Operator's Guide Book: Section 2 – Operating instructions Spare Parts Manual: Sections 782109, 783001 and 783009
PARTS BOOK REVISION	: No
DATE	: June 21st, 2005
SUBJECT	: Introduction to multiplex systems
TERMS & CONDITIONS	: No claims will be accepted with reference to this Bulletin.

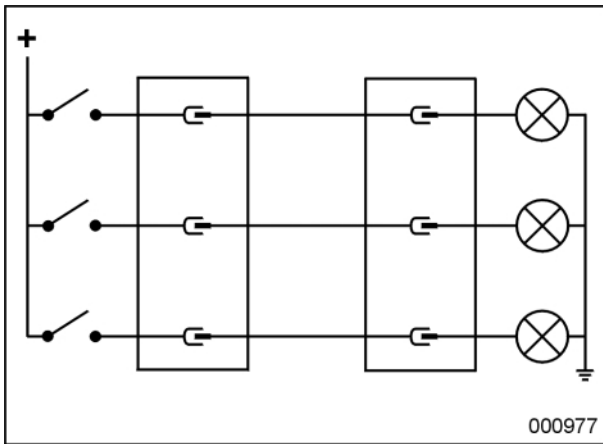
Figure 1: Classic electrical circuit with switches, conductors, plugs and load (lamps)

Multiplex is a collective term for the technology used to transmit multiple signals (data/commands) through a single conductor between two or more components in an electronic network (see Figures 1 and 2: multiplex vs. classic system).

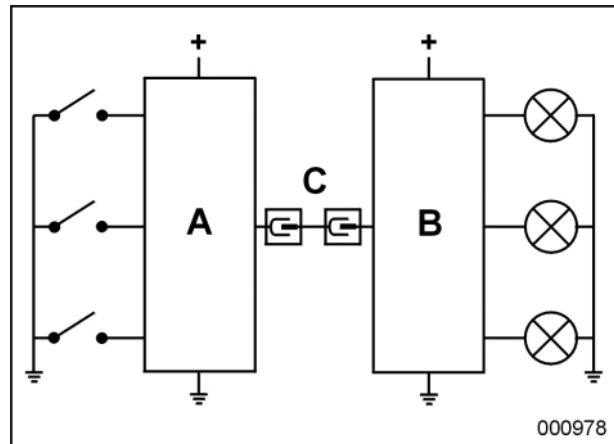
Figure 2: Multiplexed electrical circuit with switches, electronic boxes (A and B), plugs, signal line (C) and load (lamps)

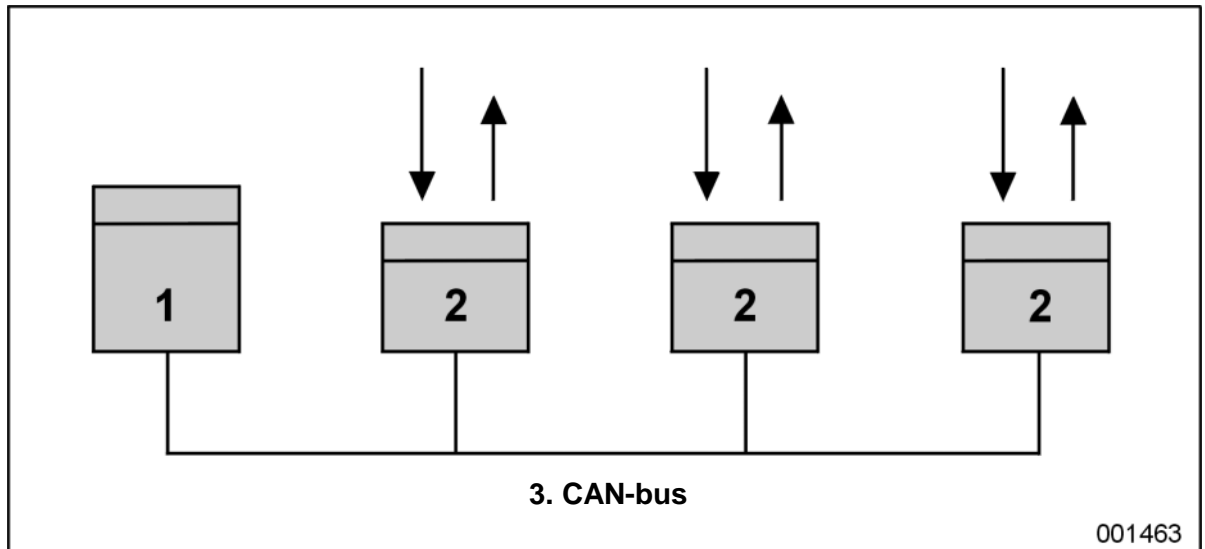
Figure 3: Basic multiplex system with: 1. Master (1x) 2. Nodes (3x) and 3. CAN-bus (1x)

- A computer module (master) which contains the driver, in other words the programmable intelligence.
- A number of nodes (slaves) without programmable intelligence with input and output gates.
- A CAN-bus (connection between the elements of the system – see Figure 3).

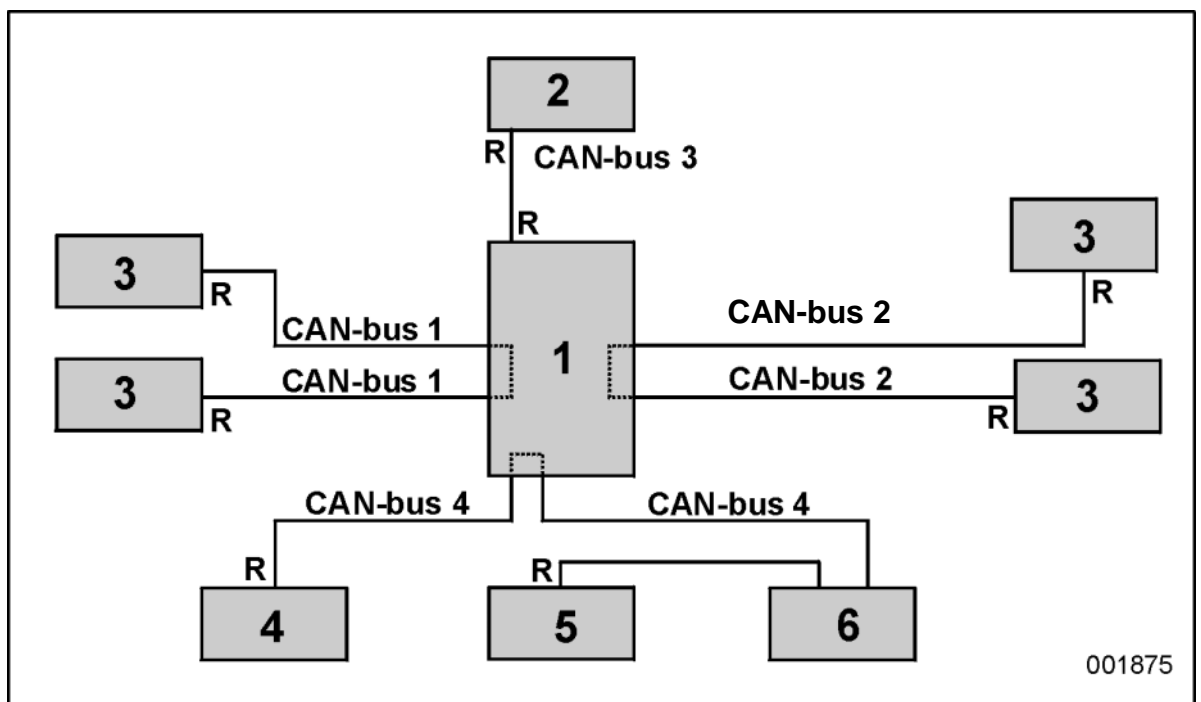
Figure 4: 1. Computer module. 2. Dashboard node (includes Multi Function Display - MFD). 3. Body nodes. 4. Vehicle engine control unit. 5. Transmission control unit. 6. ABS/ASR control unit. R: Terminal resistor

Figure 4 shows a multiplex network in practice.

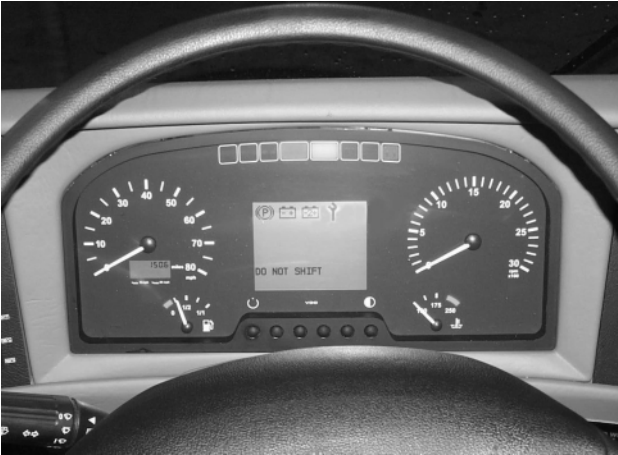
Figure 5: Dashboard node DMUX – includes MFD

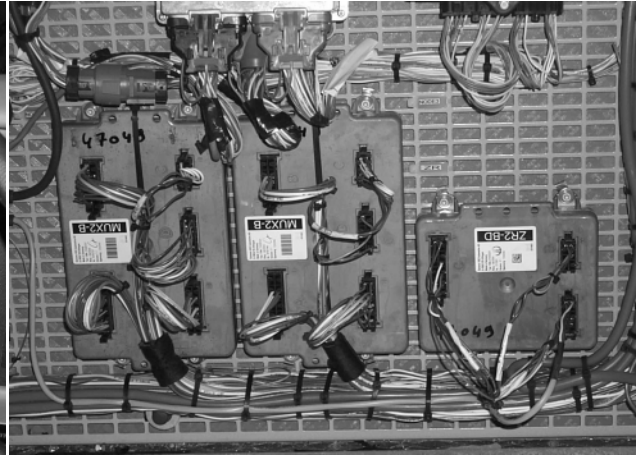
Figure 6: Computer module ZR2-BD and two nodes (located in the main junction box)

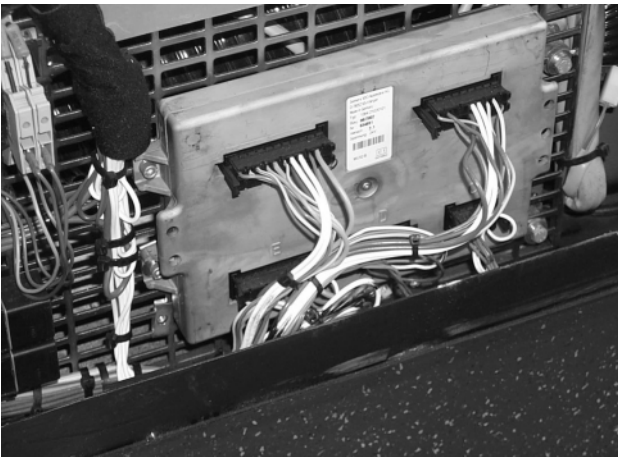
Figure 7: Typical node (this one is located behind the stepwell panel)

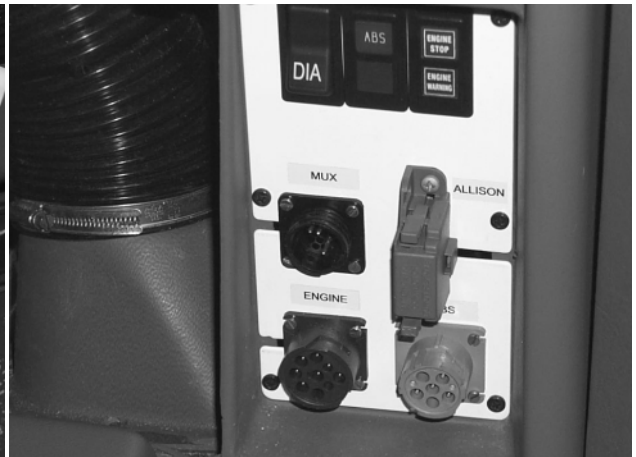
Figure 8: Diagnostic plug (located below right hand dash panel)

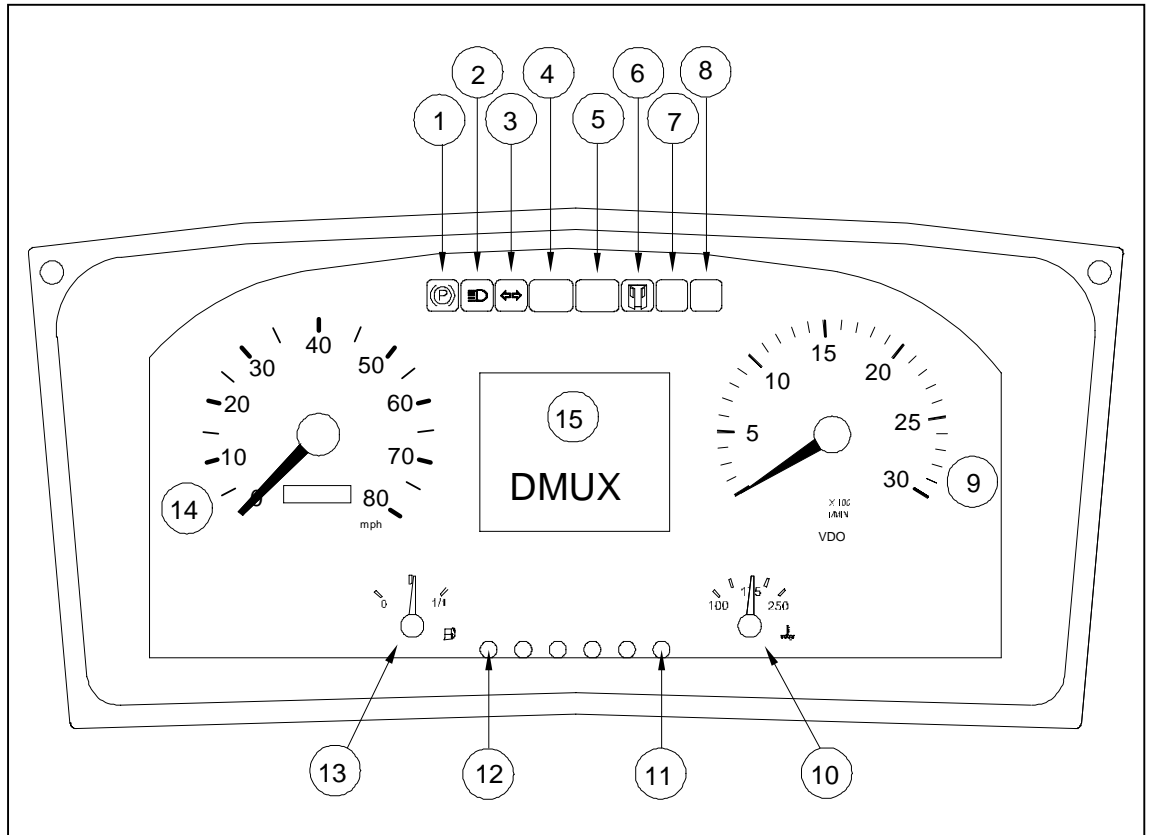
Figure 9, C2045 multiplexed center dash: 1. Parking brake ON 2. High beam indicator lamp 3. Turn signal indicator lamp 4. Red warning lamp 5. Amber warning lamp 6. Entrance door and lift door open 7. and 8. Blank 9. Rev counter 10. Coolant temperature gauge 11. Rheostat 12. MFD call-button 13. Fuel gauge 14. Speedometer 15. Multi Function Display

1. **Dash.** From the driver's seat, operators who have experience with the classic C2045 will notice a different center dash panel (see Figure 9).

- The speedometer and rev counter have switched places (9 and 14, Figure 9).

- The warning lamps in the center of the classic dash have been replaced by symbols and/or plain text on the multifunction display and by a single row of warning lamps (positions 1 through 8, Figure 9) which may or may not illuminate in conjunction with these symbols.

→ The function of lamps 1, 2, 3, 6, 7 and 8 is explained in the caption of Figure 9.

- A rheostat (11, Figure 9) allows the driver to change the light intensity of the dash.
 - With the introduction of the MFD as source of information, the warning lamp test switch has been omitted.
2. **Buzzer.** A buzzer has been installed, which can sound 4 different alarms (with engine running). These alarms may, or may not, sound in conjunction with the red or the amber warning lamp.

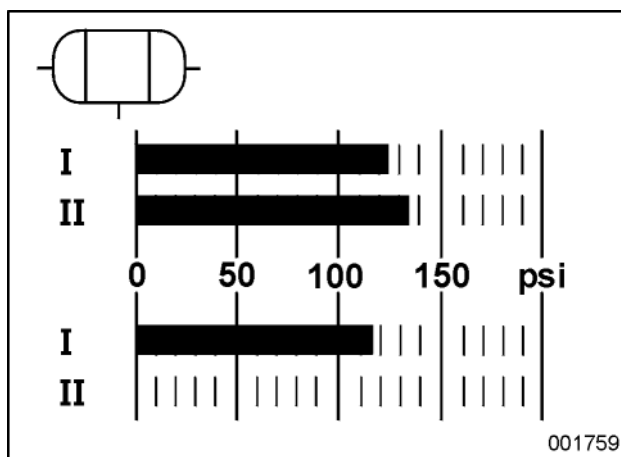
Figure 10: Bar graph showing 125 psi on the front axle (I), 135 psi on the drive axle (II) and 115 psi on the tag axle (I - beneath pressure numbers)

- The information given by the three axle air pressure gauges is now provided by the multifunction display (15, Figure 9) on a need-to-know basis or by pressing the MFD call-button once (12, Figure 9). Status is shown as a bar graph (see Figure 10) which disappears automatically after 10 seconds. Pressures are in psi units.

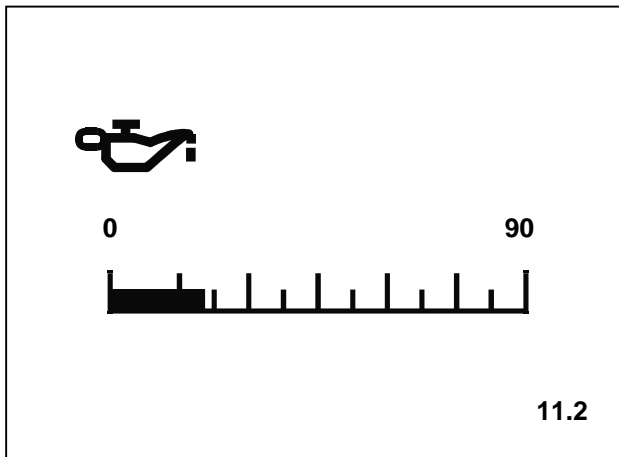
Figure 11.1: Oil pressure low – oilcan shown in center of MFD.

- The oil pressure gauge has been omitted. Oil pressure information is also provided by the MFD on a need-to-know basis (oil can shown in center of display, see Figure 11.1), or by pressing the MFD call-button (12, Figure 9) four times to obtain the actual operating pressure (Figure 11.2).

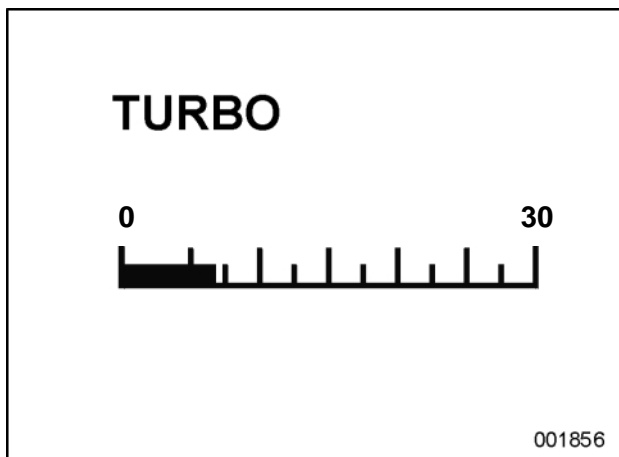
Figure 12: Turbo boost pressure shown on MFD

- The turbo boost gauge too has been deleted. This information is again provided by the multifunction display (see Figure 12) and can be retrieved by pressing the MFD call-button (12, Figure 9) three times. End of scale equals 2 bar (29 psi).

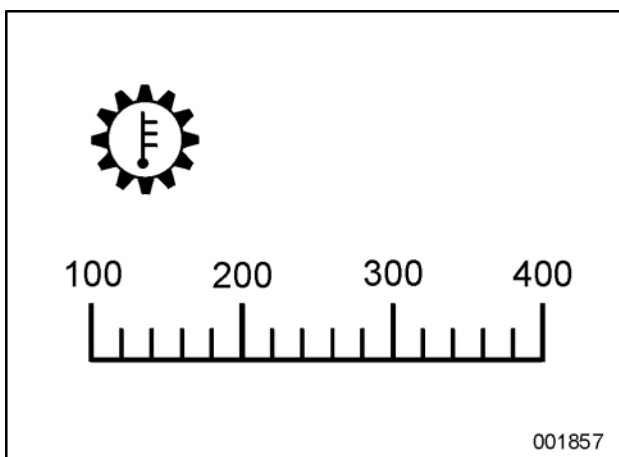
Figure 13: Transmission fluid temperature shown on MFD (no reading)

- New is the information on the temperature of the transmission fluid (see Figure 13). Press button 12, Figure 9 twice to have this information shown on the MFD.

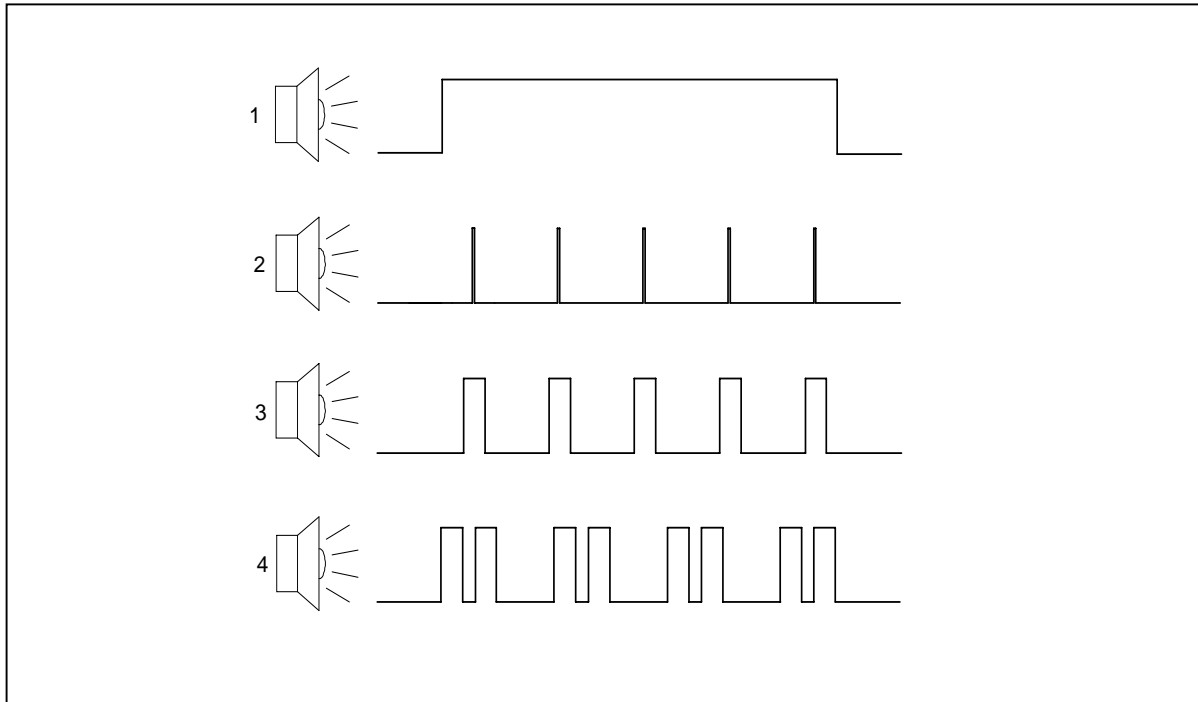
Figure 14: Multiplexed C2045 buzzer signals

1. Continuous
2. Spike
3. Single pulse
4. Twin pulse

Buzzer signal	Key	Warning lamp
Continuous (1, Figure 14)	<ul style="list-style-type: none"> • Stop engine • Suspension rising/lowering/kneeling/rear raising • Passenger emergency call 	<ul style="list-style-type: none"> • Red • Amber
Spike pulse (2, Figure 14)	<ul style="list-style-type: none"> • Check engine/Engine warning • Fuel low • Do not shift 	<ul style="list-style-type: none"> • Amber • Amber • Amber
Single pulse (3, Figure 14)	<ul style="list-style-type: none"> • Transmission fluid temperature high • Fire alarm • Lift door unlocked 	<ul style="list-style-type: none"> • Red • Red
Twin pulse (4, Figure 14)	<ul style="list-style-type: none"> • Air system pressure low • Air pressure low at front/drive/tag axle 	<ul style="list-style-type: none"> • Red • Red
