# SERVICE BULLETIN No.1167

<b>COACH MODEL</b>	: T2145 and C2045
<b>BULLETIN TYPE</b>	: Field Change Program
<b>MANUAL &amp; SECTION</b>	: N/A
<b>MANUAL REVISION</b>	: No
<b>DATE</b>	: June 28, 2005
<b>SUBJECT</b>	: <b>Condenser fan relay wiring</b>
<b>TERMS &amp; CONDITIONS</b>	: Refer to the Warranty Information in this Bulletin.

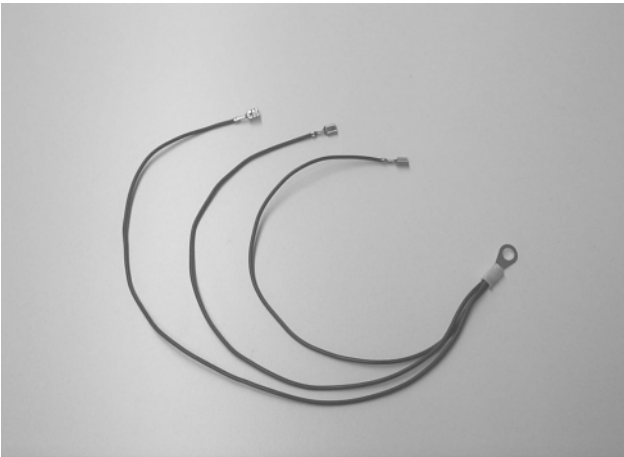
**Figure 1: Carrier/Sütrak wiring loom**

<b>Part No.</b>	<b>Description</b>	<b>Qty.</b>
VH 10962304	Wiring loom, Carrier 63.50.20.030	1

- 7) Install the female blade terminals of wiring loom VH 10962304 in the now vacant #87 slots in the #K26M, #K24M and #K22M relay sockets respectively.  
Hook-up the ring terminal to the switch panel ground stud.  
Secure with the M8 nut. Tightening torque: 15 ft.lbf (20 Nm).
- 8) Reinstall #K26M, #K24M and #K22M relays into their respective sockets.
- 9) Attach the relay bank to the switchboard back plate with the sheet metal screws.
- 10) Reinstall relays #K3A, #K23M and #K28M.
- 11) Reinstall the lower cable duct guard.
- 12) Close the HVAC junction box.

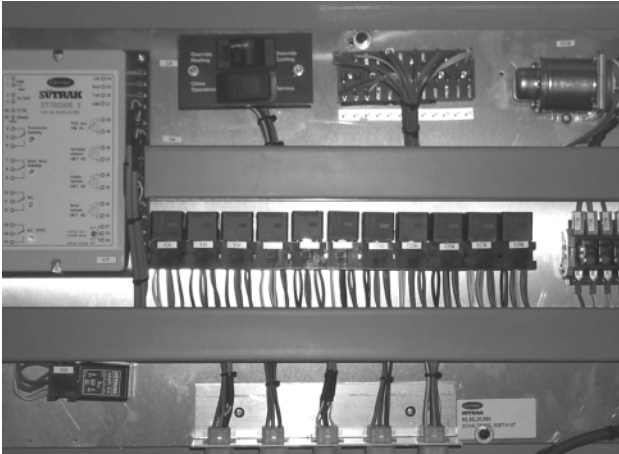
**Figure 2: Carrier/Sûtrak HVAC switchboard**

- 1) In the luggage compartment locate and open the HVAC junction box to reach the switchboard (see Figure 2)

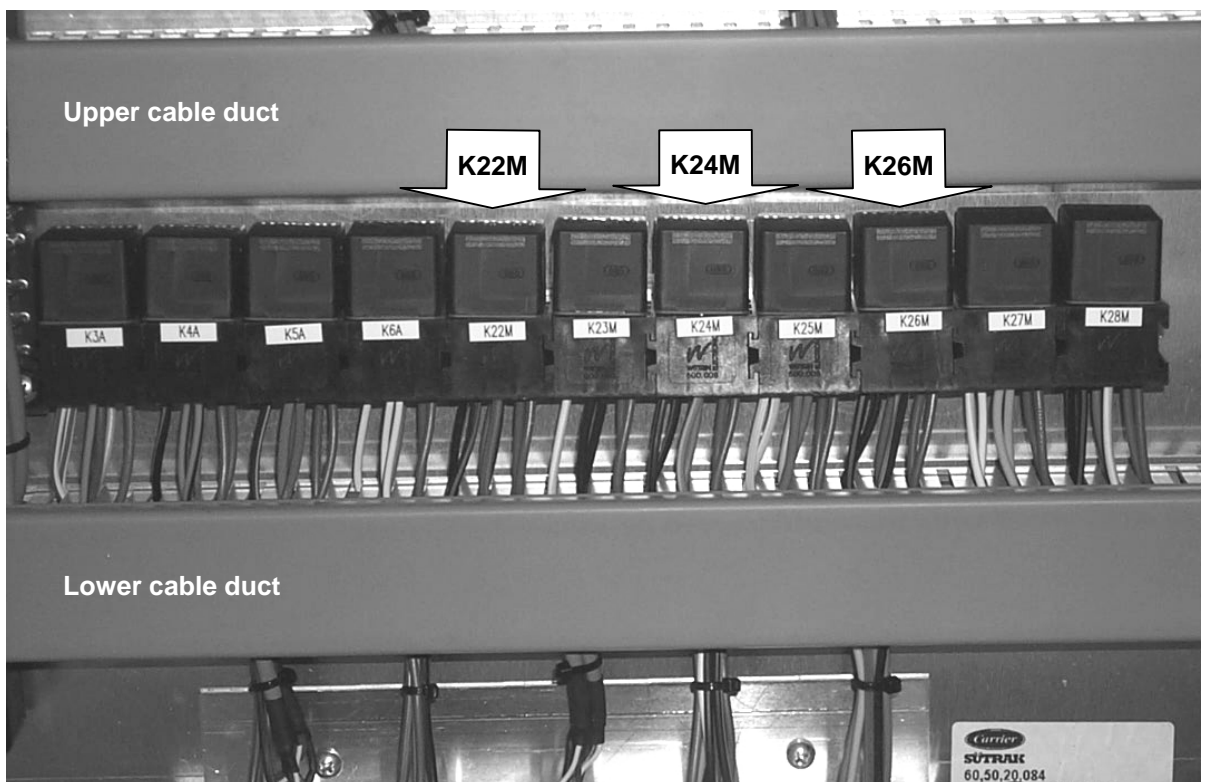
**Figure 3: Relays upper and lower cable duct**

- 2) Locate condenser fan relays #K26M, #K24M and #K22M (see Figure 3).

- 3) Remove the guard from the lower cable duct (see Figure 3).
- 4) To access the relay bank mounting screws, remove relays #K3A, #K23M and #K28M. Undo and remove the sheet metal screws securing the relay bank to the junction box back plate. Withdraw the relay bank.
- 5) Remove relays #K26M, #K24M and #K22M. To remove the #87 ground terminal press down the terminal locking tab with a small screwdriver and withdraw the terminal from the #K26M, #K24M and #K22M relay sockets.

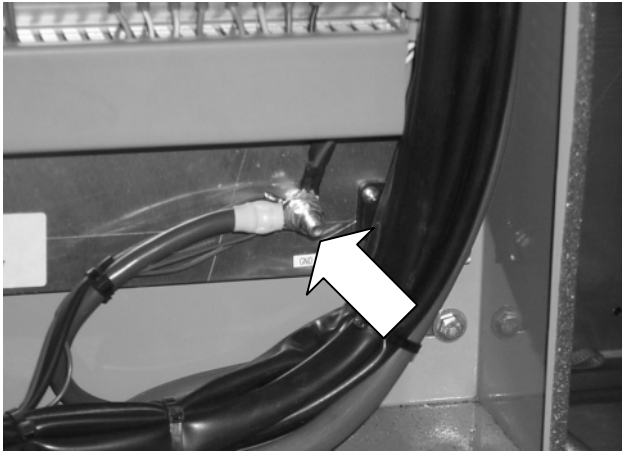
**Figure 4: Switchboard ground stud**

- 6) Undo and remove the nut securing the relay ground wires to the junction box back plate (see Figure 4).  
Remove relay #K26M, #K24M and #K22M terminal #87 ground wires.
