ADDRESSEES	: ABC Customer Care and Parts Source Owners and operators of coaches listed under 'Application'
VEHICLE MODEL	: TD925US
MANUAL SECTION	: 10.62 Body and accessories - Seats
BULLETIN TYPE	: Field Change Program
DATE	: January 18th, 2016
SUBJECT	: To replace backrest of rear bench outer seats
TERMS & CONDITIONS	: Refer to the warranty section further in this Bulletin.

- On above mentioned vehicles the backrest of the rear bench outer seats must be replaced to improve the safety belt installation of these seats.
- To address this issue, Van Hool is conducting a Field Change Program, the terms and conditions of which are explained further on under "Warranty".
- Owners and operators of the affected units should change the backrest of the rear bench outer seats as explained in this service bulletin.

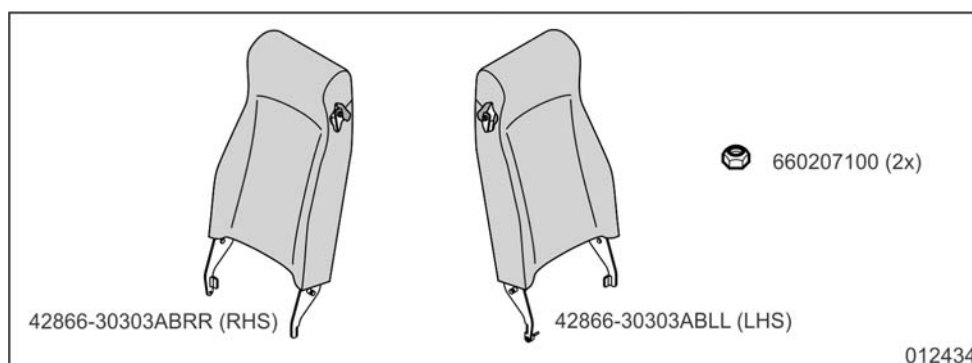
Figure 1: Identification of components

VH Reference	Description	Qty.
42866-30303ABLL	Seat backrest LHS	1*
42866-30303ABRR	Seat backrest RHS	1*
660207100	Self-locking nut	2*

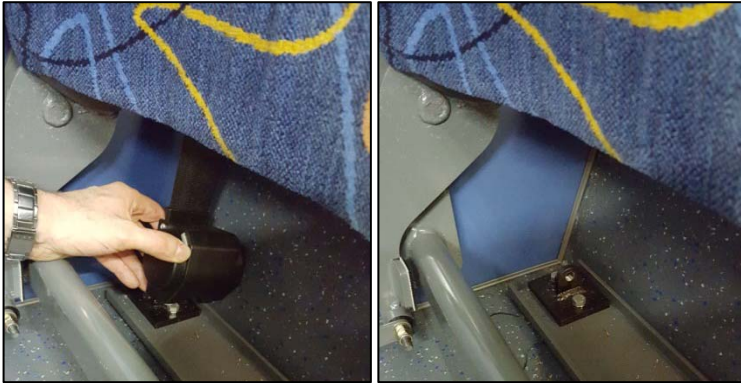
Step	Action
1	Remove the two seat cushions of an outer seat frame. The cushions are each secured to the seat frame by means of two screws accessible from underneath.
2	Remove the two safety belt retractors from their anchor bracket.

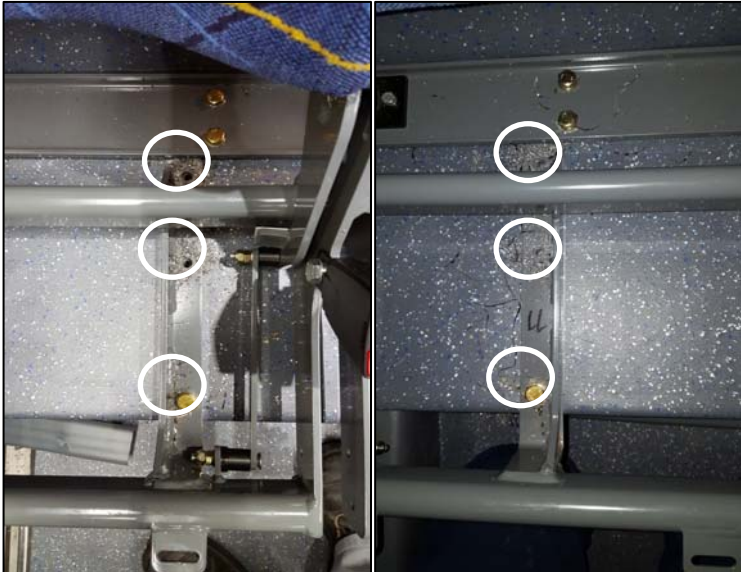
Figure 3

Figure 2
3	Remove the six screws holding the seat frame to the pedestal. Move the seat frame to the front to gain access to the rear of the backrests.

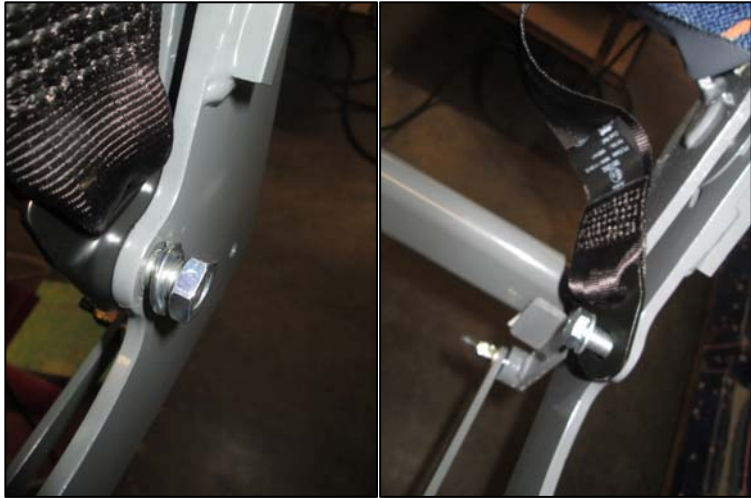
Figure 4

Step	Action
1	Remove the bolt securing the safety belt to the cushion frame.

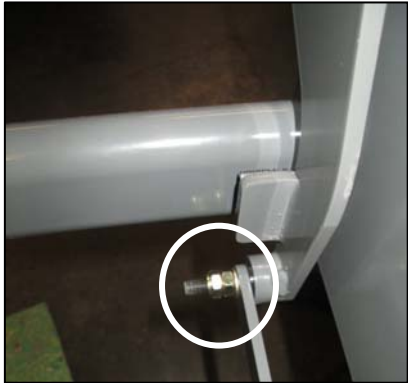
Figure 5

2	Remove the self-locking nut, the nut and the washer from the arm connecting the cushion frame to the backrest.

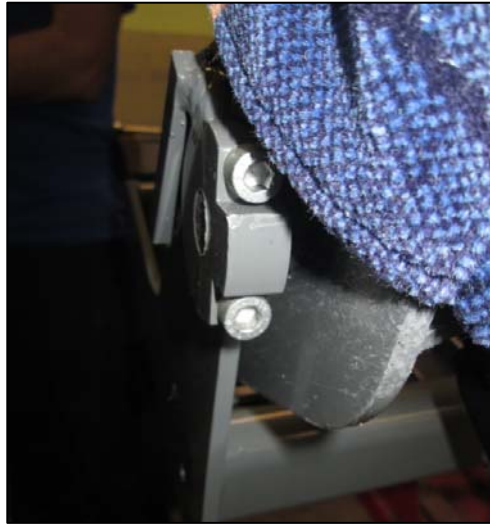
Figure 5

At the backside of the seat backrest, at both sides: remove the screws securing the shaft caps of the seat backrest to the cushion frame. Put the shaft caps aside.

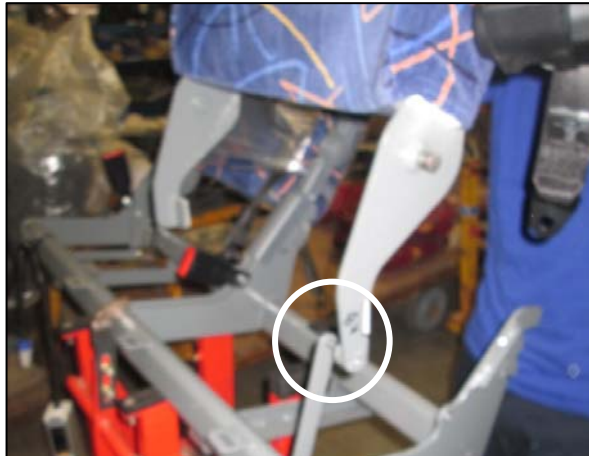
Figure 6

Lift the backrest up and disconnect the connecting arm from the backrest frame. Put the backseat aside.

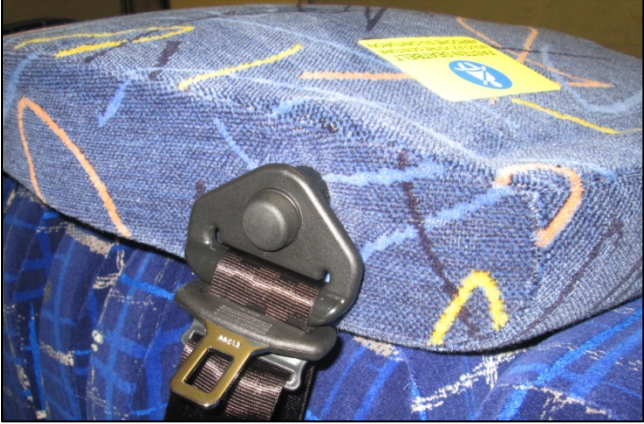
Step	Action
1	<p>Remove the safety belt from the OE seat backrest.</p> <ol style="list-style-type: none">Remove the nut cap.Remove the screw of the safety belt fixing triangle.

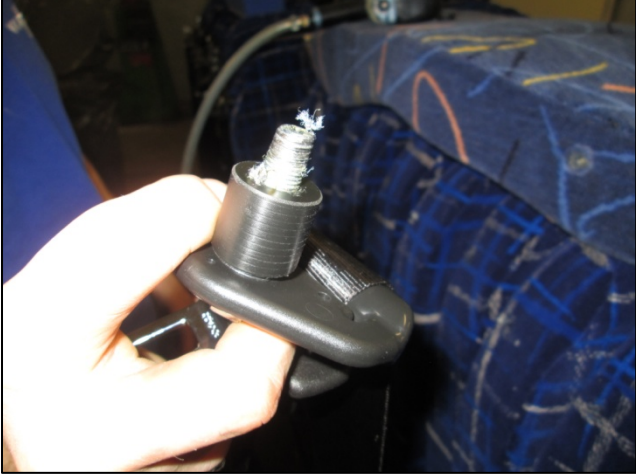
<p>Figure 7</p>
2	<p>Install the safety belt fixing triangle to the new backrest. Tighten the screw to a torque of 20 Nm (15 ft.lbf).</p>
