SERVICE BULLETIN No.1125

COACH MODEL	: T2145 and C2045
BULLETIN TYPE	: Service Information
MANUAL & SECTION	: Maintenance Manual: Chapter 10 – HVAC System Spare Parts Manual: Section 771809 – Water pump
PARTS BOOK REVISION	: Yes
DATE	: February 16th, 2004
SUBJECT	: New Proheat coolant pump
TERMS & CONDITIONS	: No claims will be accepted with reference to this Bulletin.

Part Update Bulletin

Description: **Coolant Pump CP5300 24V**

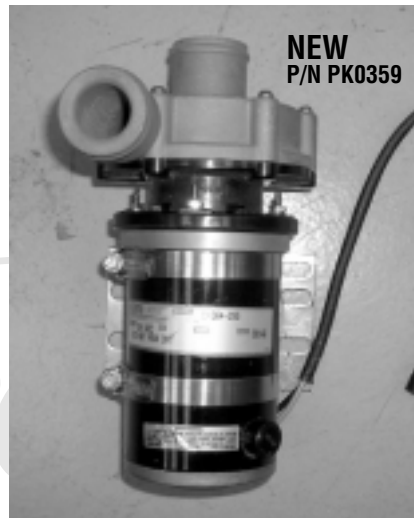
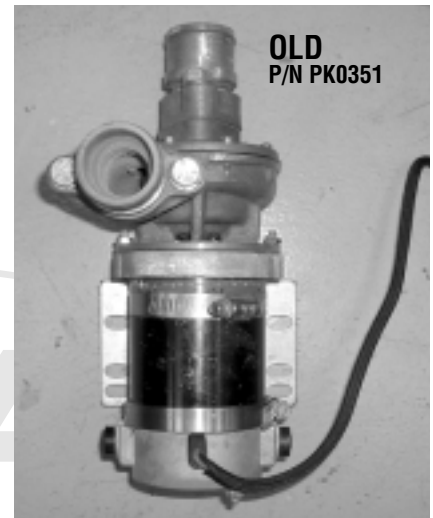
- P/N PK0359 Kit.

Replaces Coolant Pump used in:

- P/N PK0351 Long Life Coolant Pump Kit (no longer available).
- All OEM applications where Proheat supplies the coolant pump.

Product Affected: Proheat Bravo 80 applications where the PK0351 Long Life Pump was used.

- PK0359 (New Pump) – 3.2 kg. (7 lbs.)
- PK0351 (Old Pump) – 5.0 kg. (11 lbs.)

- Higher efficiency (lower amperage draw for the same or better coolant flow).
- Motor runs at a lower temperature.

- Eliminates gaskets and flange connections.

- Mounting Bracket footprint identical.
- Coolant port locations:
 - Outlet port backward compatible.
 - Inlet port is 35.5mm (1.4") shorter on P/N PK0359.
- Electrical connections identical.
