COACH MODEL : C2045, T2140, T2145 with Kibes 2 Multiplex

SUBJECT : Battery symbol with arrow pointing down on dash display

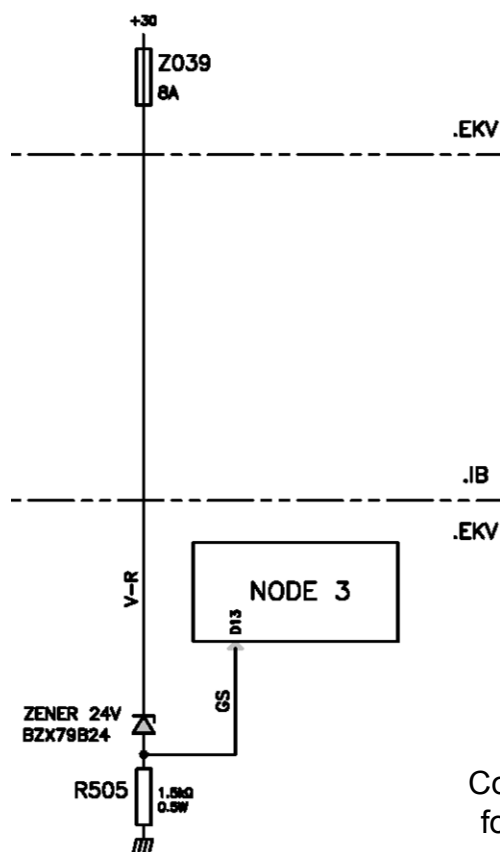
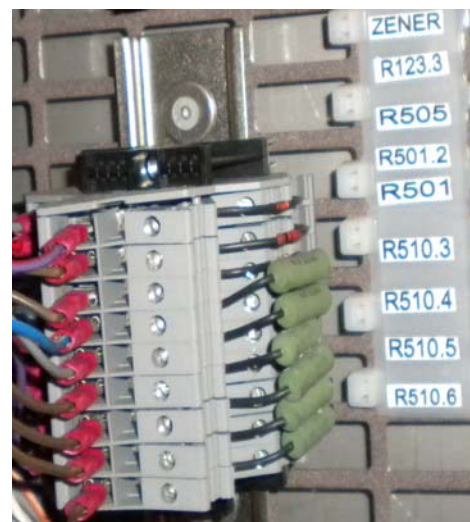
All items shown are located in the front electrical box (EKV)

A Zener diode is different than a regular diode and is used in the circuit to determine if the on-board voltage is low. Diodes behave like one way valves, they allow current to flow in one direction. Zener diodes are optimized to operate when placed backwards in a circuit. When operating properly the Zener diode will allow voltage from Z039 through to Node 3, D13.

With the engine running, 5 volts or more should be present at Node 3, D13. If not, the symbol will appear on the dash. Check Z039, R505 and the Zener diode if the voltage is below 5 volts.
