SERVICE BULLETIN No.1150

COACH MODEL	: C2045 w/ D-ELSA brakes
BULLETIN TYPE	: Service Information
MANUAL & SECTION	: Maintenance Manual: Chapter 8 - Suspension Spare Parts Manual: Section – 641105 Front axle suspension
MANUAL REVISION	: Yes
DATE	: September 8, 2004
SUBJECT	: Kneeling proximity switch- trigger bracket installation
TERMS & CONDITIONS	: Refer to the Parts and Products section in this Bulletin.

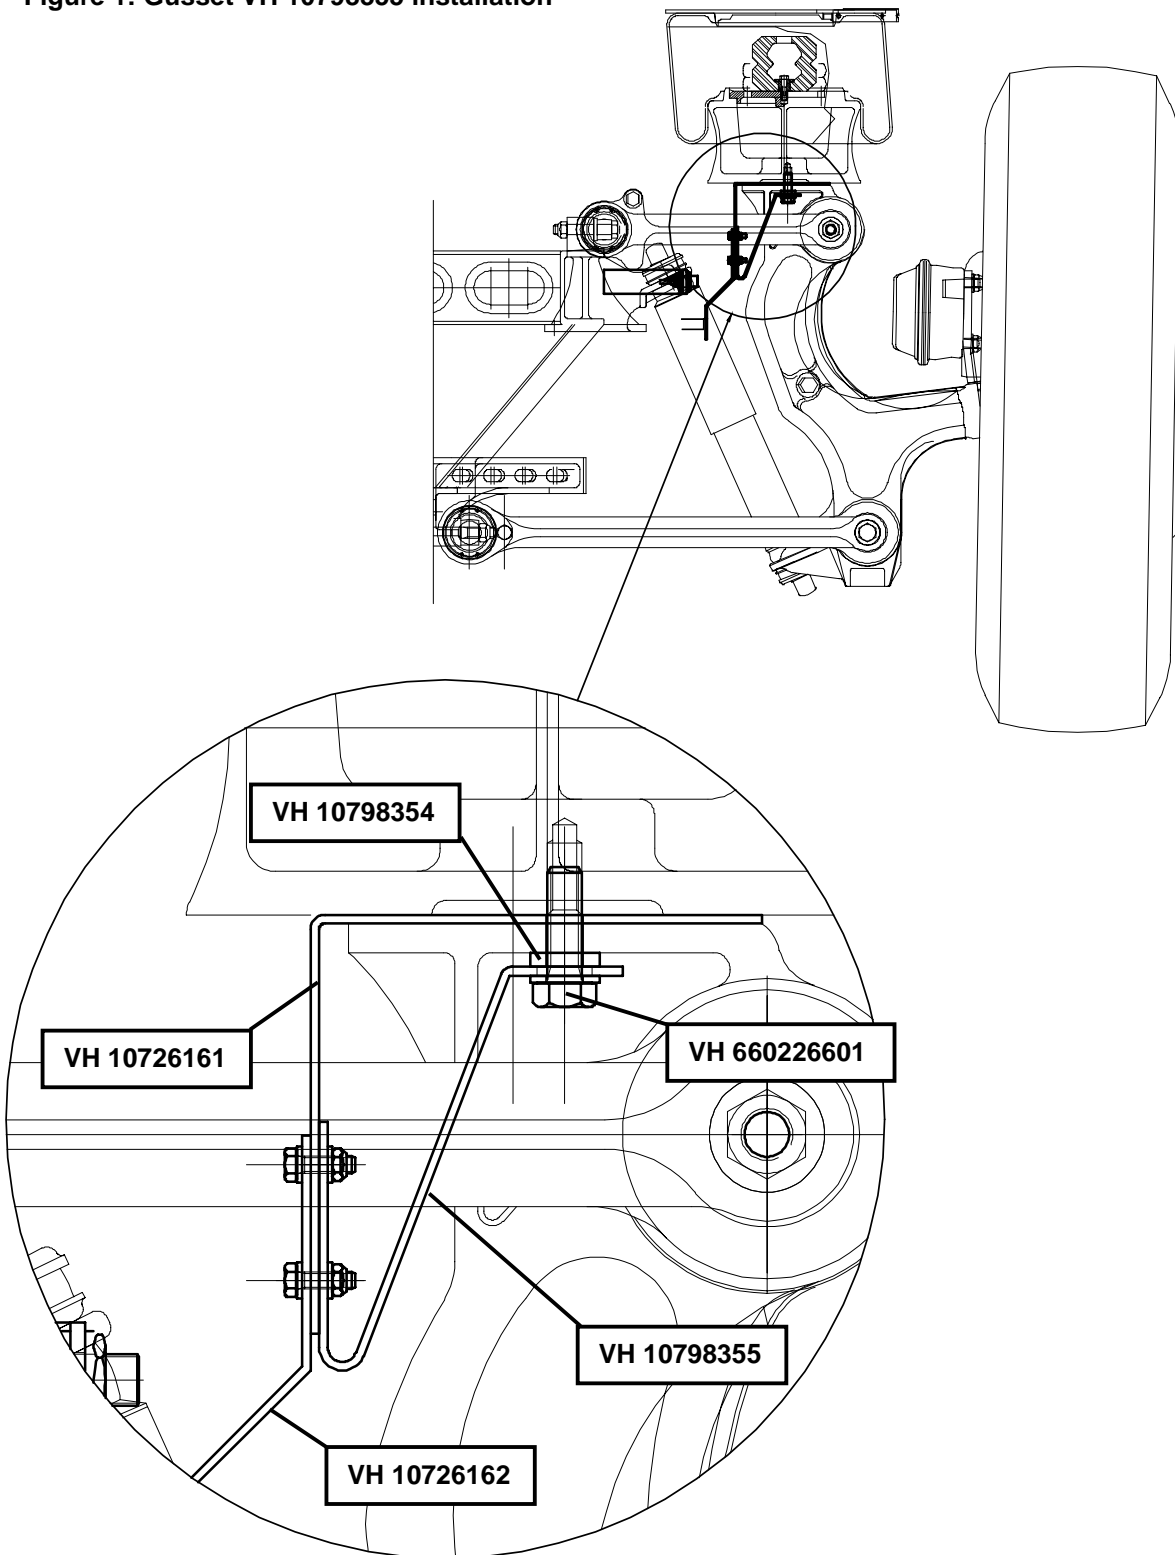
Figure 1: Gusset VH 10798355 installation

4. To install mounting bracket steady VH 10798355 (see Figure 1):

- 5) Install the trigger and gusset VH 10798355 as shown in Figure 1. Secure for a loose fit with the 6 mm bolts, nuts and washers.
- 6) Install washer VH 10798354 between the gusset and the suspension cone mounting flange.

- 7) Run-up bolt VH 660226601, which is 5 mm longer, to secure the steady, washer and suspension cone. Tighten to a torque of 45 to 60 ft.lbf.
- 8) Tighten the trigger to mounting bracket bolts to 80 in.lbf.
